| Title | Door Lock Cylinder Cover - Fitment at PDI / Replacement. |

| <b>Title</b> | Updated - Door lock cylinder cover, fitment at PDI / replacement |

# X351 DOOR LOCK BEZEL – SSM Pre-Fitment Inspection

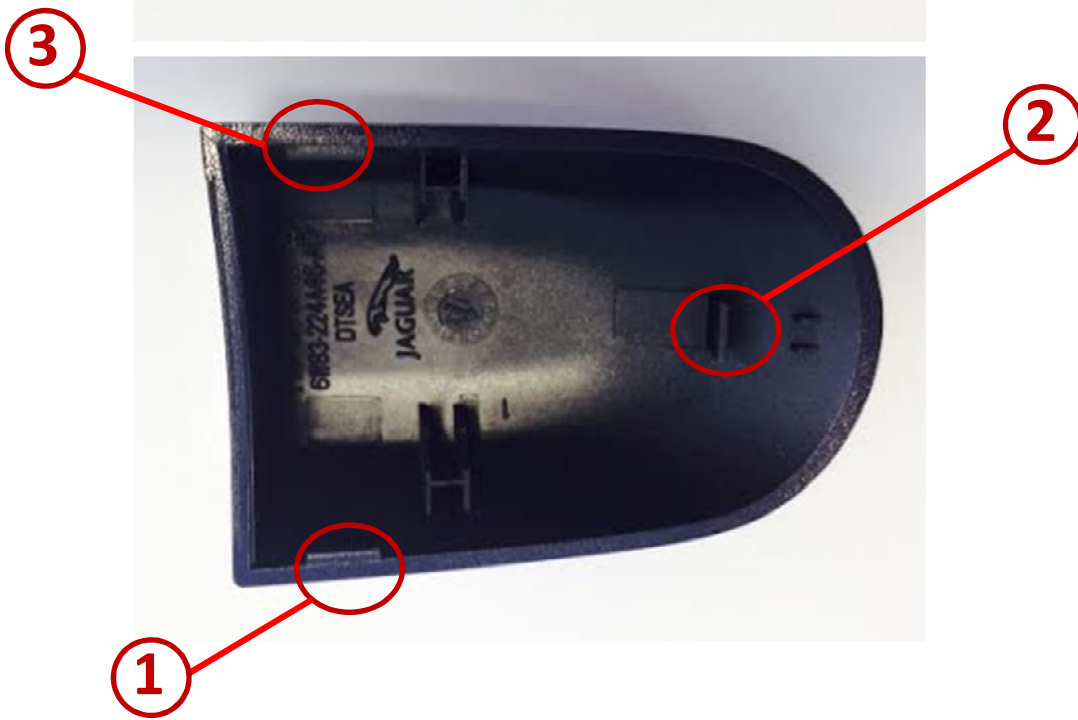
| Content | <p>Issue:<br/>Customer may report door lock cylinder cover missing.</p> <p>Cause:<br/>Cylinder cover may have been incorrectly fitted at PDI or after emergency vehicle entry.</p> <p>Action:<br/>The sequence of installing is shown on the attached doc. Please make sure that the door lock cylinder cover is pushed firmly in the sequence shown to install all 3 clips. The cover will now be securely attached to the vehicle.</p> <p><u>Ensure correct fitment by testing with a vigorous pull</u></p> |

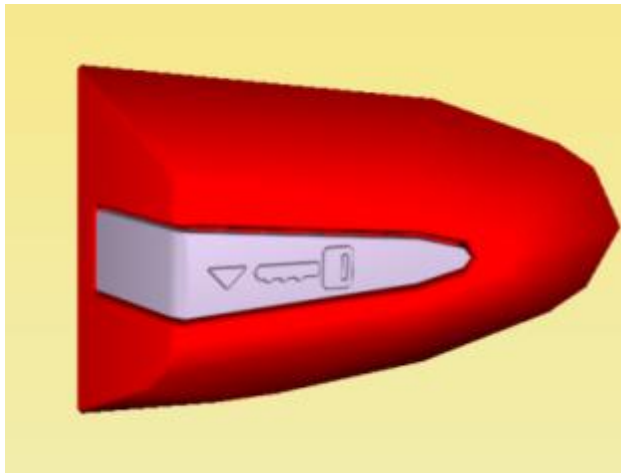
X351 Door Lock Bezel (LHD shown for illustrative purposes)

Inspect driver's door lock bezel prior to fitment.

Areas of concern – 3 clipping tabs on inside of bezel (see highlighted below)

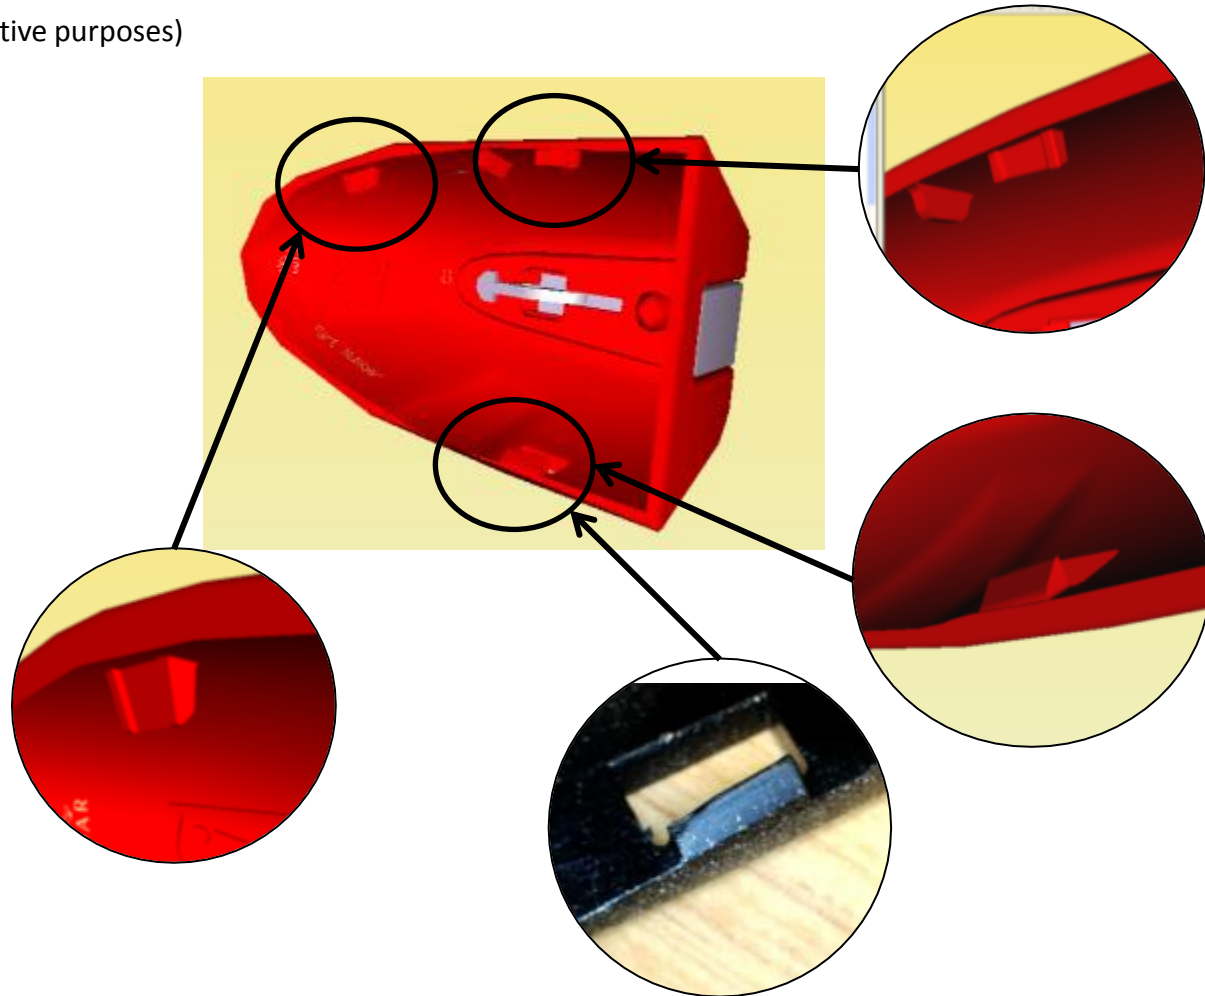
**Tab should display the conditions shown – please record if any do not.**
