Technical Bulletin

Model	Year	Eng. Code	Trans. Code	VIN Range From	VIN Range To
Passat	2012-2014	2.0L TDI (CKRA)	ALL	ALL	ALL

21 14 06 December 3, 2014 **2036110** Supersedes technical bulletin V211405 dated July 21, 2014 to modify the 1st bulleted sentence in Step 2.

Engine Lacks Performance, Shaft of Turbine Fan of Turbo Charger Broken or Seized

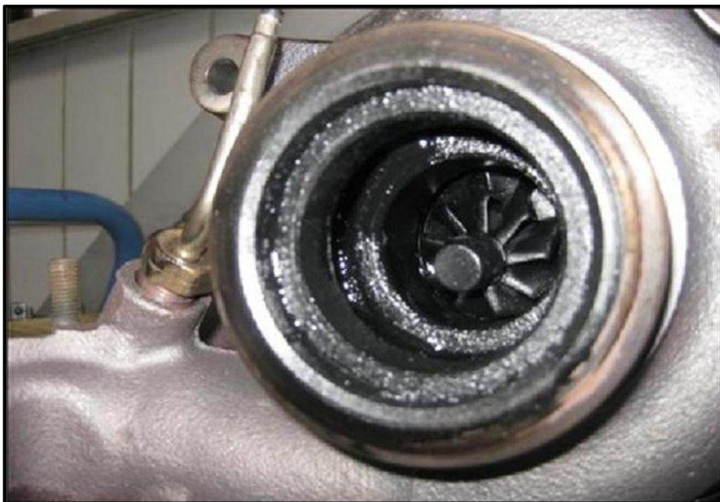
To confirm a broken shaft on the turbocharger the diesel particulate filter (DPF) must be detached on the turbocharger. This is the only way to check the turbocharger for damage and engine oil ingress on the exhaust side (figure 1).

Figure 1 (broken turbocharger shaft, engine oil ingress on exhaust side)

If the turbine fan shaft is broken, the complete engine oil circuit must be flushed out before replacing the turbocharger to avoid a repeat repair. To do this, proceed as follows:

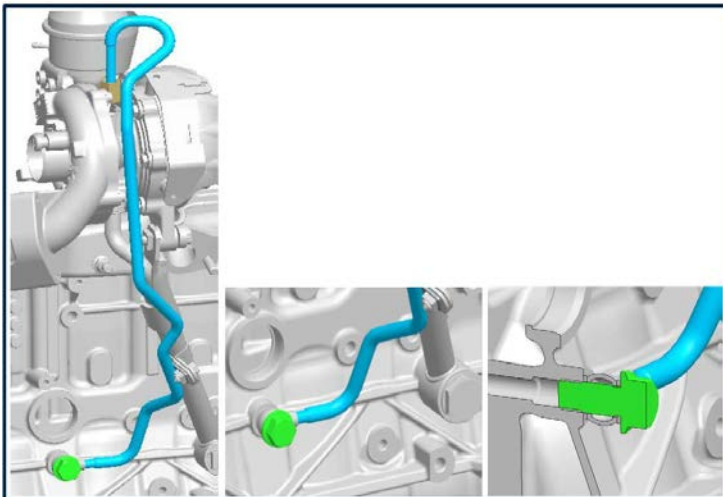
Figure 2

- Replace the oil filter according to the repair manual and thoroughly clean the inside of the oil filter housing.
- Drain the engine oil according to the repair manual.
- Unscrew the banjo bolt for the oil supply pipe on the cylinder block. Replace the banjo bolt with the hex head bolt with part number WHT 005 747 (figure 2, in green) and tighten it according to the repair manual to block oil supply to the damaged turbocharger.
