Service Bulletin

Bulletin No.: PI0740B

Subject: Engine Coolant Odor inside Vehicle Passenger Compartment

Models: 2011-2012 Chevrolet Cruze
Equipped with 1.4L Engine (RPO LUJ)

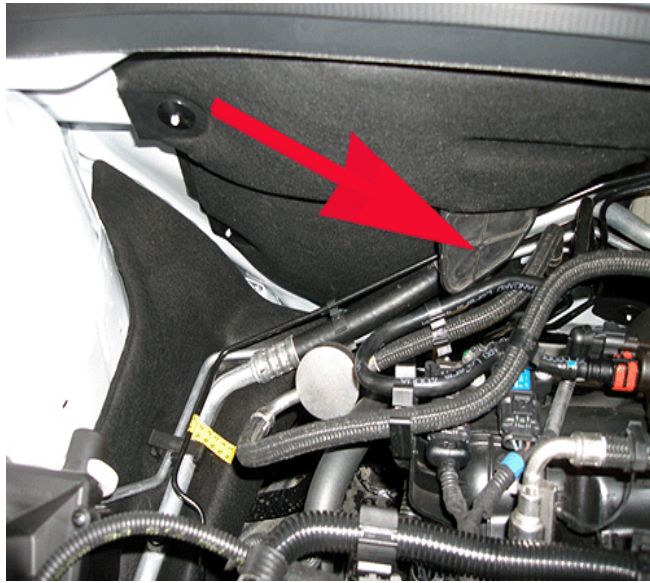
3722304

3. If any leaks are found, particularly inside the vehicle, ensure that all coolant has been cleaned/removed. This is an important step to ensure the odor is eliminated from the vehicle cabin. Coolant can accumulate in the lower areas of the HVAC housing.

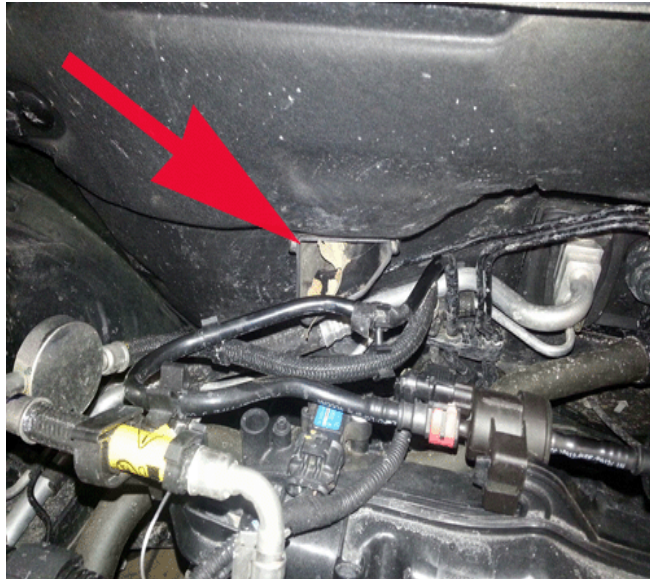
3722311

4. Inspect the plenum drain and ensure there is no foreign debris caught in the drain (leaves/twigs/pine tree needles) holding the cover open.

Clear any debris from the drain assembly (shown with cover removed).

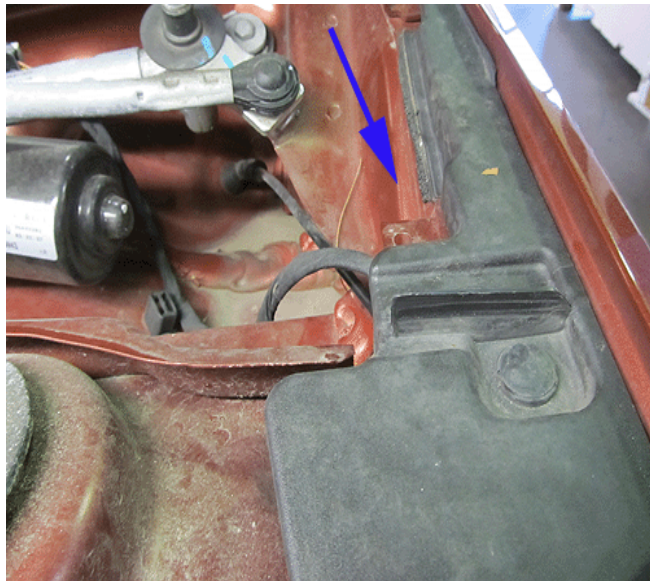
2858938

5. Inspect the front of dash seals (particularly around heater core inlet) and inspect the hood to cowl seal for gaps/poor sealing. Repair as required.
6. Install left and right hood seals as follows:
 - 6.1. Remove the air inlet grille. Refer to Air Inlet Grille Panel Replacement in SI.

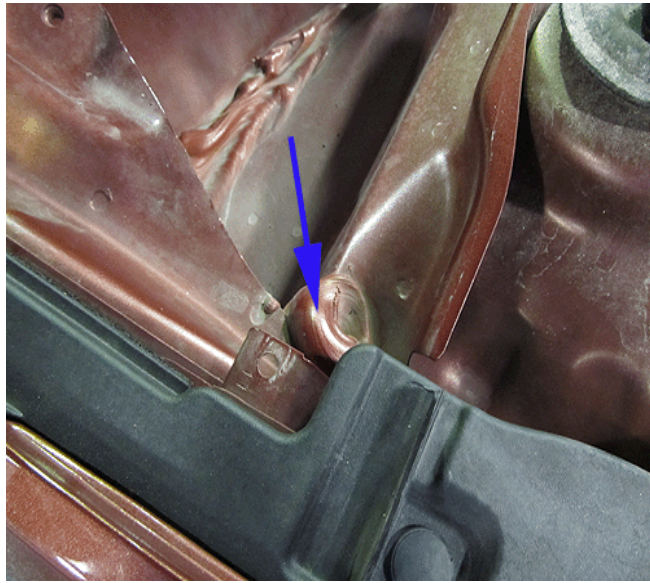
2858941

- 6.2. Clean the mounting areas with a general purpose adhesive cleaner.

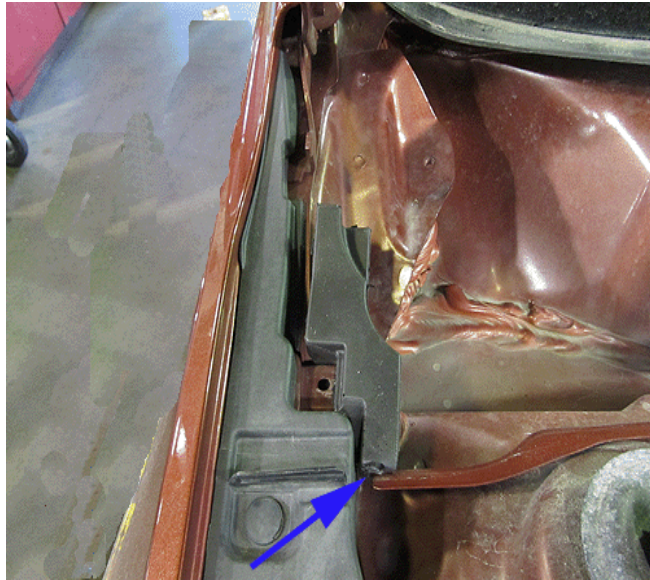
2858942

Note: It may be necessary to trim the excess body sealer in the plenum area to allow the seal to fit correctly.

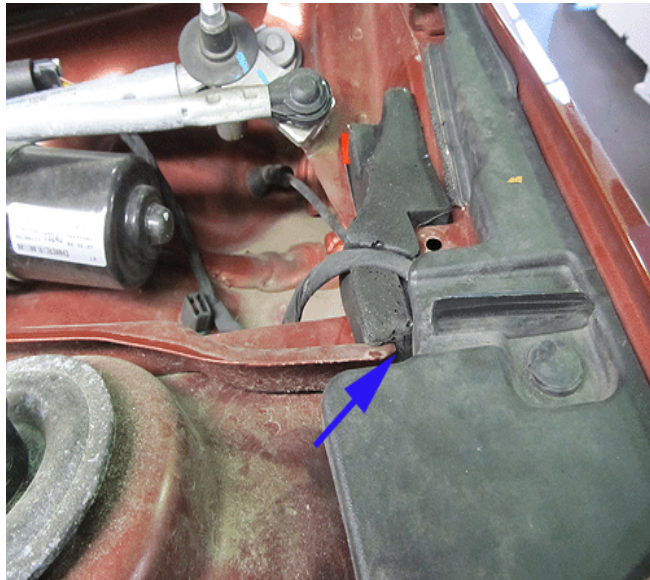
2858944

6.3. Install the right side hood seal, P/N 95486182, as shown. Ensure the gap is sealed.

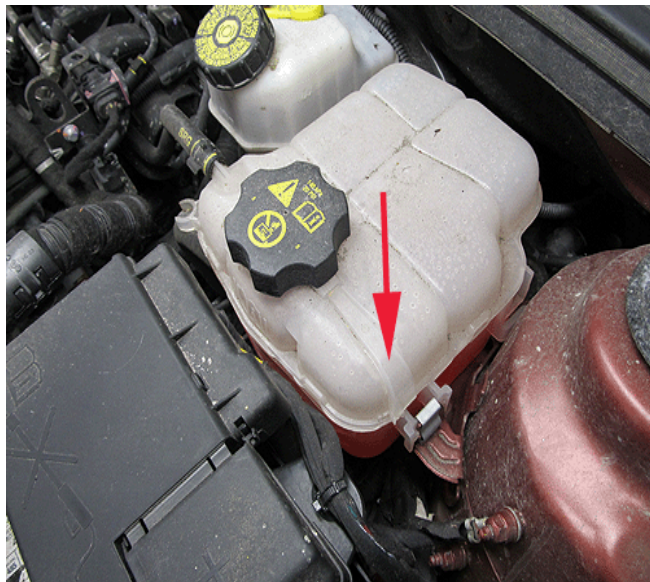
2858945

- 6.4. Install the left side hood seal, P/N 95486181, as shown. Ensure the gap is sealed.
7. Use the following steps to install a coolant reservoir drain tube:

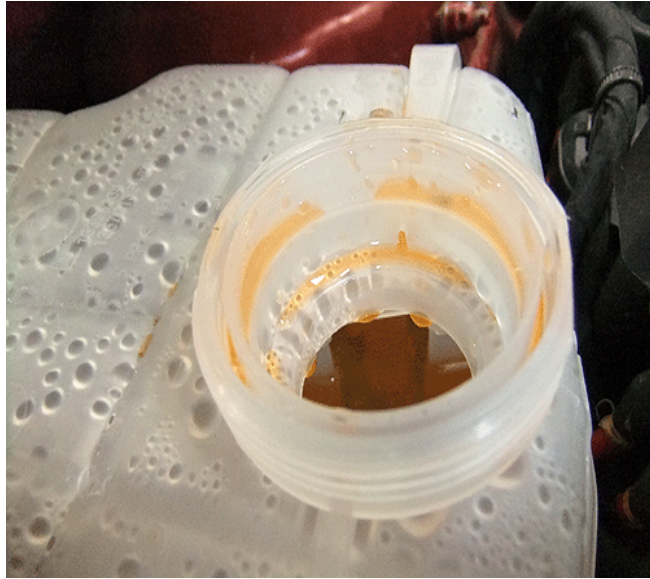
3427038

7.1. Remove the coolant reservoir vent cap/cover.

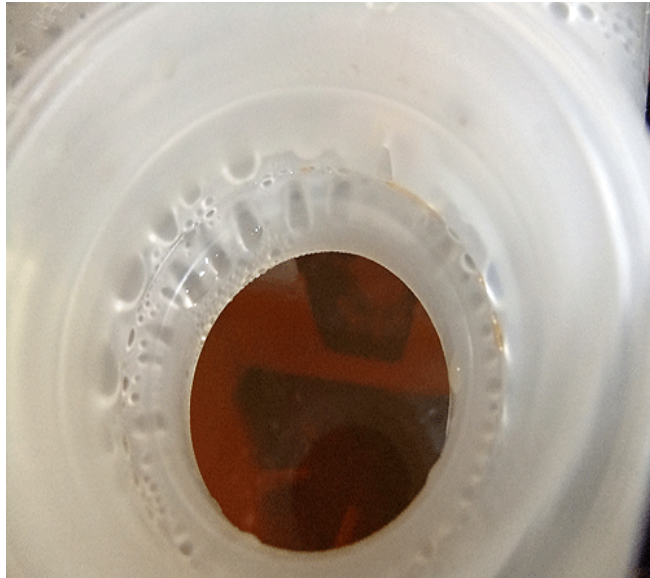
3427227

7.2. Clean any coolant residue from the fill neck area of the reservoir.

Ensure all traces of coolant are cleaned from the filler neck.

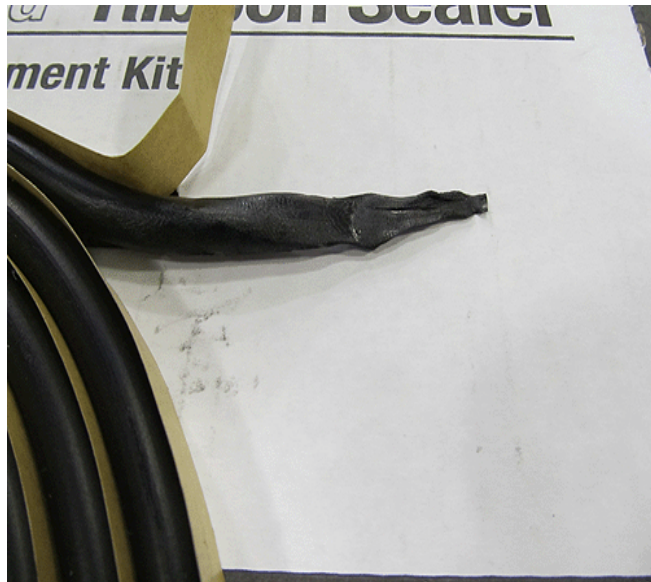
2858946

7.4. Prepare a 40 inch long section of locally sourced 0.375 in. OD and 0.167 in. ID drain hose.

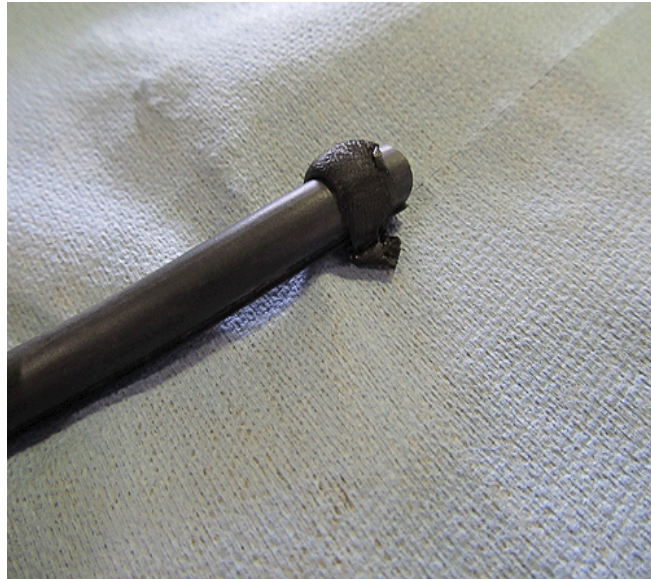
2858949

- 7.5. Stretch a small amount of butyl ribbon sealer, such as *3M® Window Weld Ribbon Sealer, Part # 08612 or the equivalent, into a thin ribbon about 25 mm (1.0 in) in length as shown.

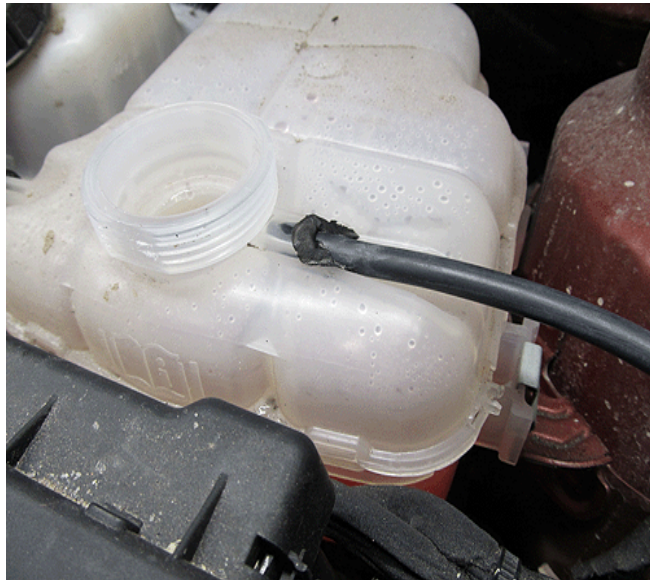
2858951

- 7.6. Wrap the butyl around the end of the hose as shown. Use care to not plug the end of the hose.

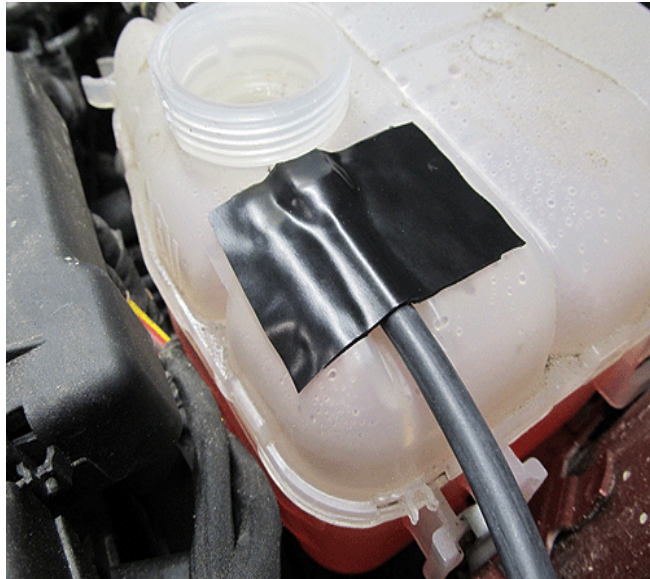
2858953

- 7.7. Insert the hose into the reservoir cavity as shown. Ensure the hose is fully inserted into the cavity and contacting the filler neck.

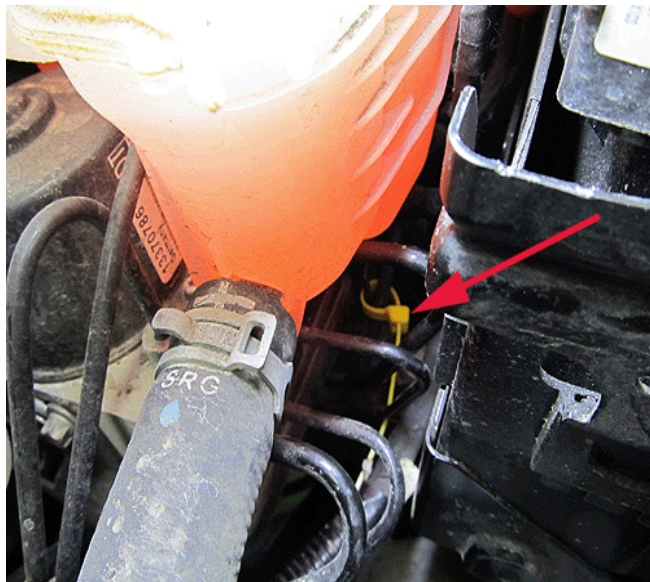
2858954

Note: Yellow wire ties are used in the following photos to better illustrate their location.

- 7.9. Route the hose down from the reservoir, along the driver side frame rail and between the control arm bracket and the frame rail. Using black wire ties, secure the drain hose as shown.

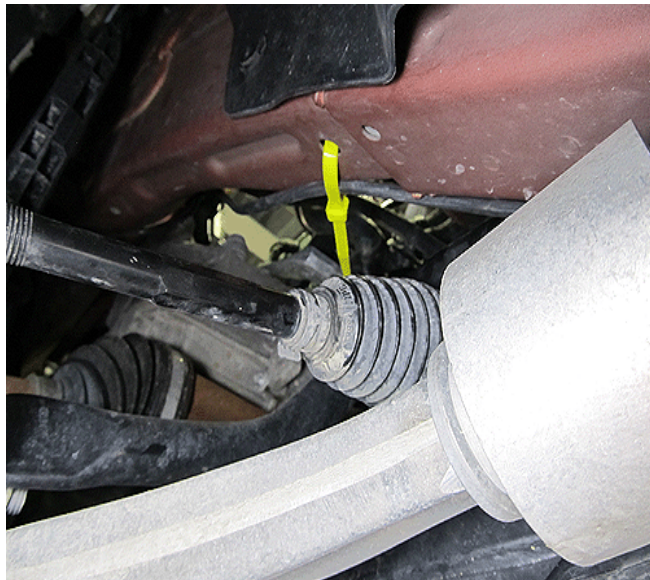
2858958

– Locate the first wire tie to the bracket directly below the coolant reservoir.

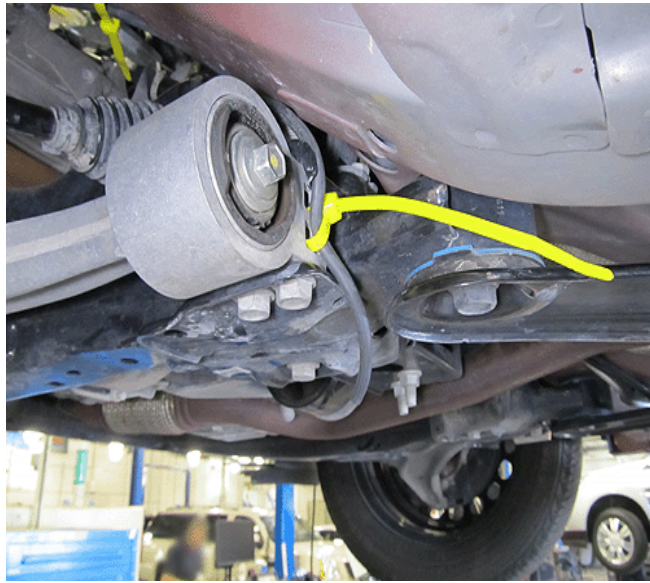
2858959

– Locate the second wire tie along the driver side frame rail as shown.

– Locate the third wire tie through the control arm mount as shown.
