Service Bulletin

Bulletin No.: PI0778A

Subject: Repair Guidelines for Intermittent, Partial or No Power Glove Box Function

Models: 2013-2014 Cadillac XTS
Built Prior to February 1, 2014

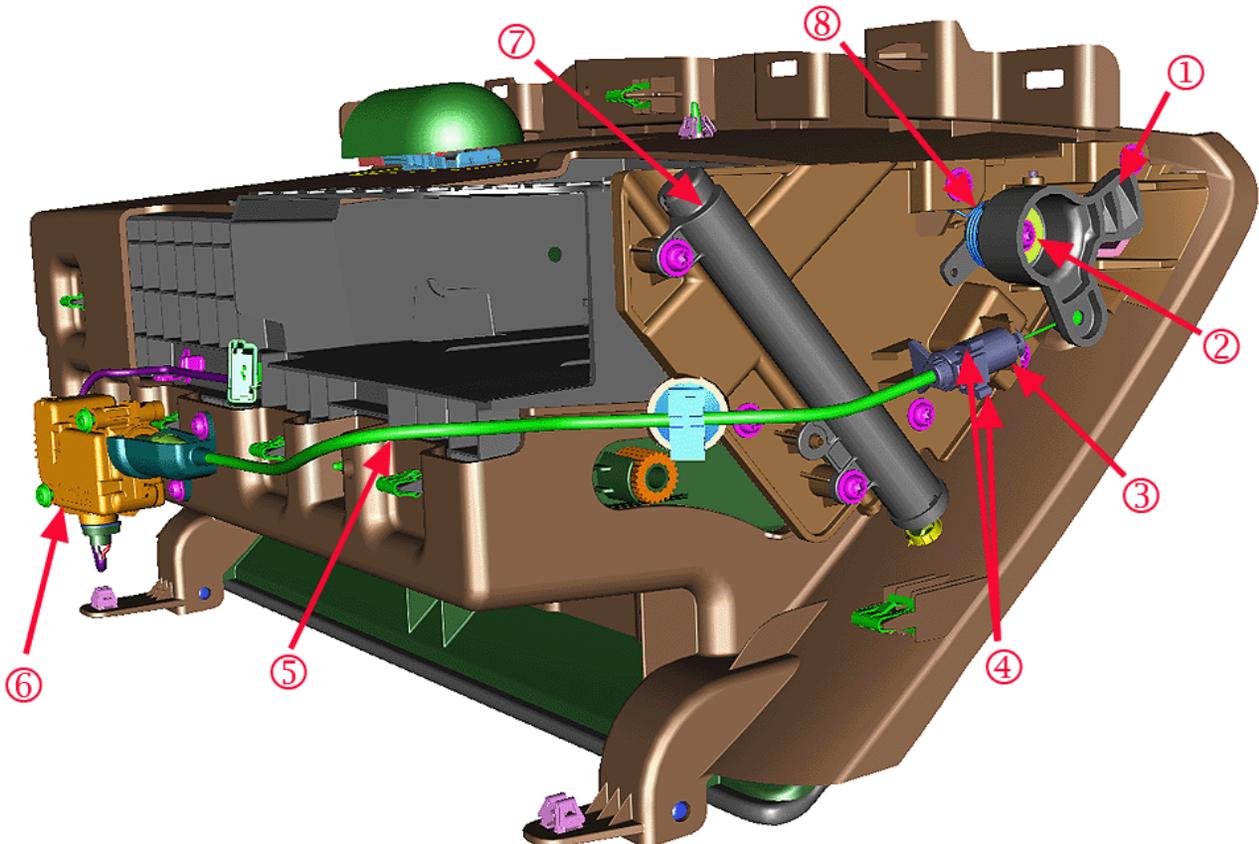
Figure 1 – XTS Power Glove Box Assembly

- (1) Actuator Cam
- (2) Cam Tension Screw
- (3) Actuator Cable Adjuster
- (4) Cable Adjuster Set Buttons
- (5) Actuator Cable
- (6) Actuator
- (7) Dampener Assembly
- (8) Cam Return Spring

Some customers may comment that the glove box door electrical switch is inoperative, or that the glove box door latch releases on one side, but not the other.

The cause of this condition may be glove box alignment, side rib interference or cam/cable adjustment issues noted in the repair procedure below.

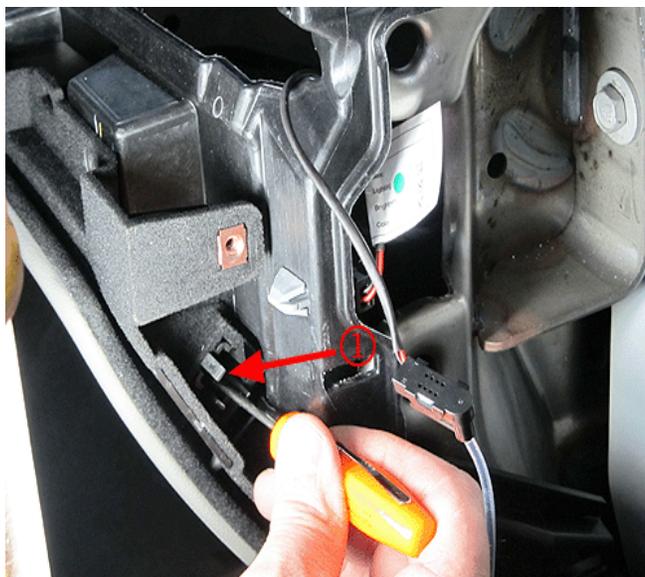
2893372

Tip: If the electrical switch is inoperative, or the glove box door is not releasing on either side, the door can be opened by inserting a small screwdriver, or similar tool, into the right side latch opening (1) and manually tripping the release.

Operate the glove box door electrical switch and listen for the sound of the actuator motor cycling.

- If you can hear the actuator cycling, move to Step 1 of the repair table below to verify if further repairs are necessary.
- If you cannot hear the actuator cycling, inspect the electrical connections to verify power to the glove box door actuator. Re-try the door after power to the actuator is established. If the door opens/unlatches, move to Step 1 of the repair table below. If power is verified and the actuator does not function, refer to I/P Compartment Door Latch Release Malfunction in SI.

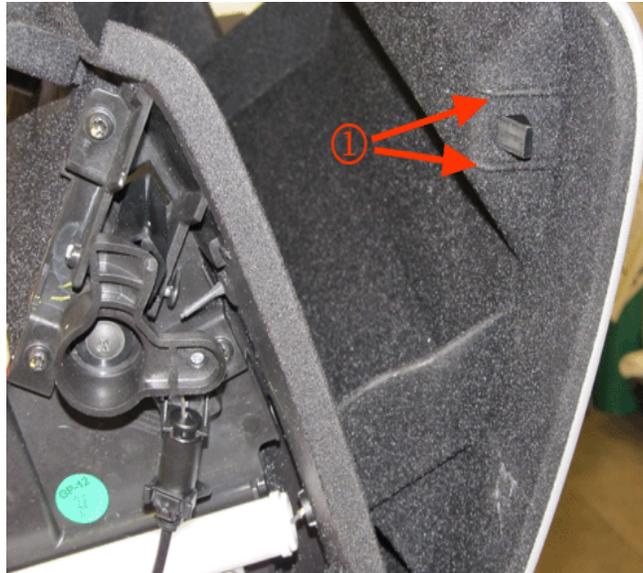
Figure 4– Inboard Ribs Removal

Carefully cut or shave off the ribs (1) using a sharp knife.

8	Check the ribs on the upper left inboard side of the glove box door (see Figure 4). Are they present?	Cut or shave off the ribs using a sharp knife. Go to Step #9	Go to Step #11
9	Re-try the door; does the door open completely ?	Go to Step #10	Go to Step #11
10	Repeat opening and closing the door ten times. Does the door operate correctly for ten iterations ?	System OK	Go to Step #11
11	Remove the glove box assembly and check the cam for looseness (see Figure 5). Is the cam tight?	Go to step #13	Go to Step #12
12	Tighten the screw at the center of the cam ¼ turn, but verify the cam will return to the design position. Retry opening and closing the door. Does the door operate correctly for ten iterations?	System OK	Go to #13
13	Check to verify that the cable adjustment set clip is snapped down (see Figure 6)	Electrical, rib, cam, and adjustment problems have been eliminated. Go to Step #16	Go to Step #14

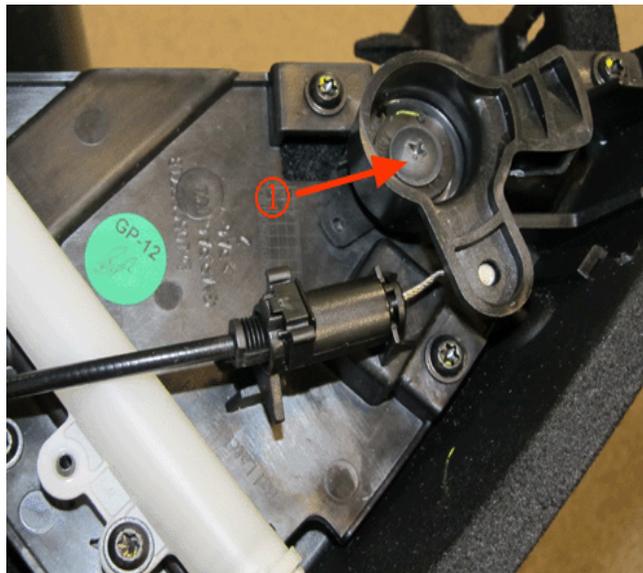
Figure 5– Cam Tension Adjustment

(1) *Cam Tension Screw*

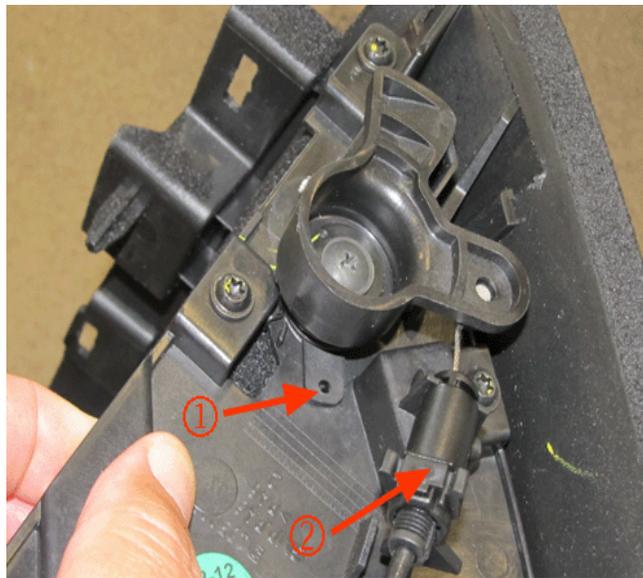
Figure 7– Cam Align/Cable Adjust

- (1) *Cam Set Pin Hole*
- (2) *Press Locking Feature*

14	Complete the following cable adjustment procedure (see Figure 7): <ul style="list-style-type: none"> • Release the cable locking mechanism by pulling up the cable set buttons (cable should be free to move inside the retainer). • Align hole in cam to the hole in the glove box housing and set with a pin. • Once the cam position is set with a pin, the cable can be set statically by letting its own return spring set that length prior to clipping the locking feature (cable set clips) into place. Listen for an audible double-click. <p>Note: The actuator cable must be secured on both ends to function properly.</p> <p>Does the door open completely ?</p>	Go to Step #15	Electrical, rib, cam, and adjustment problems have been eliminated. Go to Step #16
15	Repeat opening and closing the door ten times. Does the door operate correctly for ten iterations?	System OK	Go to Step #16
16	Replace the glove box assembly. Refer to I/P Compartment Replacement in SI. Have the electrical, rib, cam, and adjustment problems been eliminated?	Go to Step #17	Repeat all the repair steps beginning with #1 until the door opens and closes properly ten times.
