Service Bulletin

Bulletin No.: PI1005A

Subject: Exterior Roof Panel Sag/Depression

Models: 2013-2014 Chevrolet Express with 15 Passenger Seating (RPO ZP3)
2013-2014 GMC Savana with 15 Passenger Seating (RPO ZP3)

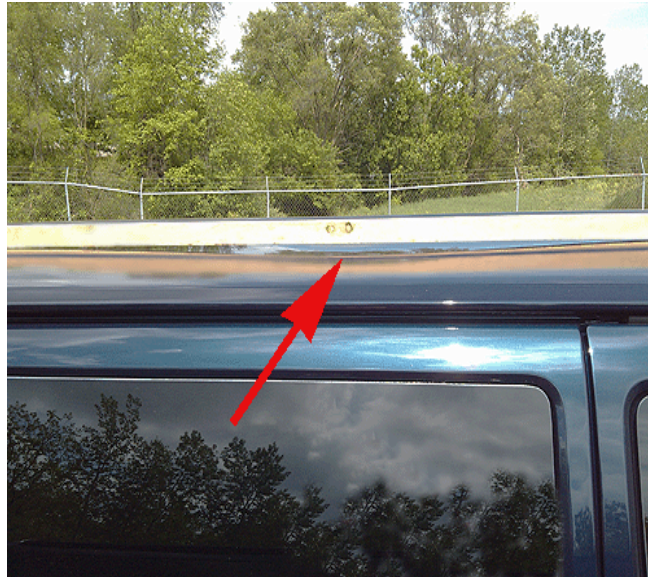
3490812

Some customers may comment that a sag/depression area appears on the roof of the vehicle at times and then goes away. This condition is most prevalent on dark colored vehicles. The affected area is 3 to 7 feet (0.9-2.1 m) from the rear edge of the roof with the deepest depression at 5 feet (1.5 m) from rear edge. The sag appears when the van is sitting outside in the sun and it will go away when van roof surface cools down but will re-appear when parked back in the sun. This sag is most prevalent on the passenger side of the vehicle. In some rare cases it may also appear on the driver side.

This condition is caused by an insufficient amount of (anti-flutter) sealer between the third and fourth roof bows and the outer panel. As the roof panel expands in the sunlight, the sealer does not expand as intended, causing the low areas to appear.

Use the following steps to remove the sealer (anti-flutter) in the affected area and install shim material.

Note: If possible, perform these steps in direct sunlight. This causes the roof outer skin to expand and increases the gap between the roof panel and the roof bows allowing easier installation of the shim material.
