Bulletin No.: PI1168

# Service Bulletin

**Subject:** Passenger Seat Power Adjustable Bolster Inoperative

**Models:** 2014 Cadillac ELR  
Equipped with Passenger Side Seat with Power Adjustable Bolster (RPO H6P, 4ER)  
Built Prior to January 9, 2014

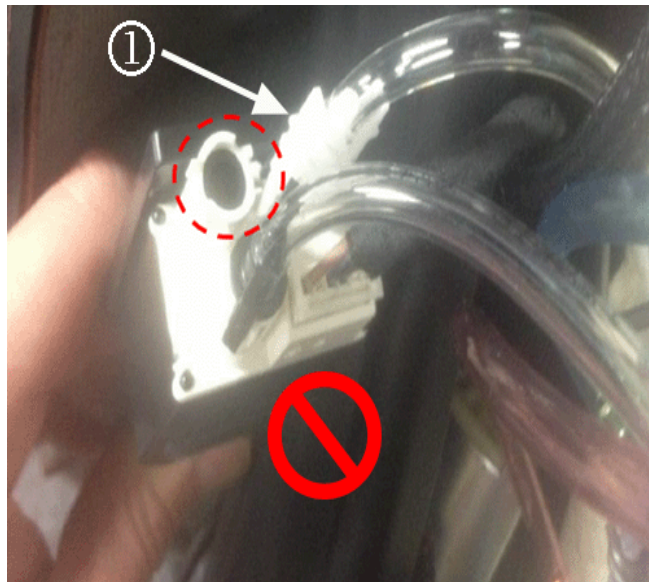
3705316

The cause of this condition may be that a pneumatic hose is in the wrong port on the adjustable bolster solenoid in the passenger seat back.

10. Inspect the position of the pneumatic hose with the white fitting (1). For the condition noted, the hose will likely be in the INCORRECT position (diagonal to the hose with the black fitting), shown in the graphic above. The correct hose position is circled above.
