Service Bulletin

Bulletin No.: PI1177

Subject: Front Door Striker Cover Not Staying Secure to Striker, Falls Off

Models: 2014 Cadillac ELR
Condition/Concern

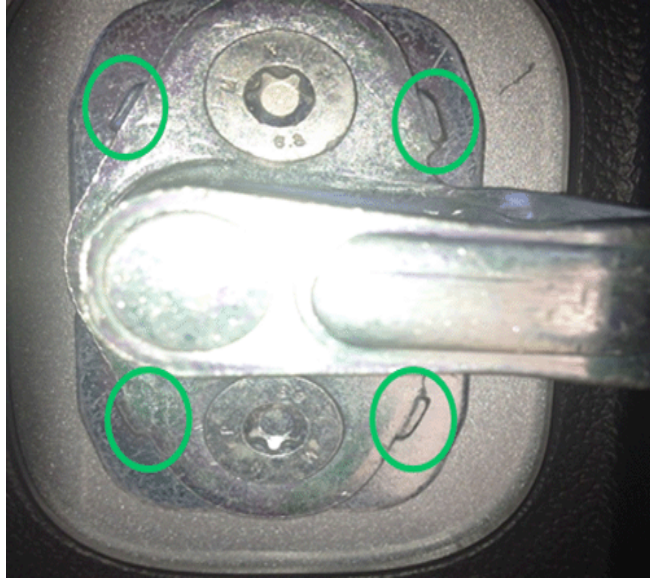
3711980

Inspect the front door strikers to make sure they are the design intent strikers that contain four tangs (circled above) that properly retain the covers. An example of the wrong design striker (with the tangs missing) is shown in the graphic below.
