Technical Bulletin

Model(s)	Year	Eng. Code	Trans. Code	VIN Range From	VIN Range To
Passat	2006 – 2010	All	All	All	All
Passat Wagon	2006 – 2010	All	All	All	All
CC	2009 – 2012	All	All	All	All

58 14 03 December 17, 2014 2039212

Corrosion on Rear Door in Trim Strip Area

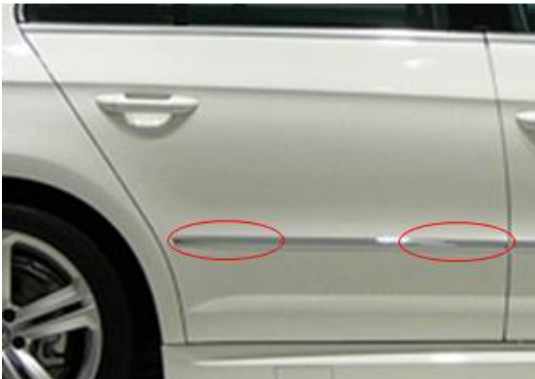
Figure 1 (the red ellipses show the area which can be affected by the corrosion)

Because of incomplete bonding of the trim strip (Figure 2, red circle) water can get between trim strip and door. Because of water ingress, corrosion is possible in the area of the guide holes (Figure 1, red circles).

- Disassemble the door according to the repair manual. See Repair Group 58 in Elsa
- Remove the corrosion on the inner and outer door in the area of the guide holes using a pneumatic brush grinder.

- Apply a VOC compliant epoxy primer as an anti-corrosion treatment and primer to both sides of the door (locally sourced).
- Repaint the rear door according to Volkswagen guidelines.

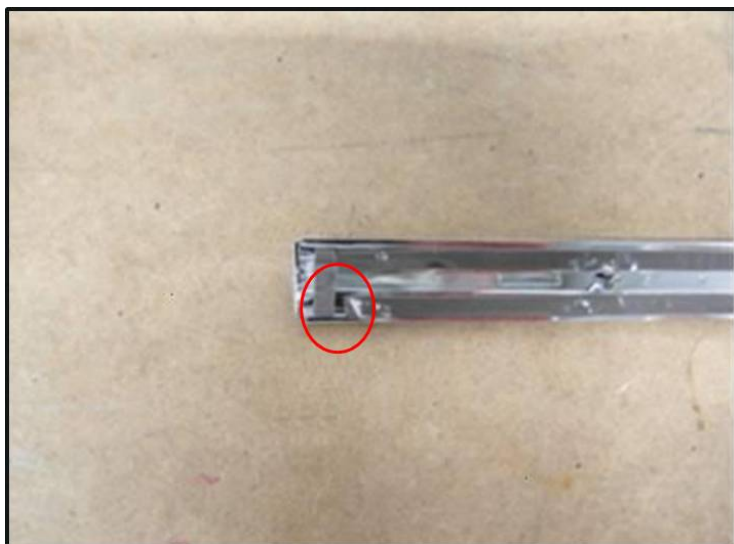
Figure 2 (the red circle shows the opening of the incomplete bonding)

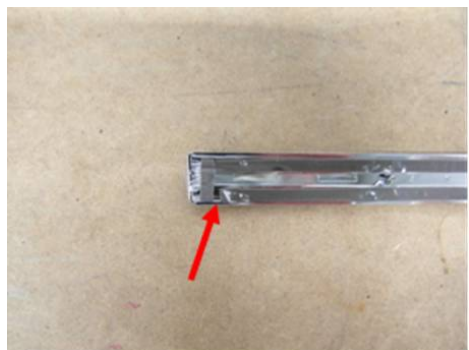
Figure 3 (rear end of a trim strip)

- To avoid repeated water ingress, close the open areas on the trim strips in the end points of the adhesive tape with butyl sealing cord (part number AKL 450 005 05 - Figure 3 and 4, red arrows).

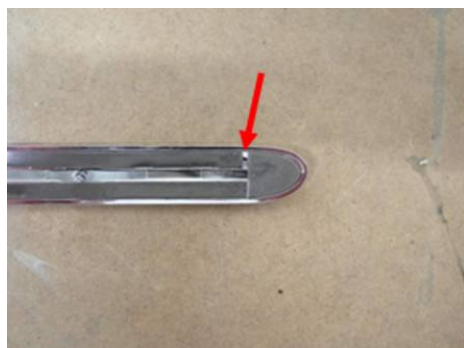
Figure 4 (front end of a trim strip)

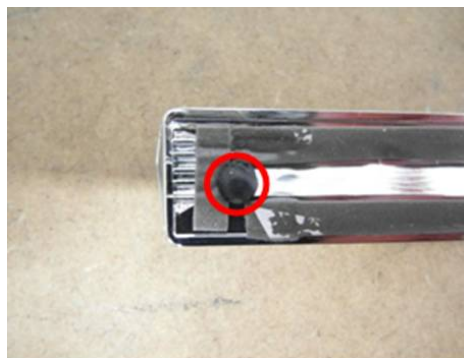
Figure 5 (rear trim strip area)

- Form two balls of butyl sealing cord (part number: AKL 450 005 05) per trim strip with a diameter of 4-5 mm. Attach the butyl balls centrally in the end areas of the trim strip from the inside (Figures 5 and 6).

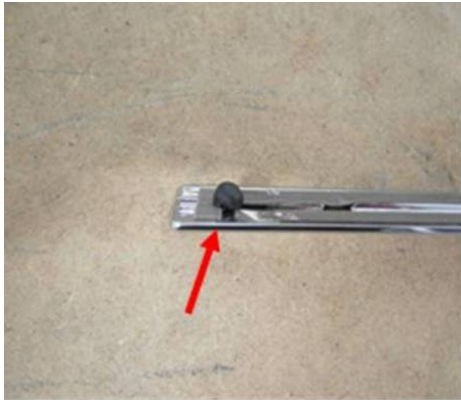
Figure 6 (rear trim strip area)

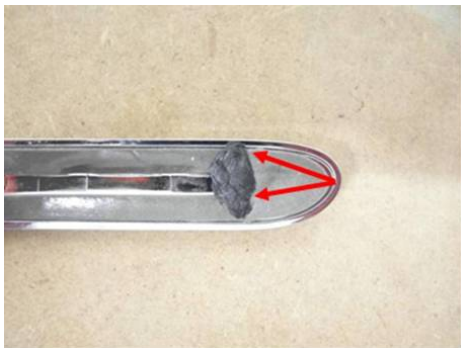
Figure 7 (front trim strip area)

- The open areas of the adhesive tape must be closed by pressing the butyl balls into the gaps of the tape (Figure 7).
