Service Bulletin

Bulletin No.: PIP5237

Subject: 2014 Chevrolet Cruze Diesel P0133 And Or P22FA

Models: 2014 Chevrolet Cruze
Equipped with the 2.0L (RPO-LUZ) 4-cyl Diesel Engine

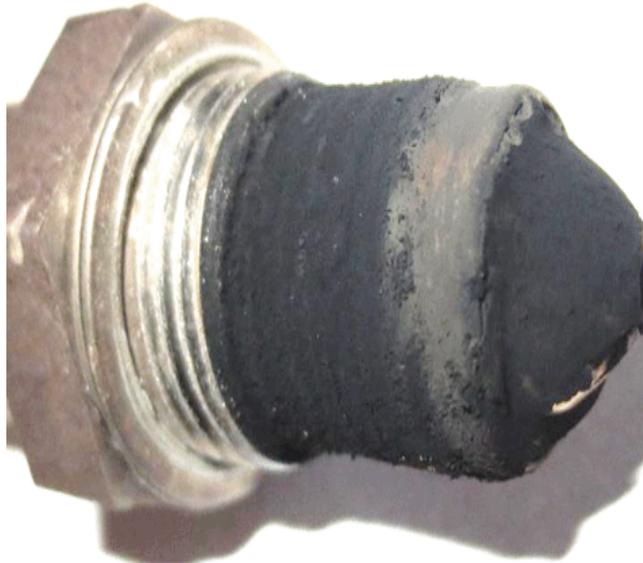
4002246

If DTCs P0133 or P22FA are found, remove and inspect the Heated Oxygen Sensor (HO2S) and the NOx Sensor 1 (NOx1) for soot build up.

Soot Covered HO2S

If found to be covered with soot, replace both sensors and continue with the remaining steps of this PI.

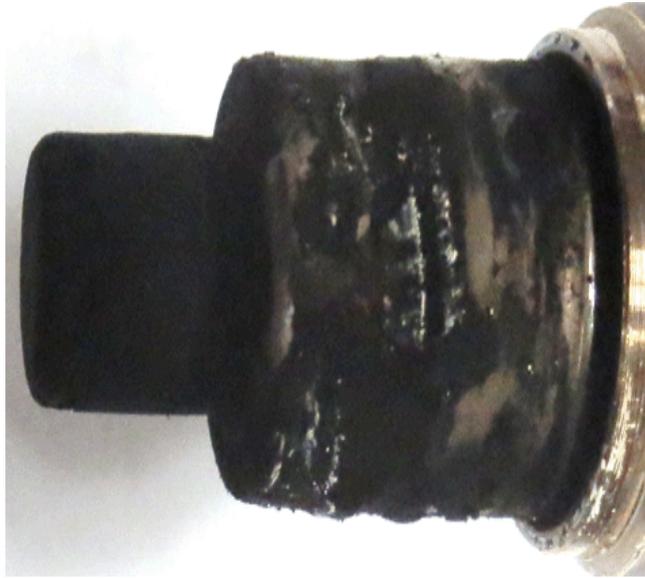
4002247

Soot Covered NOx 1 Sensor
