# TECHNICAL BULLETIN

## LTB00057NAS5

## Suspension Warning Lamp Illuminated - Diagnostic & Repair Procedure

#### **Range Rover Sport (LS)**

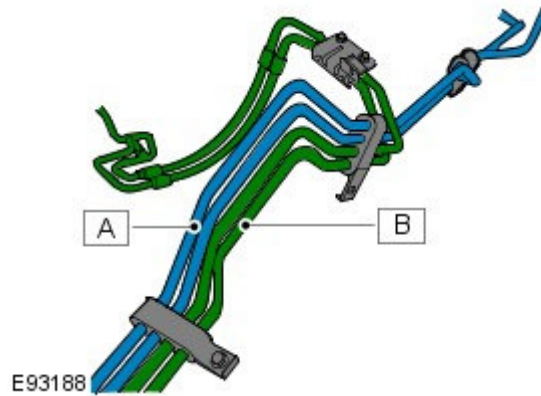
- Select 'Special Applications'.
- Select 'Dynamic Response system Hydraulic Control - System Test'.
- Demand 50 Bar of pressure for up to five minutes or until the primary circuit pipes (A) are hot. Check pipe temperature under right-hand wheel arch.
- If 50 bar cannot be obtained then the Pressure Control Valve (PCV) in the valve block is faulty and requires replacement with the PCV service kit (see TOPIx Workshop Manual, Section: 204-06).
- Open Directional Control Valve 1 (DCV1) and check system pressure is still 50 Bar. Hold for two minutes. If pressure has dropped by over 5 Bar, this indicates a faulty actuator.
- Open Directional Control Valve 2 (DCV2) and check system pressure is still 50 Bar. Hold for two minutes. If pressure has dropped by over 5 Bar, this indicates a faulty actuator.

Confirm which actuator is faulty.

- If all four pipes in the front wheel arch area are hot and at a similar temperature, this indicates that the front actuator is faulty. Replace the front actuator (see TOPIx Workshop Manual, section 204-06).

- If the pipes in the rear wheel arch are hot, this indicates that the rear actuator is at fault. Replace the rear actuator (see TOPIx Workshop Manual, section 204-06).

- If the pressure has dropped but there is no increase in the actuator pipes temperature (B), and rear pipes, then the valve block requires replacement (see TOPIx Workshop Manual, section 204-06). There should be a corresponding DCV fault code logged.

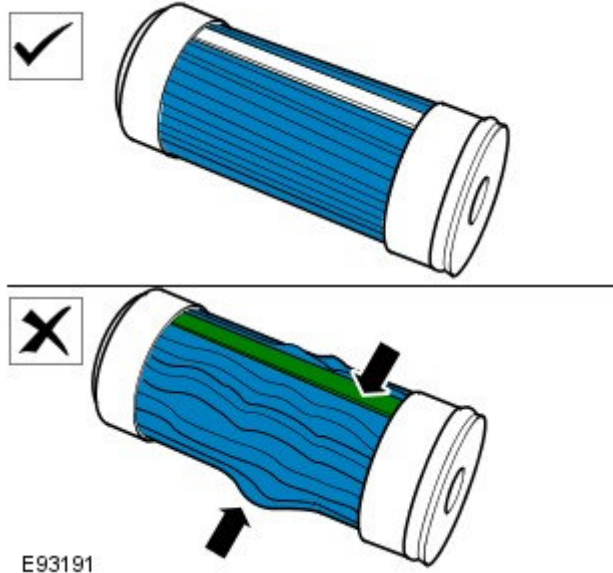
- 15.** Remove the valve block filter (see TOPIx Workshop Manual, Section: 204-06).
- 16.** Inspect the valve block filter.

- Check filter for signs of distortion. A distorted filter indicates excessive system pressure.
- Replace the filter.

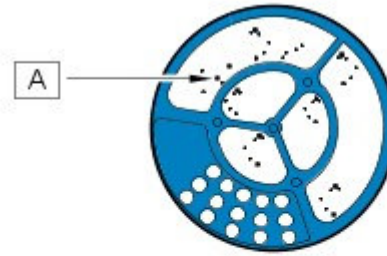
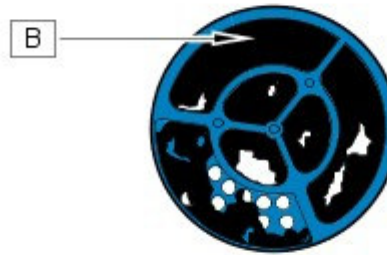
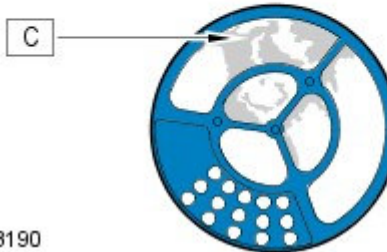
E93190

Inspect the reservoir fluid filter for signs of contamination.

- A small number of particles is acceptable (A). The reservoir does not require replacement.
- If the filter is lightly contaminated with

grey metallic looking particles, this would indicate a pump failure. Discard the reservoir if this condition is found. Proceed to next step.

- If the filter is heavily contaminated with black particles and sludge (B), this would indicate an actuator internal piston seal failure. Discard the reservoir. Proceed to step 24.

**23.** If required, install a new Dynamic Response system pump. It will not be necessary to change any actuator if the pump is replaced.

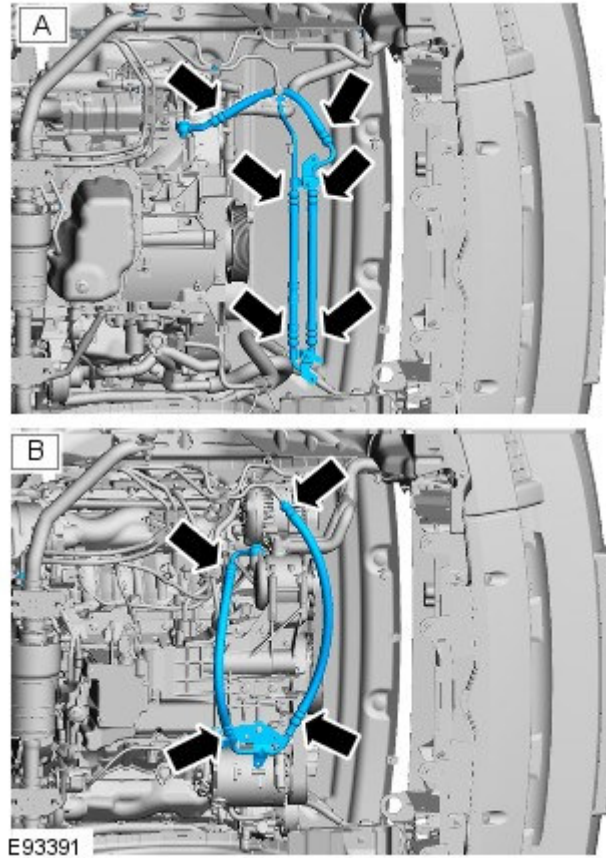
Inspect the high-pressure hose crimps for signs of movement.

- A = all AJV8 petrol engines
- B = TDV8 diesel only

- AJV8 petrol models the hose assembly shown in graphic E93391 [see step 24 (A)] must be replaced if required.

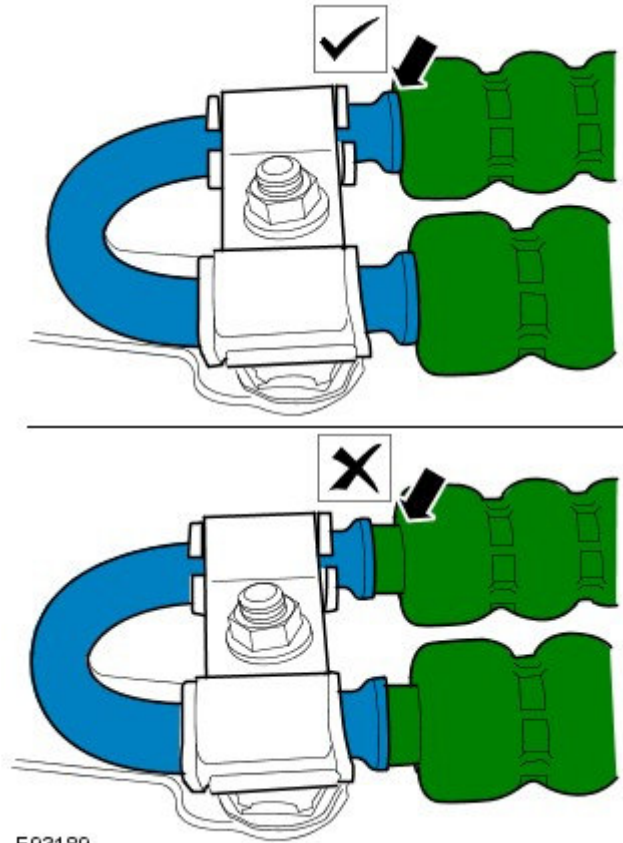
**25.** Any pipe assembly that shows signs of movement must be replaced.

- Any gap larger than 1mm is not acceptable.

26. Replace the hose assembly as follows.

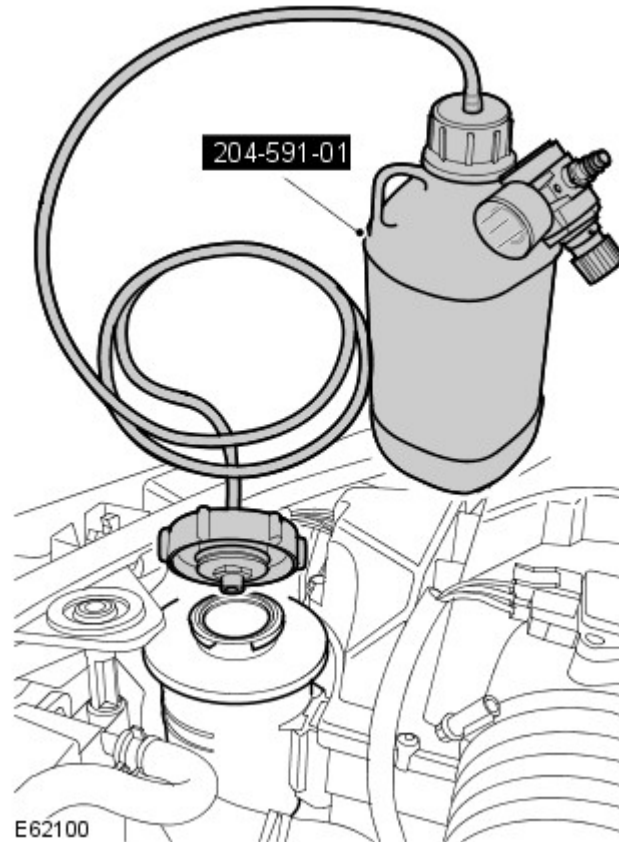
**31.** Install the special tool to the Dynamic Response system reservoir.

- Completely fill the reservoir with fluid.
- Make sure the pressure regulator on the special tool is turned OFF.
- Fill the special tool bottle approximately  $\frac{3}{4}$  full with fluid.
- Connect the special tool to a suitable workshop air supply.

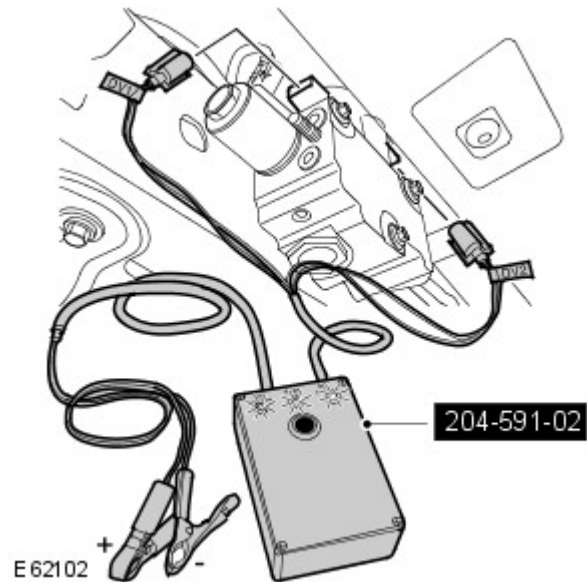
**34.** Connect the special tool electrical connectors to the valve block.

- Connect the special tool power supply leads to the vehicle battery.

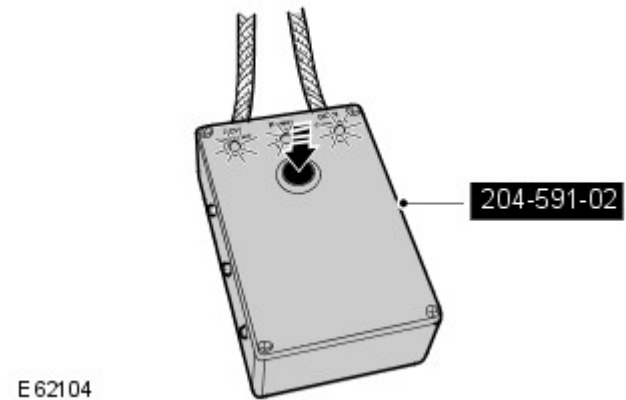
**36.** Using the special tool, open both actuator control valves.
