# Service Bulletin

Bulletin No.: PI1190A

**Subject:** Sunroof Sunshade Binds and/or Will Not Retract Properly

**Models:** 2012-2015 Buick LaCrosse  
2014-2015 Chevrolet Impala  
Equipped with Sunroof (RPO C3U)

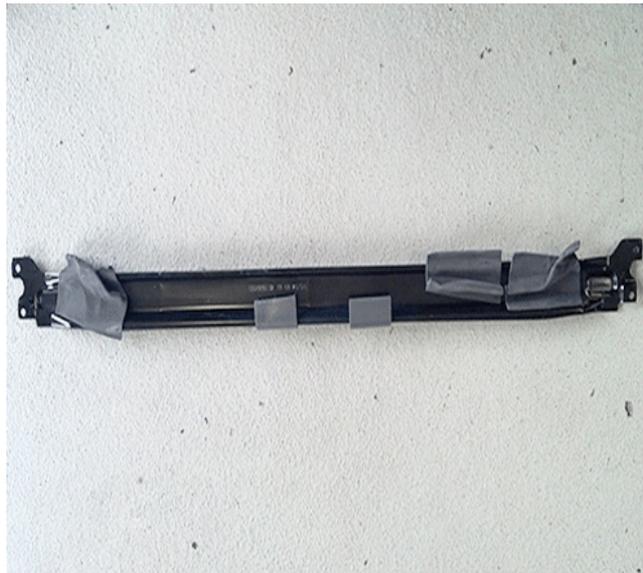
3749683

- Flutter containment patches on the rear crossmember may be sticking to the sunshade and impeding it's travel (2014 Impala only).

Inspect the sunroof sunshade assembly for damage. If damage to the sunshade is evident, refer to the GM electronic parts catalog (EPC) for the current sunshade service part and replace the sunshade following the steps and tips below:

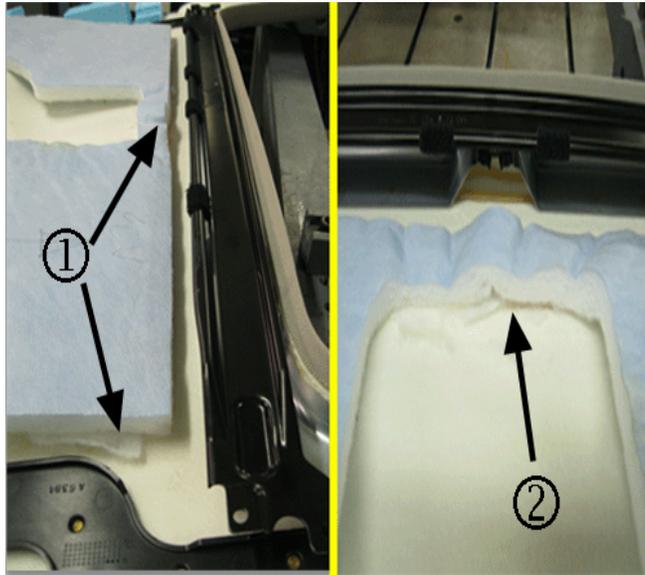
3749684

- Acoustic panels attached to the rear of the headliner may have partially detached (1) and/or bunched up (2) putting too much tension on the sunshade roller.

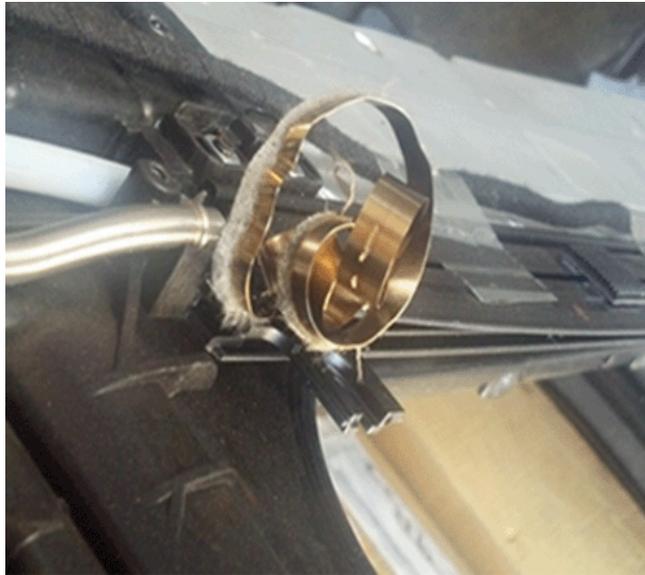
3749685

- The rolled steel springs on the outboard ends of the sunshade may have become kinked or damaged due to improper travel of the sunshade.

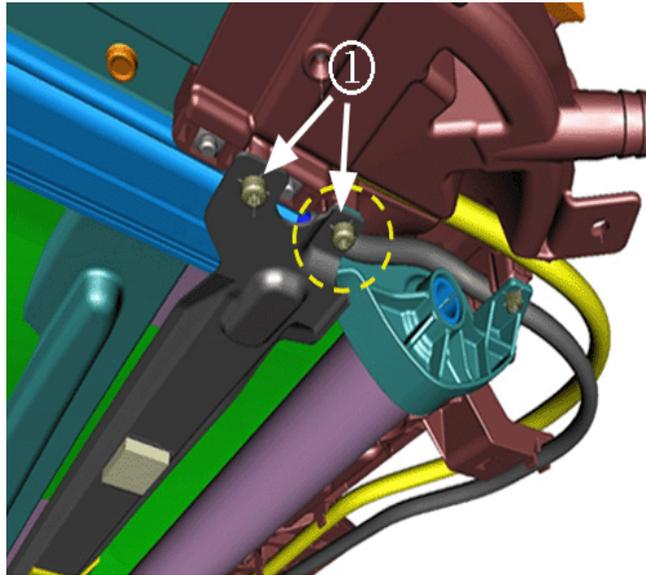
3749687

**Note:** The rearward crossmember retaining screw (circled in the graphic above) is also the retaining screw for the forward fastener location of the sunshade end cap.

5. From the inside of the vehicle, remove the sunroof module rear crossmember by removing the two retaining screws (1) located on each side. Do Not remove the sunshade end cap to module retaining screws yet.

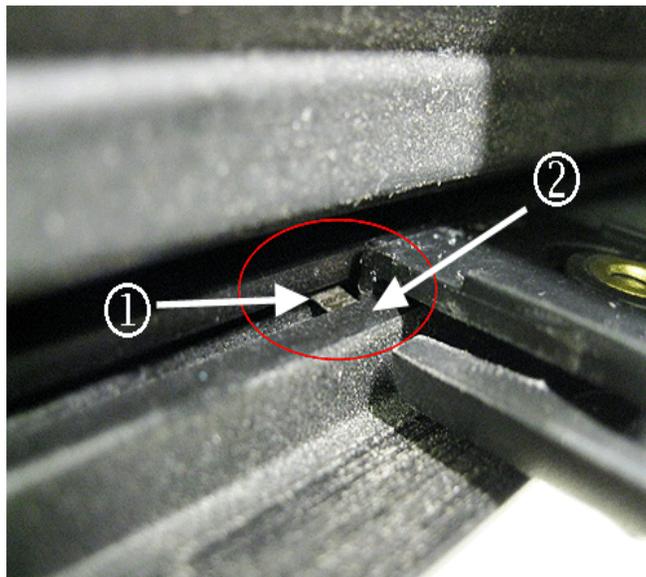
3749694

**Important:** Before attaching the front bar screws, inspect for proper installation of the sunshade within the track. When properly installed, the metal coil on the end of the sunshade (1) is BELOW the track (2). The graphic below shows an example of incorrect installation; with the metal coil (1) positioned ABOVE the track (2).

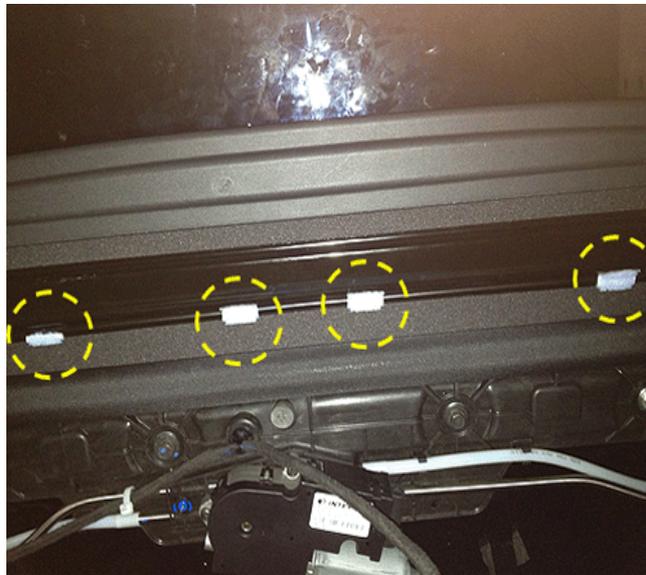
3749697

**Note:** The graphic above shows the current design crossmember, which has four hook and loop anti-rattle patches. The patches are shown blue in color on the above example to improve viewing. These patches will be black on the actual production crossmembers.

**Important:** Before reinstalling the rear crossmember, inspect that it is the current design. **If these patches are not evident, the crossmember is an earlier design and should be replaced with the service part listed in the part table below.**

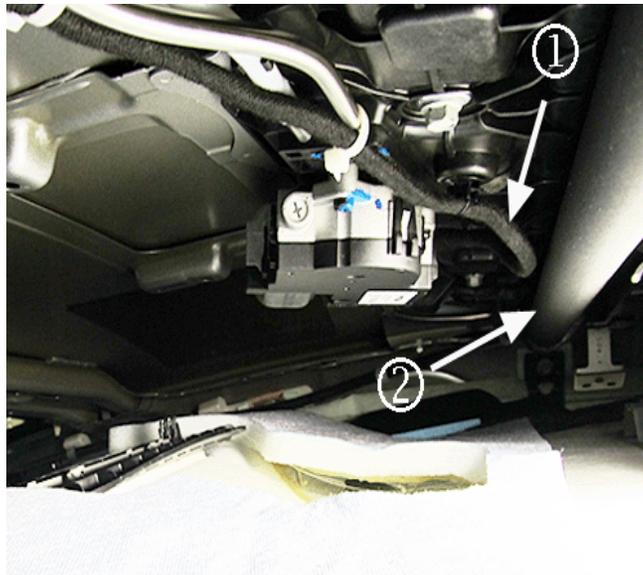
3749700

**Important:** While cycling the sunshade, closely inspect for possible contact/interference between the motor wiring harness (1) and the sunshade rolo fabric (2). If contact is evident, install an additional tie strap to hold the harness away from the shade.

22. Slowly cycle the sunshade. Inspect the sunshade for binding and ensure proper operation.
