Service Bulletin

Bulletin No.: P11213

Subject: Information on Correct Hoist Lifting Procedure to Prevent Vehicle Damage

Models: 2013-2014 Cadillac ATS
2014 Cadillac CTS (VIN Code A)

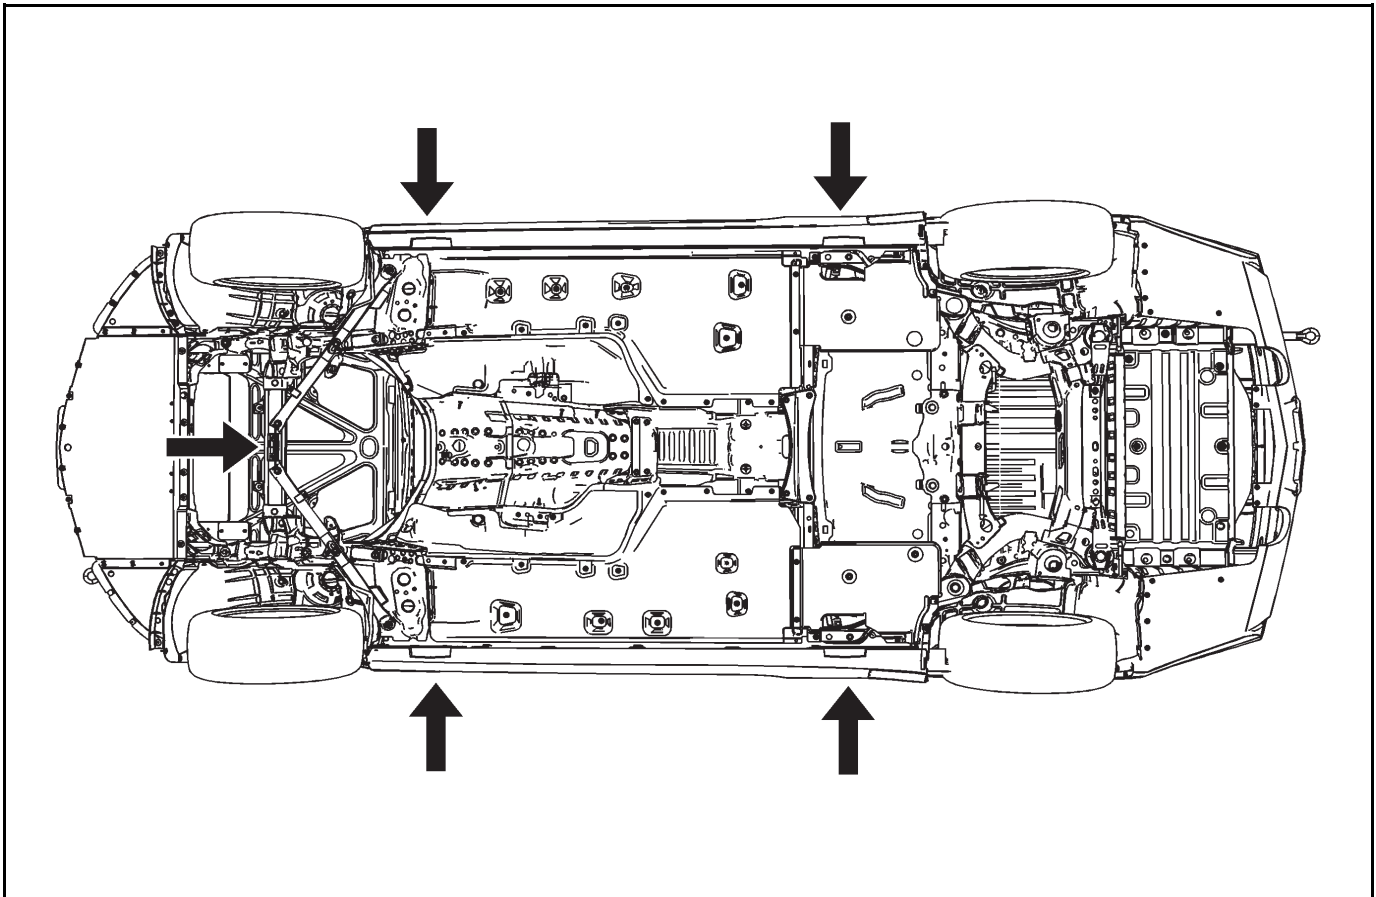
2844345

The vehicle should be lifted so that the hoist pads and or lift arms do not contact the rocker panel molding. The hoist pad must be located in the designated area. In the front location, place the lift pads on the rocker outer panel weld flange. In the rear location, place the lift pads on the rocker outer panel rear cradle brace. Care should be taken to ensure the hoist pad is inside the rocker panel molding cut out area (notch) to prevent damage to the vehicle.

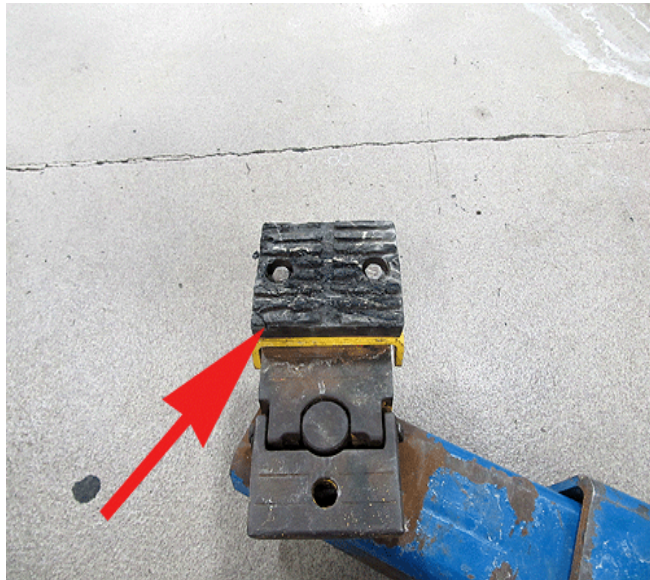
3794084

In some cases you may need to contact your hoist supplier to obtain adapters to allow proper clearance.

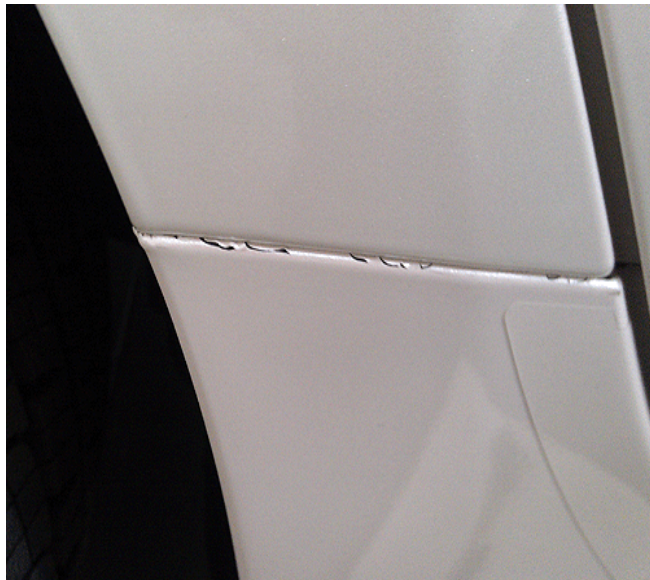
3794077

The above photo shows damage to the rocker panel molding where it contacts the lower front of the quarter panel (dog leg). This damage occurs when the rear hoist pad contacts the rocker panel molding and shifts the position of the molding, peeling the paint where it meets the step in the body panel.

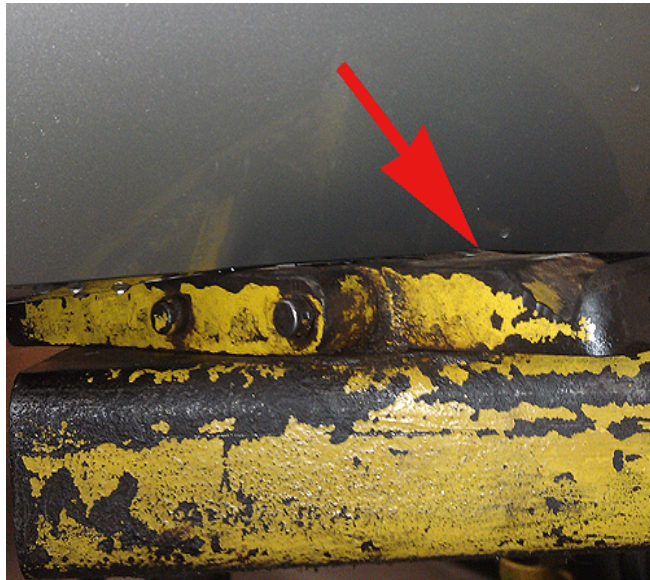
3794079

This photo shows damage to the molding in the area where the hoist pad is making contact.

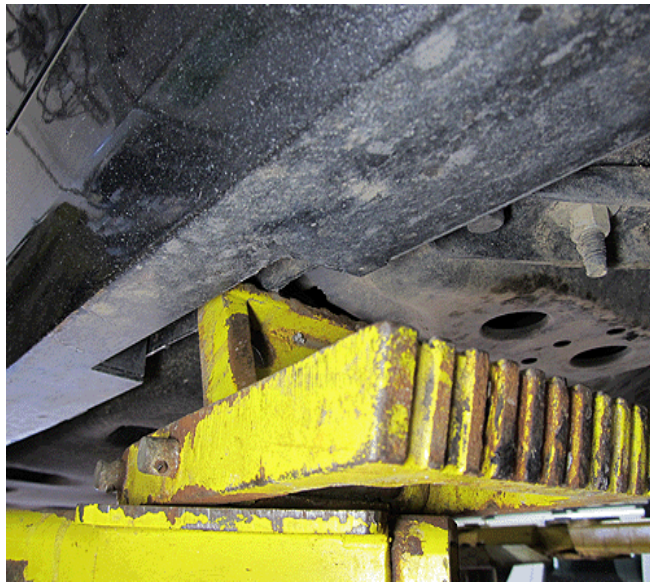
3794086

Correct hoist pad placement (front)

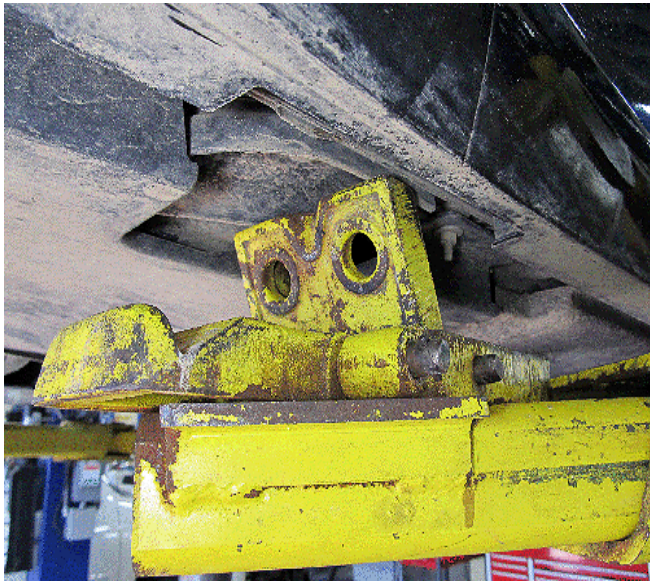
Correct hoist pad placement (rear)
