# Service Bulletin

Bulletin No.: PI1213A

**Subject:** Information on Correct Hoist Lifting Procedure to Prevent Vehicle Damage

**Models:** 2013-2015 Cadillac ATS Sedan  
2015 Cadillac ATS Coupe  
2014-2015 Cadillac CTS (VIN Code A)

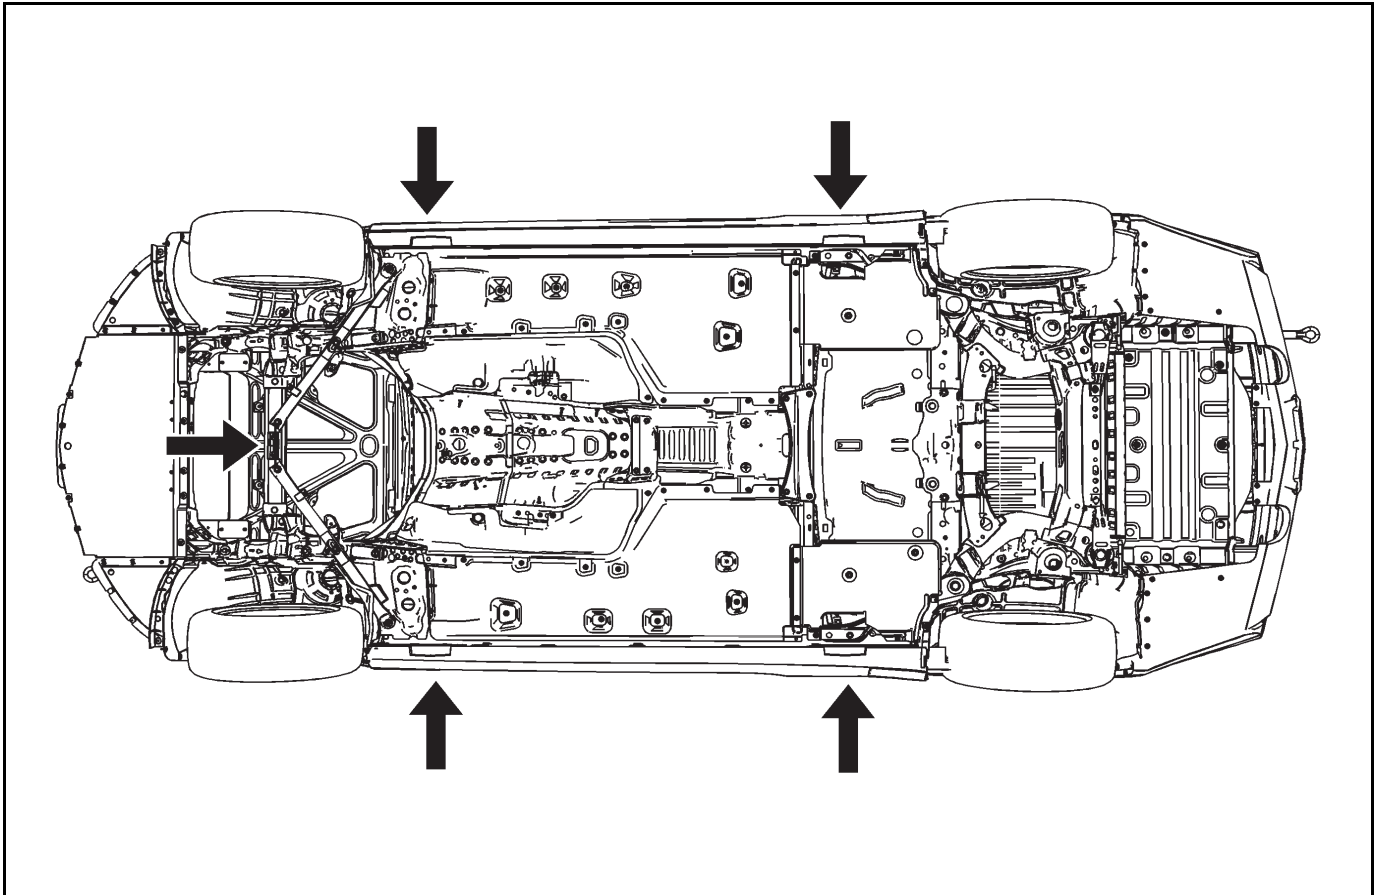
2844345

The vehicle should be lifted so that the hoist pads and or lift arms do not contact the rocker panel molding. The hoist pad must be located in the designated area. In the front location, place the lift pads on the rocker outer panel weld flange. In the rear location, place the lift pads on the rocker outer panel rear cradle brace. Care should be taken to ensure the hoist pad is inside the rocker panel molding cut out area (notch) to prevent damage to the vehicle.

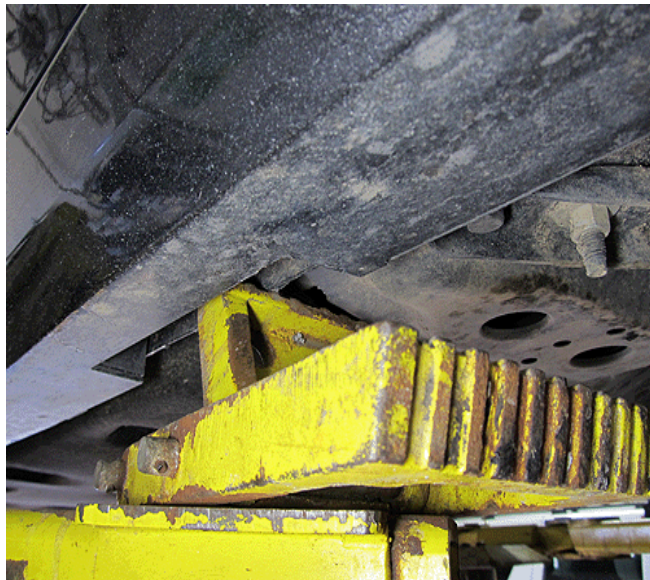
3794086

**Correct hoist pad placement (front)**
