Service Bulletin

Bulletin No.: PIT5313A

Subject: Paint Peeling Above Anti-Chip Area

Models: 2014 Chevrolet Silverado 1500
2015 Chevrolet Silverado 2500/3500
2014 GMC Sierra 1500
2015 GMC Sierra 2500/3500
Built at Ft. Wayne Assembly (11th VIN Position = "Z")
Built Prior to 5/15/2014

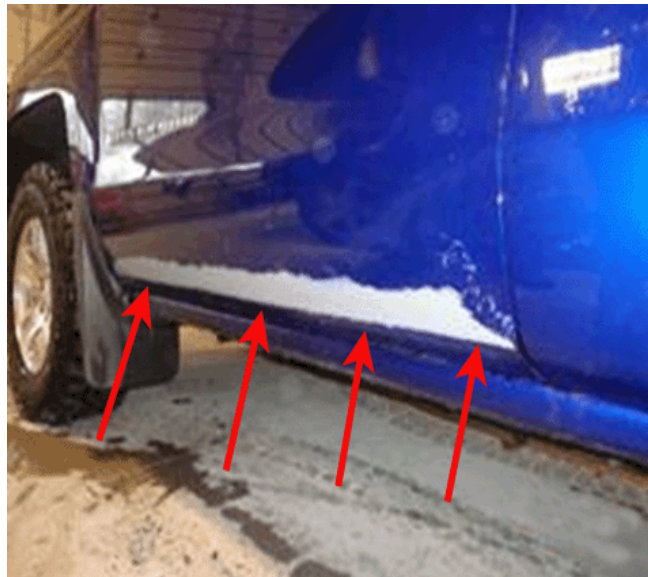
3966524

Some owners may comment of the paint peeling above the anti-chip area, as shown below:

Note: Process revisions were made at the vehicle assembly plant to resolve this issue effective 5/15/2014.

Refinish the affected areas using the appropriate material supplied by the refinish material supplier being used by the repair facility for finish repairs.
