Service Bulletin

Bulletin No.: PI1264A

Subject: Accessory Fog Lamp Kit Inoperative

Models: 2014-2015 Chevrolet Equinox
Equipped with RPO SSD

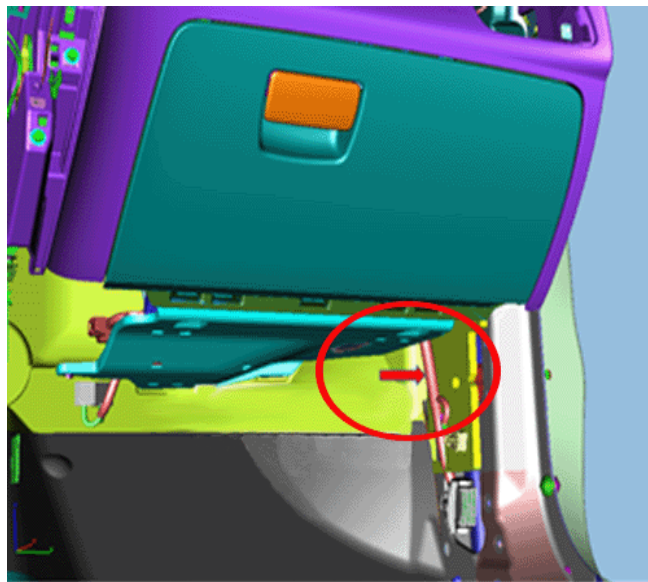
3942259

- 2.1. Visually inspect the I/P Harness part number tag on the Harness per below (I/P harness part number tag located between ground 207 and body inline connector):
 - 2014 MY Harness Part Numbers # 23164353; 23164354 and 23181681 requires an added circuit.
 - 2015 MY Harness Part Numbers # 23235768; 23235769 and 23235770 requires an added circuit.

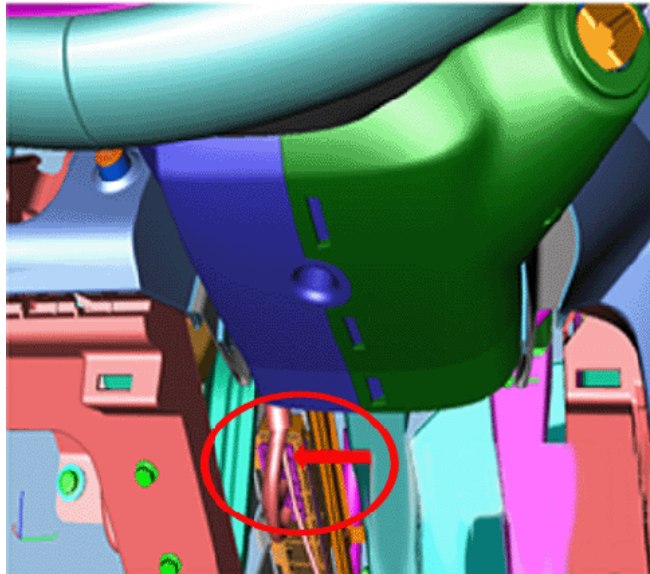
3942260

2.2. Visually inspect the I/P Harness BCM Connector 19151262 Cavity 14.

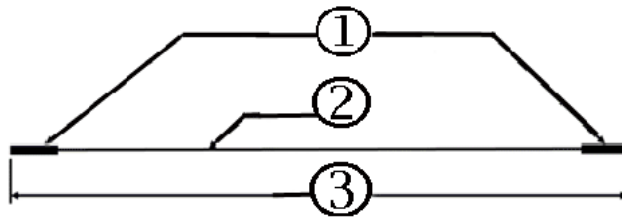
3942263

- (1) JST Terminal: SNAC3-A031T-M0.64. Crimp and solder terminal to wire
- (2) 0.80 (18 ga) TXL
- (3) 1000.0 mm (39.4 in)

-
3. If circuit 192 is missing, create the above circuit.
- Wire size can be from 0.35 to recommended 0.80.
 - Wire insulation type can be TWP or recommended TXL.
