Service Bulletin

Bulletin No.: PI1270

Subject: Rear Closure Center Applique Carrier Cracked

Models: 2014 Chevrolet Impala (VIN 1)
Vehicles Built Prior to June 1, 2013

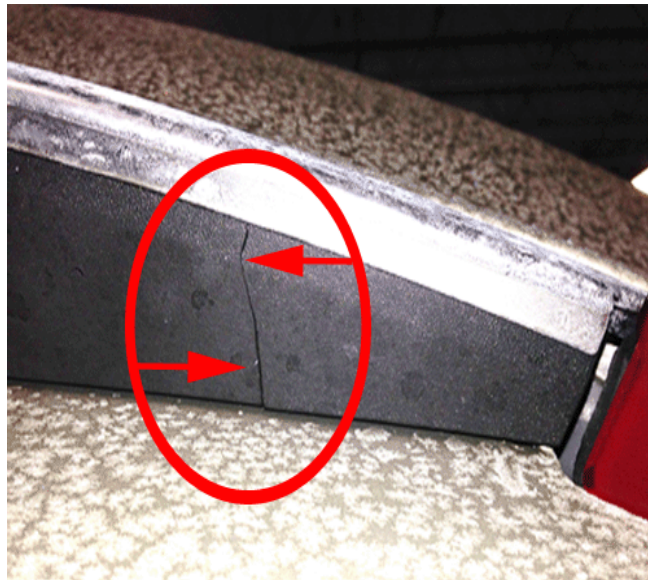
3940146

Some customers may comment on cracks on the end of the rear applique carrier as shown in the illustration above.

Replace the rear closure center applique carrier with one of the revised part numbers listed below. Refer to Rear Closure Center Applique Carrier in SI.

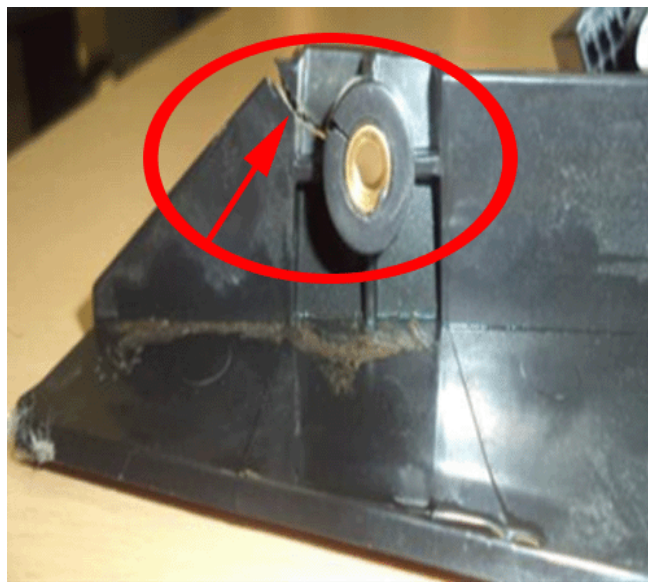
3939373

This condition may be due to stress at the brass insert, as shown in the illustration above, which initiates cracking on the plastic.
