# Service Bulletin

Bulletin No.: PI1316

**Subject:** Visible Rust on Top Hat Painted Surface of Rear Rotors

**Models:** 2014 Chevrolet SS  
**Condition/Concern**

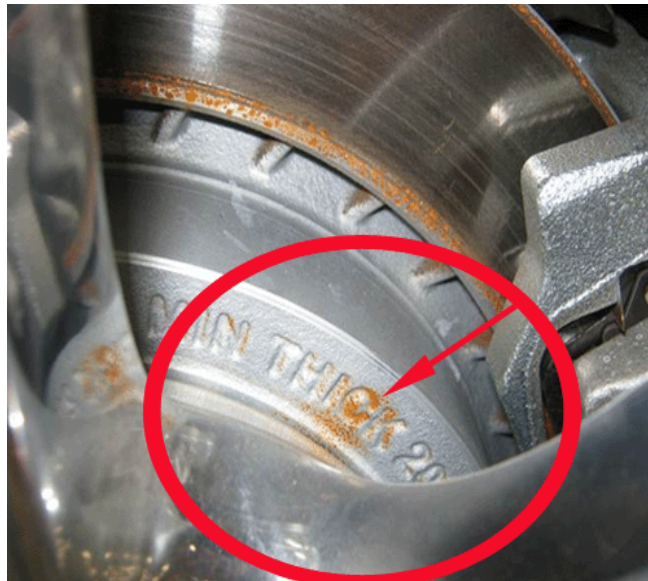
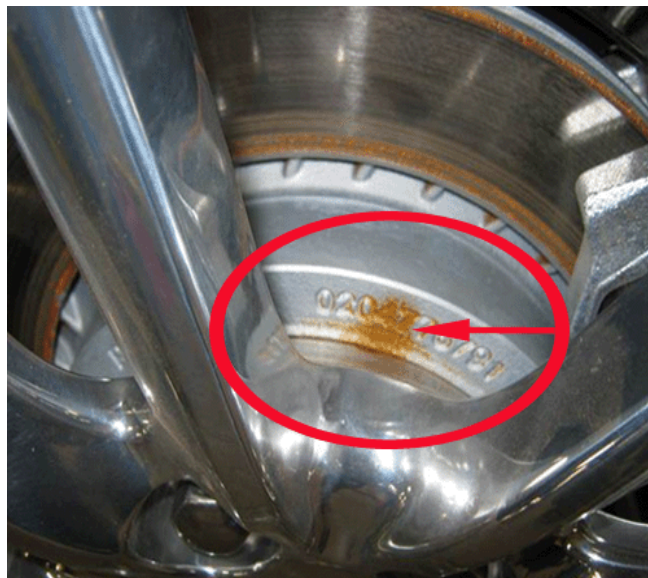
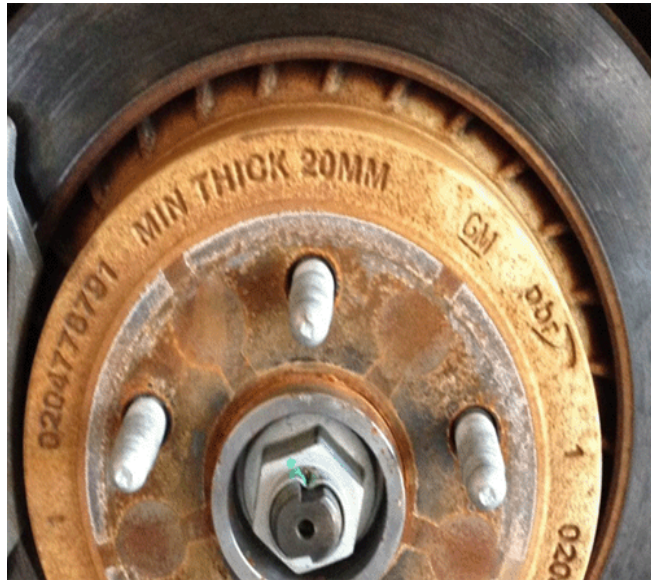
Some customers may comment on visible rust on the top hat painted surface of the rear rotors.

**Important:** Please **DO NOT** replace the rotors at this time as the current replacement rotor will experience the same condition.

Engineering is aware of this concern and currently releasing an updated rotor that will have a new paint coating. Once this new part is available, this PI will be updated.
