# Service Bulletin

Bulletin No.: PIC5824A

**Subject:** Diagnostic Tip: Radio Center Select Button Is Inoperative On ICS And/Or Touch Screen Is Inop

**Models:** 2013 - 2015 Buick Encore

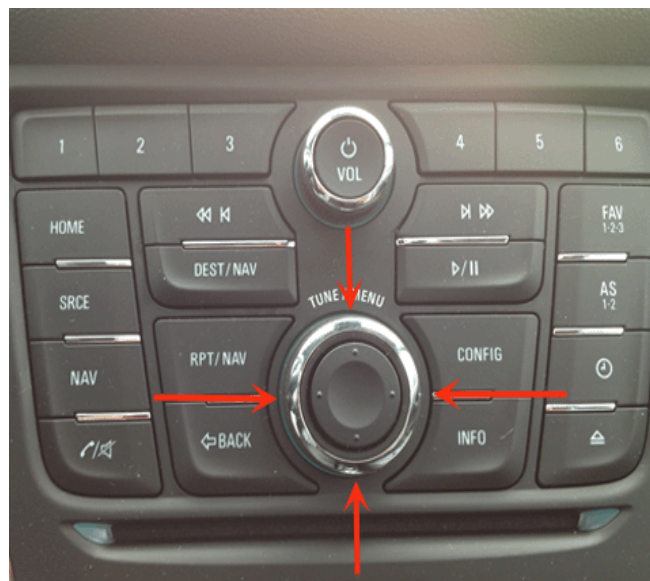
3338368

The center Joystick ONLY operates when in the Map Mode. The large chrome dial in the center of the ICS must be used to make a selection then the chrome outer edge needs to be pressed in to make the Selection. See photo below:

**Important:** Do not replace any parts for the concern.
