Bulletin No.: PIC5986

Subject: Backup Camera Inoperative

Models: 2013 - 2014 Chevrolet Malibu

With Rear View Vision (RPO UVC)

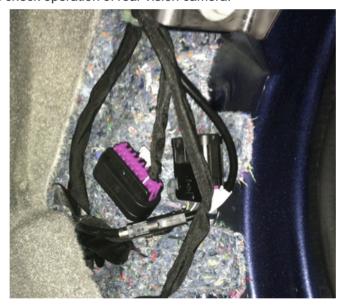
3802826

A customer or technician may indicate the rear vision camera is inoperative.

When diagnosing this concern, first verify that connector X220 is properly connected. Connector X220 is a black 16 way connector located behind the passenger kick panel. It could have as few as 3 wires or 13 wires in the connector. Please secure connector and check operation of rear vision camera.
