# Service Bulletin

Bulletin No.: PIC6030

**Subject:** Service Engine Soon Light On DTC P0442

**Models:** 2013 - 2015 Cadillac ATS Sedan  
Built prior to 8/9/2014

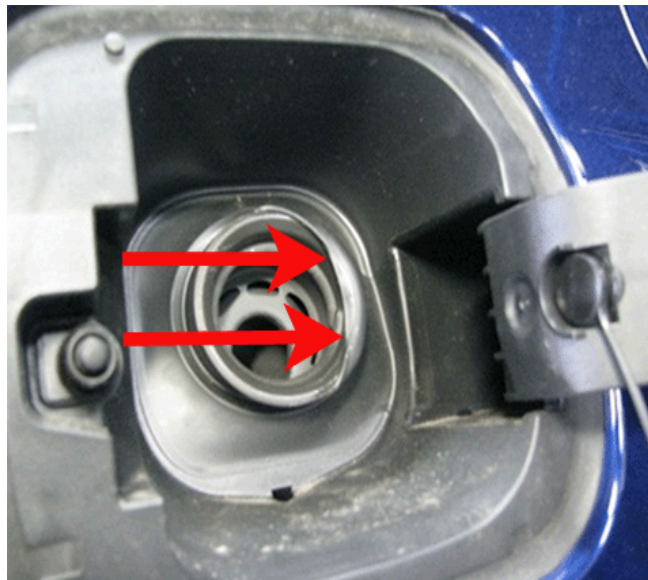
3979093

Please check the fuel filler pocket rubber insulator to make sure it is not rolled over the fuel pipe neck as per the picture below.

If the rubber is rolled over the filler neck, roll the rubber back over to the correct position. Check fuel filler cap to make sure the seal on the cap has not been damaged.
