Bulletin No.: PIE0321

Service Bulletin

Subject: Engineering Information – Lower Oil Pan Leak

Models: 2015 Cadillac Escalade, Escalade ESV
2014 Chevrolet Silverado 1500
2015 Chevrolet Silverado, Suburban, Tahoe
2014 GMC Sierra 1500
2015 GMC Sierra, Yukon, Yukon XL
Equipped with 5.3L or 6.2L Engine (RPO L83 or L86)

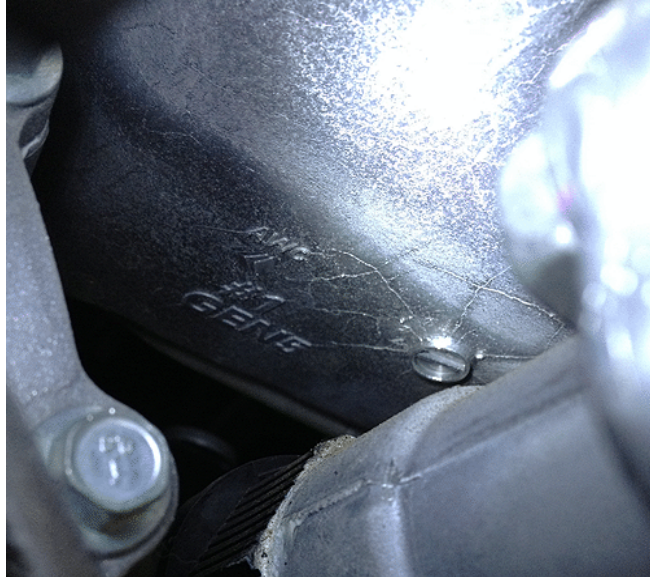
4008589

AWC — Ahresty

- Identify the manufacturer by the marking on the pan. Use the above photos that show the markings of each supplier (Auma or Ahresty). This mark is found on the bottom of the flat horizontal bottom of the cast pan. One mark will say "AWC" with diamond shapes under it, and the other will be a "Round Circle" with two lines in the circle.

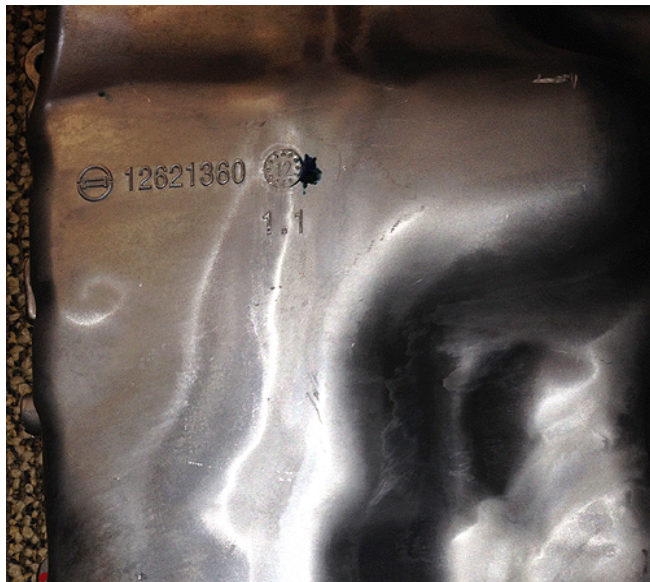
4008591

Circle — Auma

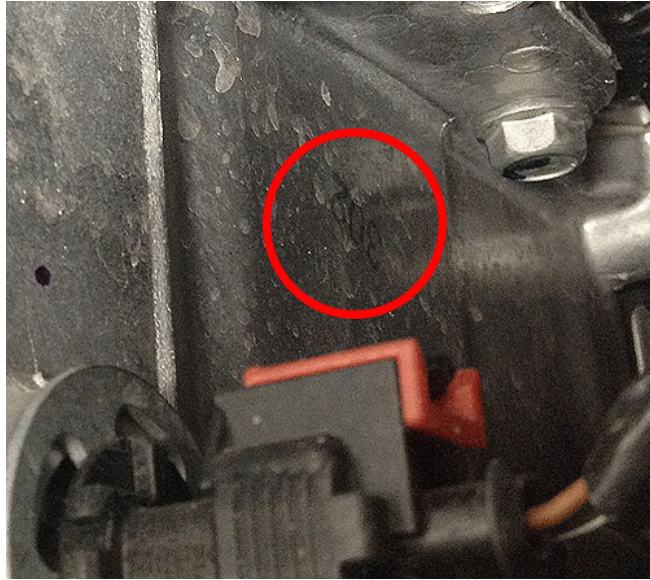
4020678

- If it is an Ahresty oil pan, identify the manufacturer date code. The code will be located on the right side of the oil pan (passenger side of vehicle) forward of the engine oil level switch. The date code will be a set of two numbers stamped on the pan as shown in the photos above.
- If it is an Auma oil pan, no further information is required.
