Countries: CANADA, UNITED STATES, MEXICO **Document ID:** IK0800475
Availability: ISIS, Bus ISIS, FleetISIS **Revision:** 3
Major System: ELECTRICAL SYSTEM **Created:** 1/29/2014
Current Language: English **Last Modified:** 9/29/2014
Other Languages: NONE **Author:** Chris Moody
Viewed: 4363

Title: Radio Diagnostics and Information

Applies To: All Vehicles

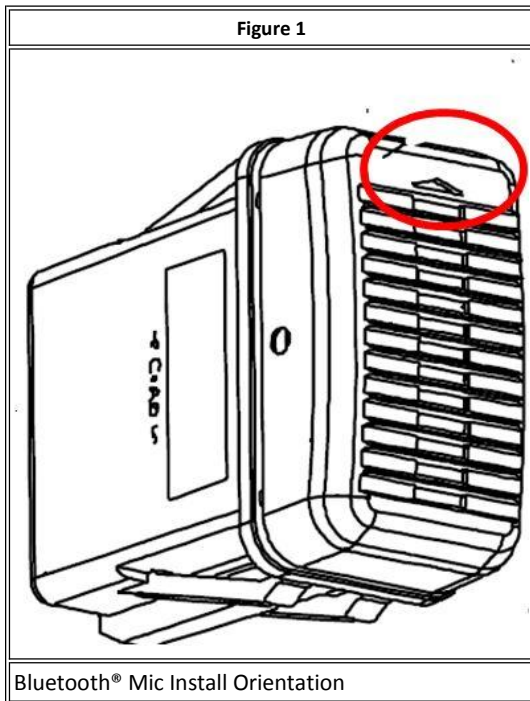
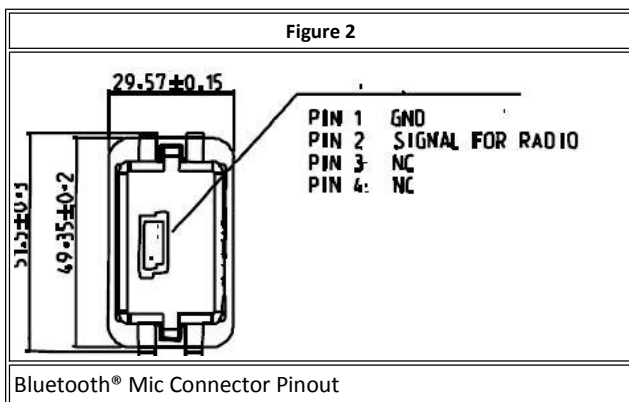
The Bluetooth® Mic must be installed with the arrow on the Mic facing toward the front of the vehicle or the performance will be drastically impacted. See Figure 1.

The Microphone should have approx 7.2v - 8.8v power supply.

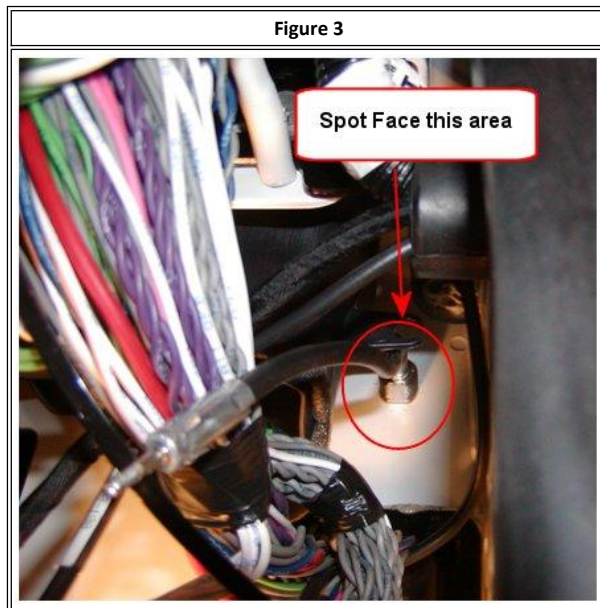
1. Cant identify XM radio ID#
 - To identify XM ID perform the procedure below:
 - Select XM as source, then tune to channel 0 , "RADIO ID" label alternates with the SXM radio eight-digit code.
 - **NOTE:** Some customers have had trouble activating the radio. This has been found to be due to misinterpretation of the radio ID. It's easy to mistake a "Q" for a "0"
 - Example: 9904248G should be 99Q4348G
2. Poor radio reception
 - Resolution:
 - If poor radio reception is experienced, the mounting location needs to be spot-faced from the inside of the cab.
 - Remove the Nut and Star washer
 - Use a die grinder and remove the paint (spot face) around the antenna base. You do not need to remove the antenna.
 - Apply dielectric grease to the spot faced area.
 - Re-install the star washer and nut.

Figure 3 below shows location near the passengers kick panel under the IP. Builds after mid-December have the area spot-faced.

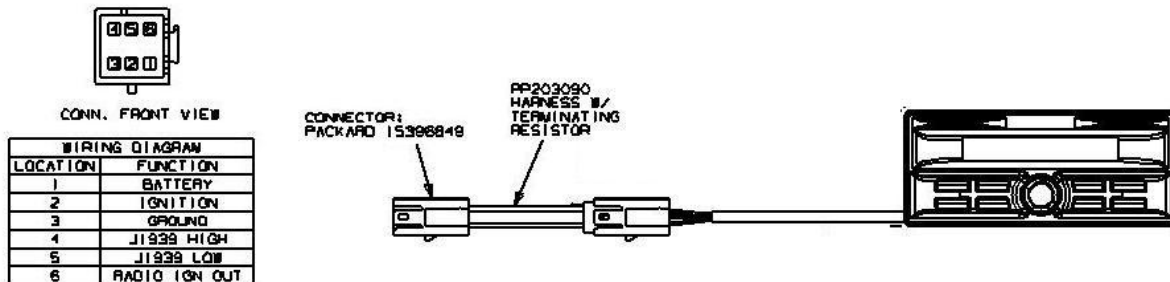
- This data link is similar to the other J1939 data links on the vehicle.
 - With no power applied, there should be 60 Ohms of resistance between the circuits. If this is not correct, there may be an open circuit or missing terminating resistor. The terminating resistor for the remote is in a jumper harness between the sleeper radio control and the truck harness. (See picture below)

- With power, there should be approximately 2.5 Vdc on each data link circuit.
 - Note: The voltages should not match
 - If problems persist or reoccur, it may be necessary to relocate the terminating resistors so that one is as close to the radio as possible and the other is as close to the remote control as possible.
