SERVICE BULLETIN

APPLICABILITY: 2013-14MY Legacy & Outback Models
 with 2.5L FB Engine

NUMBER: 02-150-14R

SUBJECT: Revised Valve Train Parts to Reduce a Warm
 Engine Tapping Sound from the Left Cylinder Head

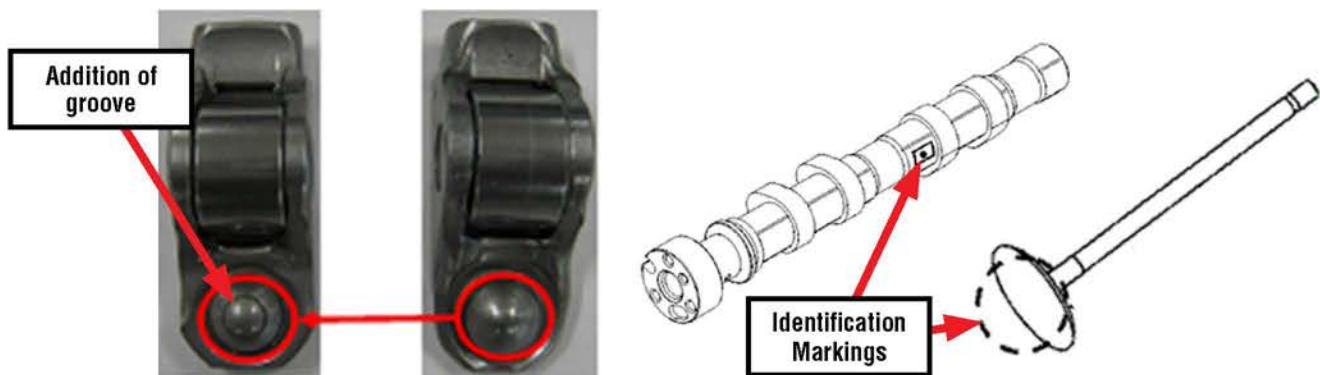
The illustrations below show additional information about the changes to the valve rockers, camshafts and valves to help readily distinguish them from the previous version parts.

- Design change to the valve rockers
- Camshaft profile change
- 1.65mm longer intake and 2.4mm longer exhaust valve stem lengths

If you receive a customer concern of a tapping sound from the B2 cylinder head, confirm it is isolated to the B2 valve train area before proceeding with any repairs. Once verified, order and replace the intake and exhaust camshafts, the 4 intake and 4 exhaust valves, and all 8 rockers. Depending upon the VIN (see part information table) you may also need to replace all 8 rocker pivots. To clarify, if the VIN is BEFORE VIN D*017921 for Legacy or D*242757 for Outback, you will need to replace the rocker pivots. Vehicles built after these VINs already incorporate the new pivots. Refer to the service procedures outlined in the applicable Service Manual for installation.

NOTE: When setting the valve clearances, the intakes should be set to 0.13mm +0.02 / - 0.03 and the exhausts set to 0.22mm +/- 0.02. **These are revised clearance specifications and are not reflected in the Service Manual.**

IMPORTANT: Do not mix old and new parts together as it will become impossible to obtain intake valve clearances that are within specification.
