GROUP Body	MODEL 2015MY K900 (KH)
	NUMBER 108	DATE December 2014
TECHNICAL SERVICE BULLETIN		
SUBJECT: SERVICE ACTION: FRONT SEAT HEADREST ELEVATOR MODULE REPLACEMENT (SA177)

**SUBJECT: SERVICE ACTION: FRONT SEAT HEADREST ELEVATOR
MODULE REPLACEMENT (SA177)**

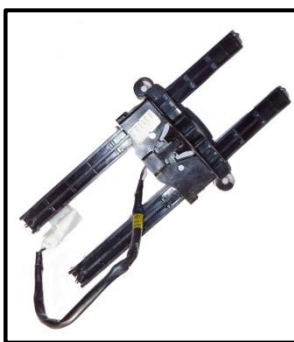
Headrest Elevator Module

This bulletin provides the procedure to replace the headrest elevator module of some K900 (KH) vehicles, produced from March 20, 2014 through September 19, 2014 and equipped with manually adjustable headrests, which may exhibit difficulties when adjusting the headrest height. To prevent and/or correct this condition, replace the headrest elevator module with a new one by following the service procedure outlined below. Kia is requesting the completion of this Service Action on all affected vehicles, including dealer stock, prior to delivery.

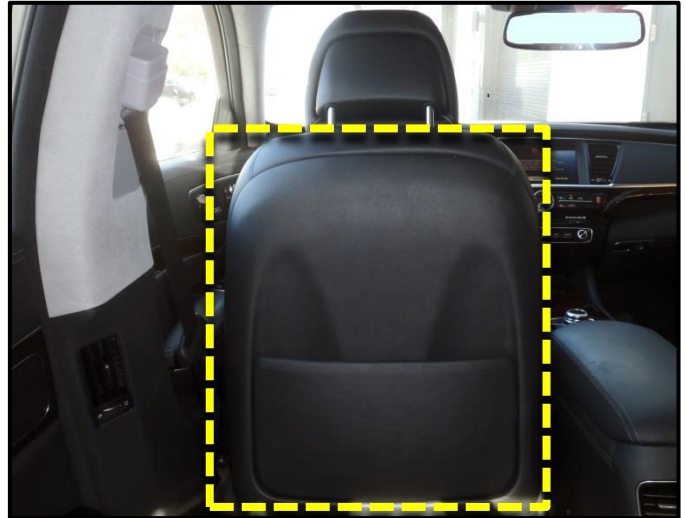
1. Set the Ignition to OFF position.
2. Remove the seat back board by referring to applicable workshop manual on KGIS (see below).

Body (Interior & Exterior) > Front Seat > Front Seat Back Cover > Repair Procedures > Replacement

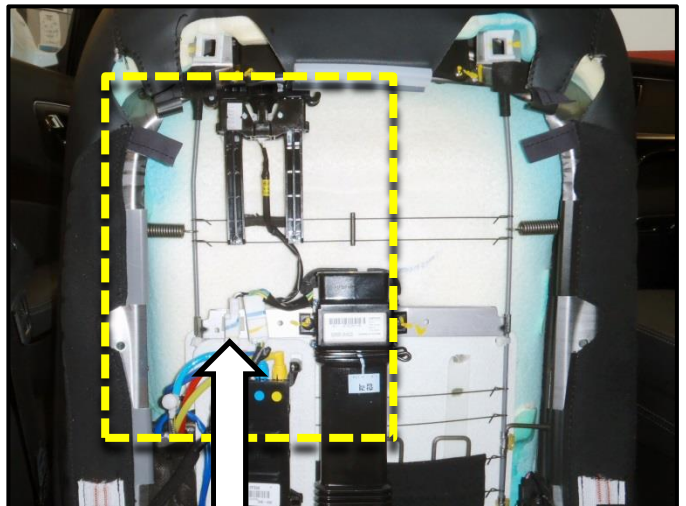
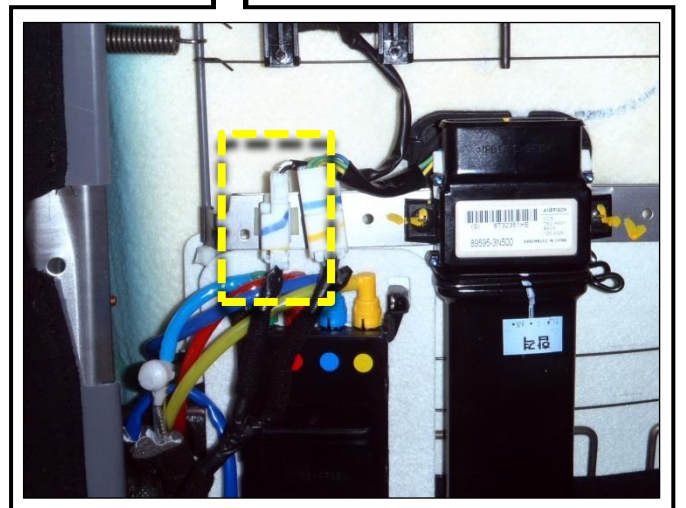
3. Locate the left side seat elevator module, harness and the harness connector.

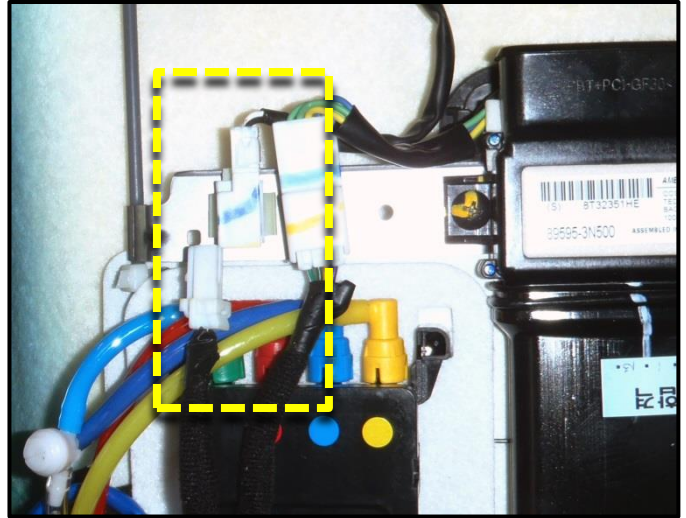
4. Disconnect the male portion of the harness connector and remove the female portion of the connector from the bracket.

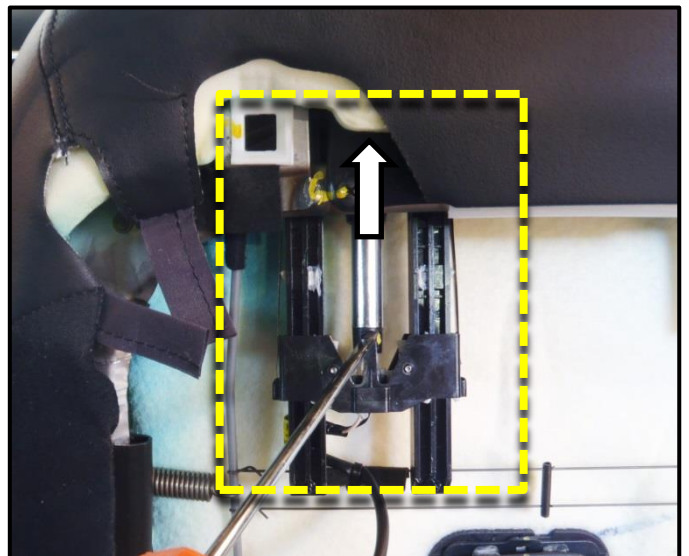
5. Use a flathead screwdriver to remove the headrest shaft from the elevator module and remove the headrest.

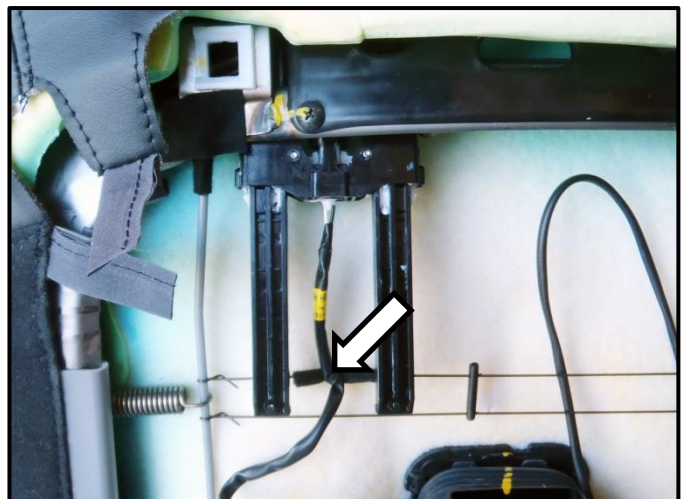
6. Remove the cable tie securing the harness to the cross wires.

Make sure to secure the harness in the same position during reassembly.

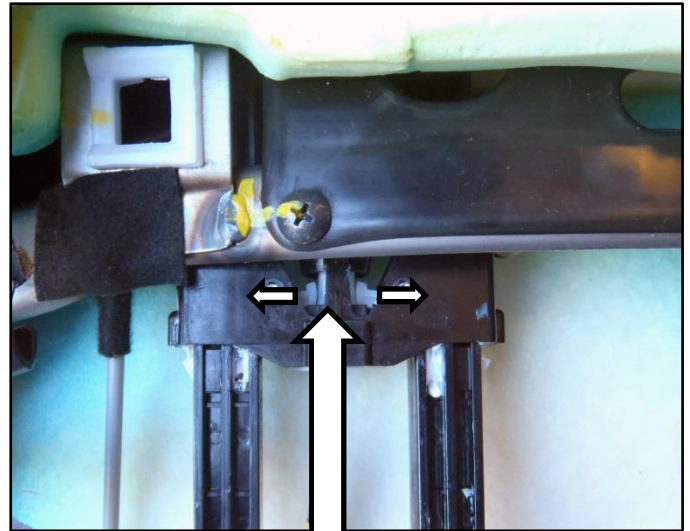
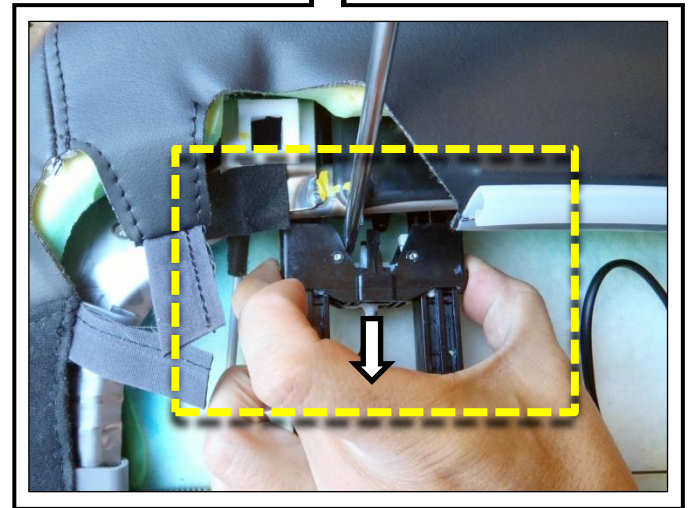
7. Grasp the elevator and use a flathead screwdriver to pry the left and right locks, until the elevator can be lowered by hand.

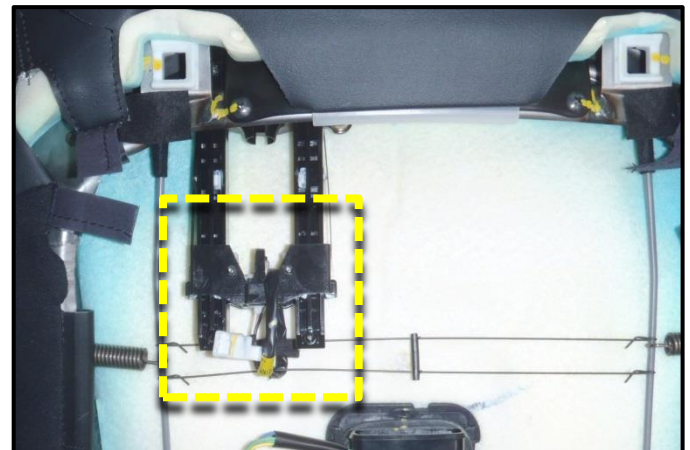
8. Wrap the harness around the cross wires and the elevator, as shown, to keep it from moving vertically.

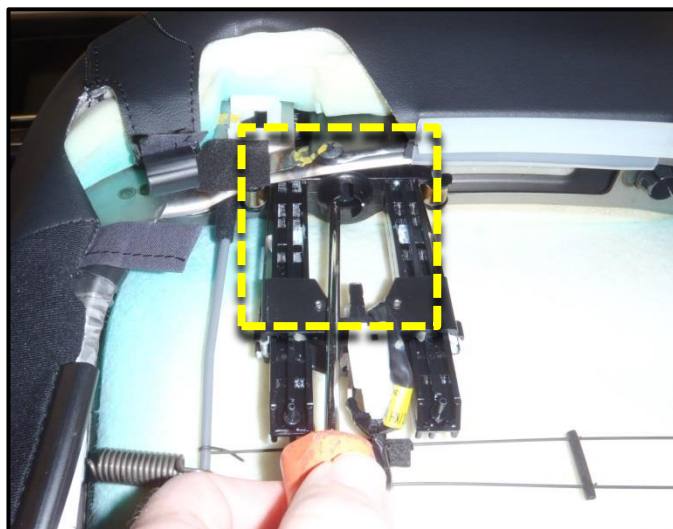
9. Use a flathead screwdriver to pry the two (2) left side headrest guide retaining lugs.

Repeat this step for the right side headrest guide.

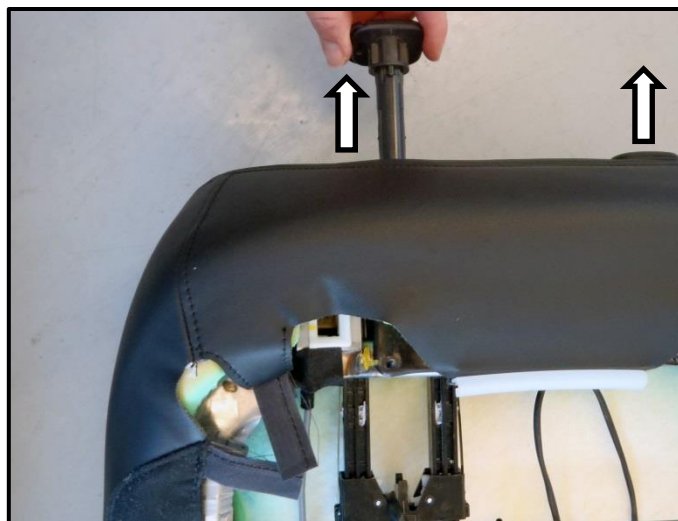
10. Pull the two (2) headrest guides through the top of the seat.

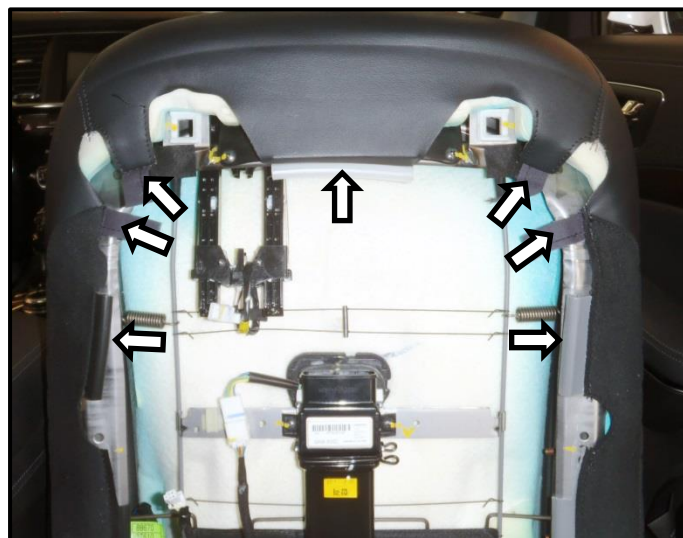
11. Remove three (3) seat cover retainers and four (4) J-Hooks securing the seat cover to the seat frame. Then, gently pull the seat cover material over the top of the seat.

To prevent tearing at the seams, be careful when reinstalling the leather material over the seat frame.

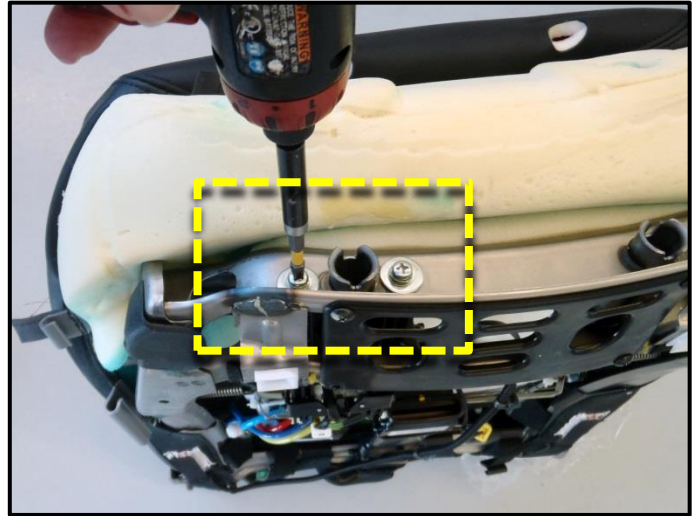
12. Locate and remove two (2) screws and two (2) washers securing the elevator module to the seat frame, as shown.

Save all hardware for reuse.

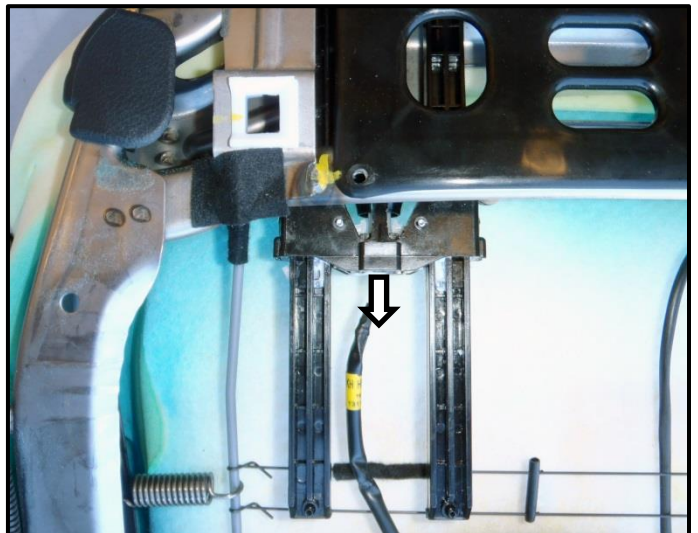
13. Release the harness, previously wrapped around the elevator module on step 8, and remove the elevator module from the seat frame, as shown.

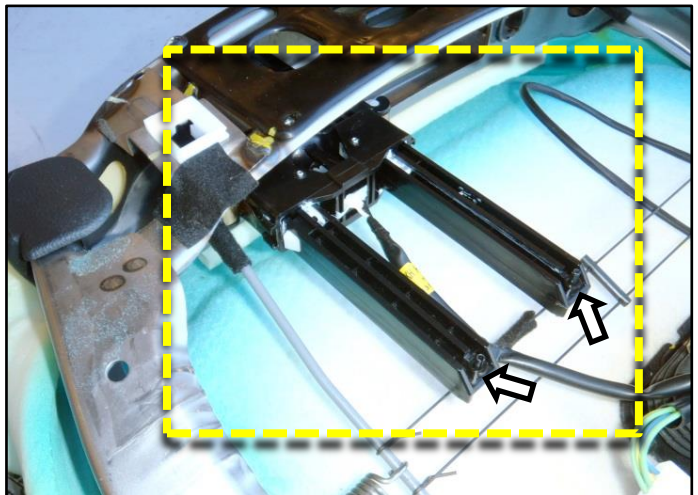
14. Install the new headrest elevator module by reversing the removal process. **NOTE: The chamfered ends of the replacement elevator should face towards the installer.**

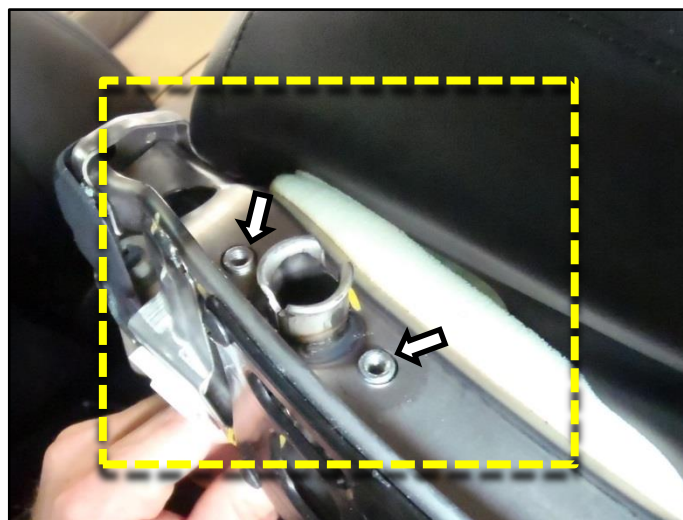
15. Make sure the threaded inserts on the replacement elevator protrude through the seat frame mounting locations, prior to installing the retaining hardware.

Pay close attention when installing the replacement headrest elevator, as it will only fit in one direction. If improperly installed, the headrest elevator will not seat properly against the seat frame mounting locations.
