SERVICE BULLETIN

APPLICABILITY: 2011-12 MY Forester Models with 2.5L FB Engines UP to and Including VIN C*411693
NUMBER: 02-147-13R
DATE: 12/09/13
SUBJECT: Surface Treatment Change To Oil Control Piston Rings
REVISED: 03/20/14

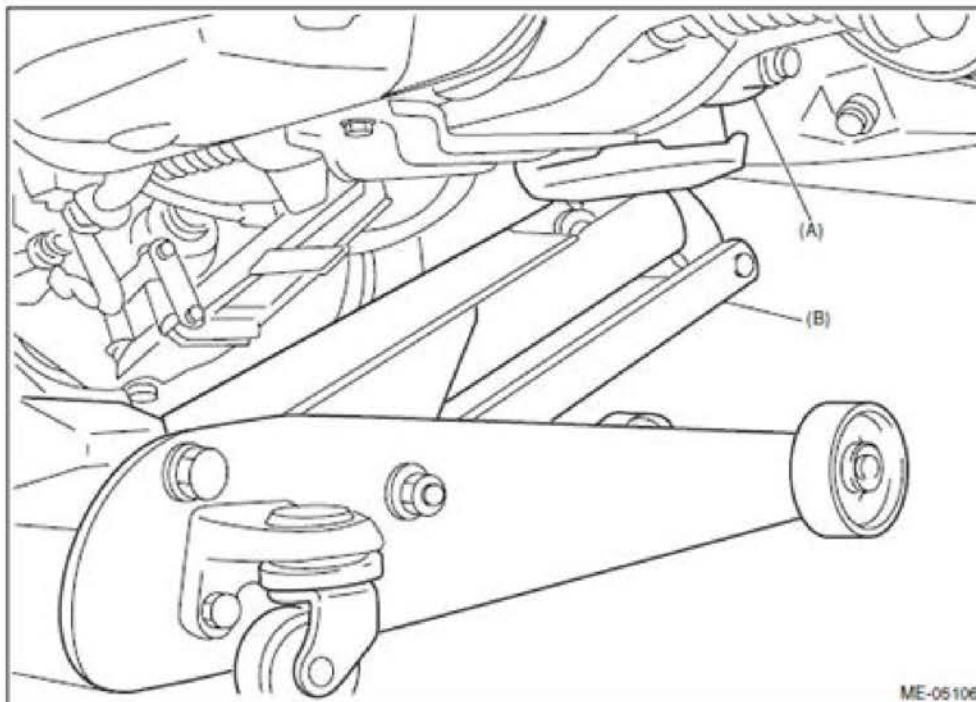
- When draining the engine oil, do not remove the engine oil filter. Leave the existing oil filter in place through engine disassembly, reassembly, installation and initial startup after engine reassembly.
- When removing the engine, there is no need to remove the transmission case cover (CVT only) or to disconnect / disturb any of the transmission harness connectors. While raising the transmission with the service jack placed under the front differential as shown in the illustration below, **only raise it enough to access and remove the engine mounting hardware**. Raising it too high can push the transmission up into the bulkhead / transmission tunnel and possibly cause damage.

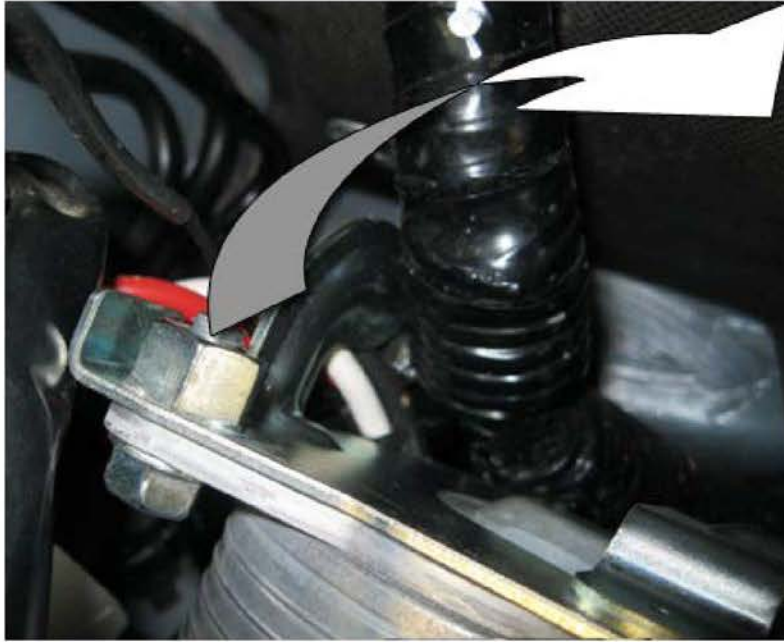
- When removing the CVT fluid cooler, leave it attached to its mounting bracket and remove as an assembly (3 bolts) from the transmission. Disconnect just the engine coolant hoses from it and do not disturb the 2 short CVT fluid lines. Hook one of the cooler's mounting bracket "ears" behind the bulkhead harness as shown in the photo below to keep the cooler assembly out of your way. Use a shop cloth between the "ear" and the bulkhead harness to prevent any chafing.

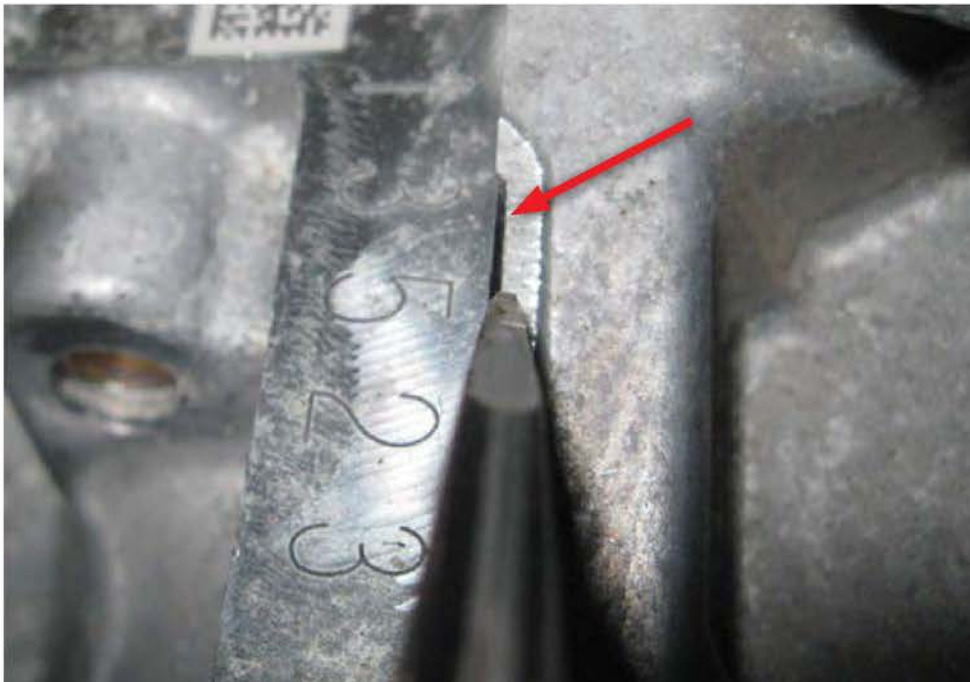
- To make separating the transmission (CVT) from the engine easier, there is a pry relief shown below in the machined mounting surface of the transmission case near the engine number. Use caution when applying any prying pressure and avoid twisting the tool to prevent case damage.

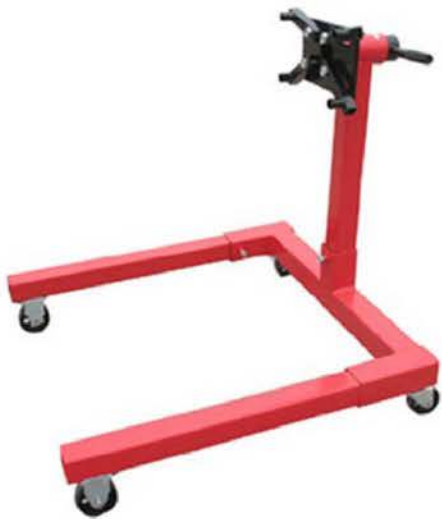
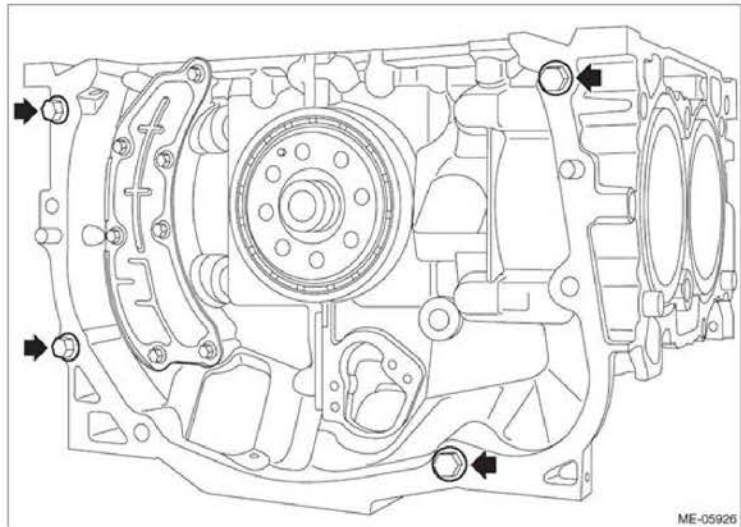
- Once the engine is removed, if you are using a generic engine stand (preferable since engine rotation is necessary), use the four mounting holes on the engine block shown below to mount it. **NOTE:** Do not use the mounting studs in the upper oil pan.

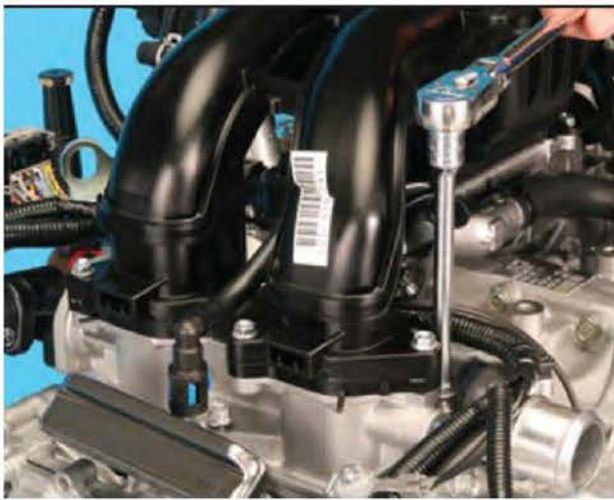
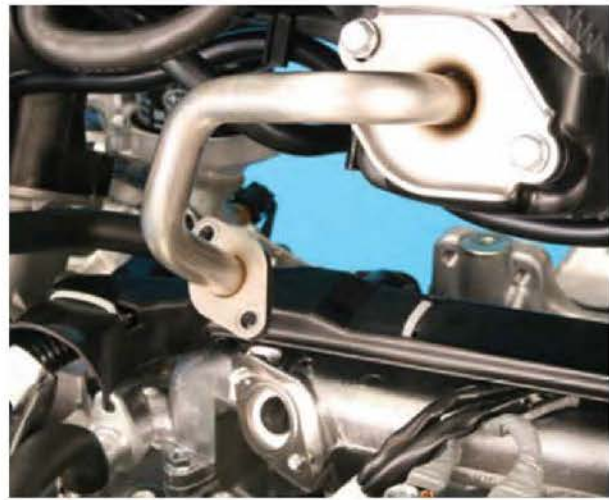
- When removing the intake manifold, as shown in the photos below, leave the TGV assemblies attached to the upper intake, remove the 2 nuts holding the EGR tube to the water pipe then remove the complete assembly from the cylinder heads as a unit.

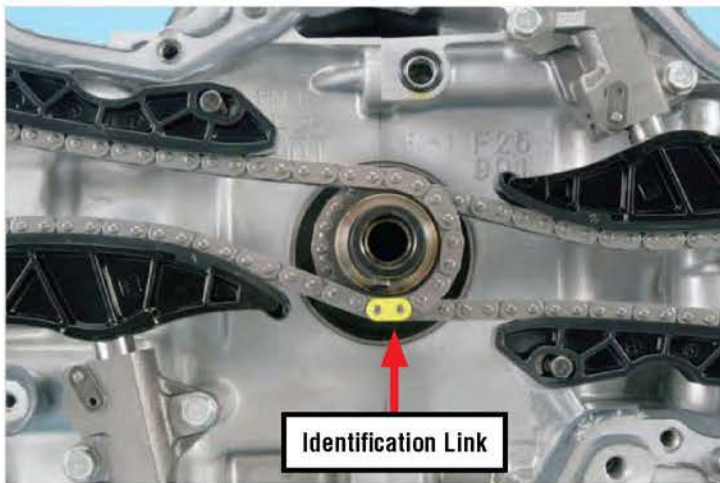
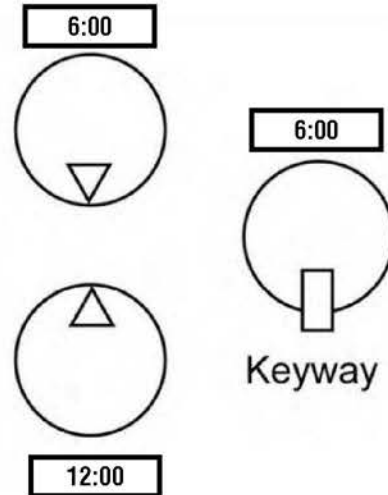
- Begin timing chain removal by positioning the crankshaft keyway at the 6:00 position. The RIGHT bank intake camshaft timing mark (Δ) must be at 6:00 with right bank exhaust timing mark at 12:00 (camshafts will be unloaded).

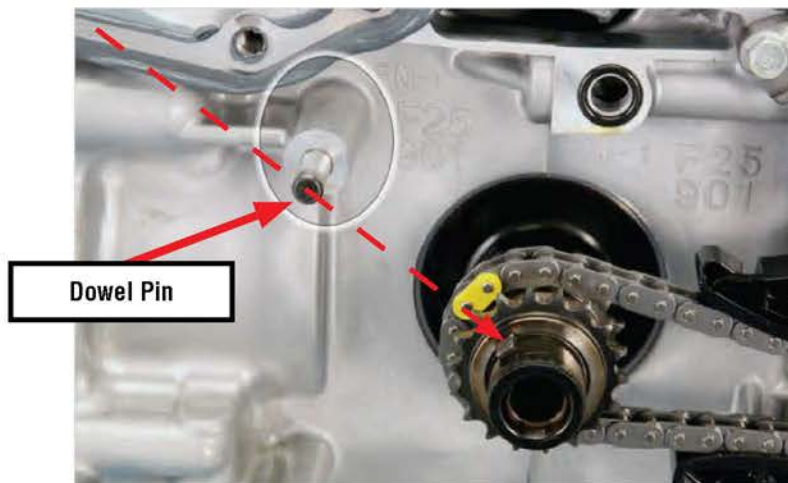
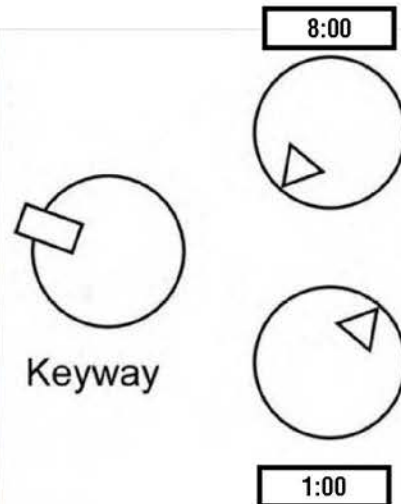
- Compress the chain tensioner by hand, insert a pin through the lever into the access hole to lock the plunger in place then remove the 2 bolts, tensioner, guides and right side timing chain.
- After turning the crankshaft **CLOCKWISE**, repeat the procedure for the LEFT side with the timing marks (Δ) positioned as shown below. Align the crank sprocket keyway with RH chain dowel pin (shown in red below).

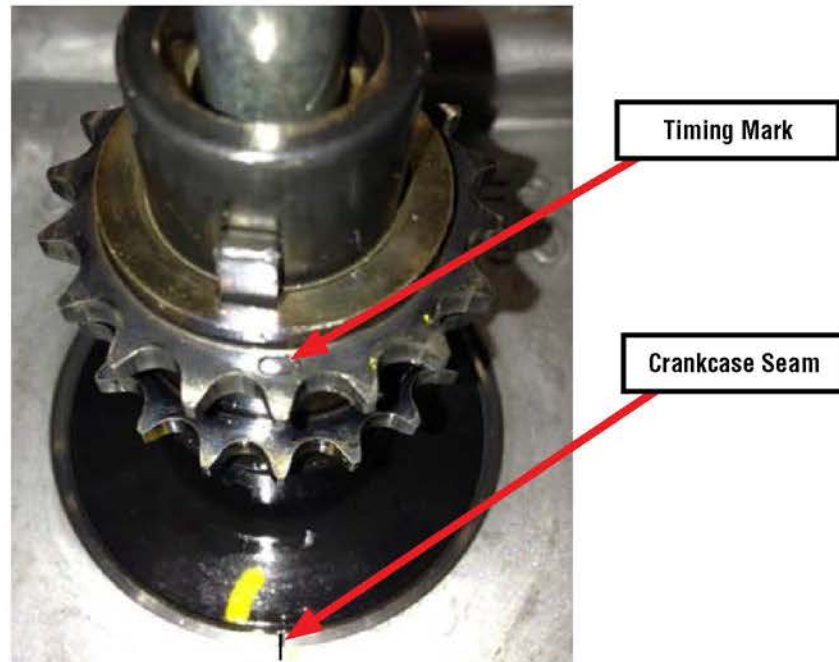
- Compress the chain tensioner by hand, insert a pin through the lever into the access hole to lock the plunger in place then remove the 2 bolts, tensioner, guides and the left side timing chain.
- After the left chain is removed, turn the crankshaft in a **COUNTER CLOCKWISE** direction until the timing mark on the crankshaft sprocket (NOT the keyway) is back to the 6:00 position as shown below. This positions all the pistons away from TDC and prevents accidental contact between the pistons and valves.

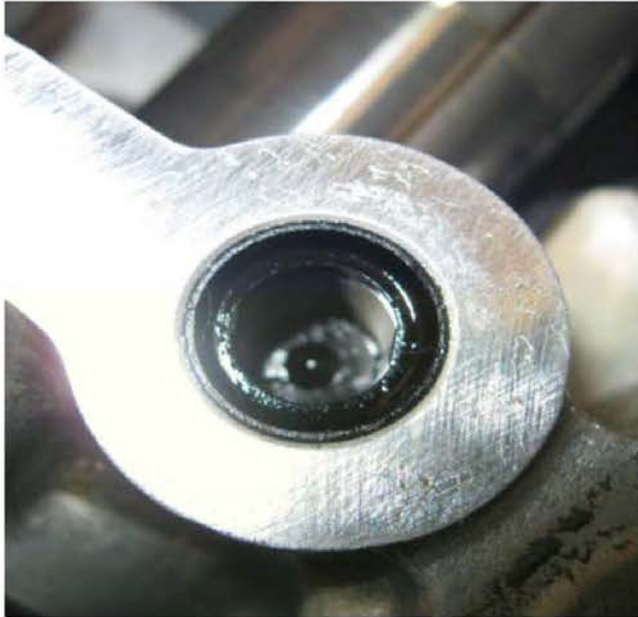
Cam Carrier Filter Screen

- Don't forget to clean (**without removing**) the filter screens in the cam carriers (one filter in each carrier). In addition, always be sure to do a thorough inspection and cleaning of the oil pan, pick-up tube and screen as shown in the photos below before reassembly.

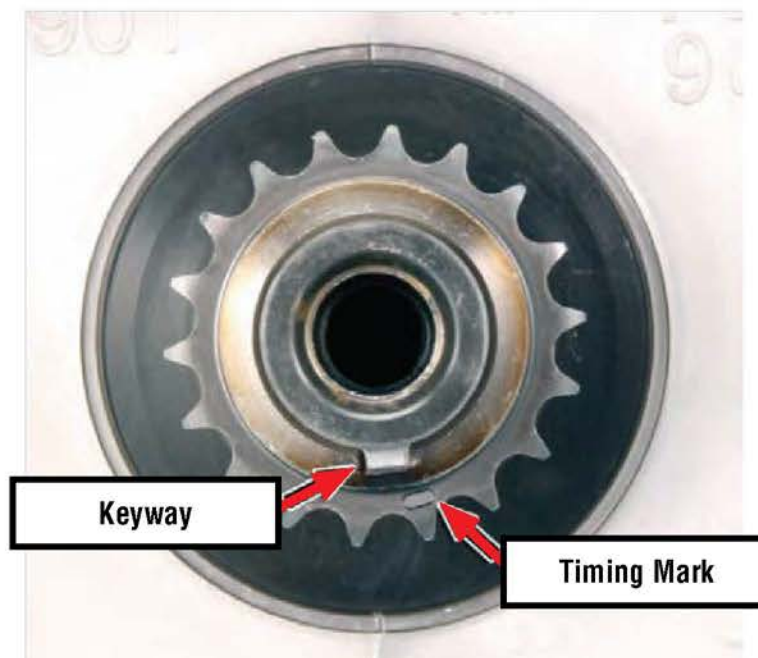
- To begin timing chain re-installation, turn the crankshaft **COUNTER-CLOCKWISE** until the crankshaft sprocket keyway is back to the 6:00 position. **This positions the pistons away from TDC and prevents accidental contact with the valves.** **NOTE:** The keyway is **NOT** a timing mark.

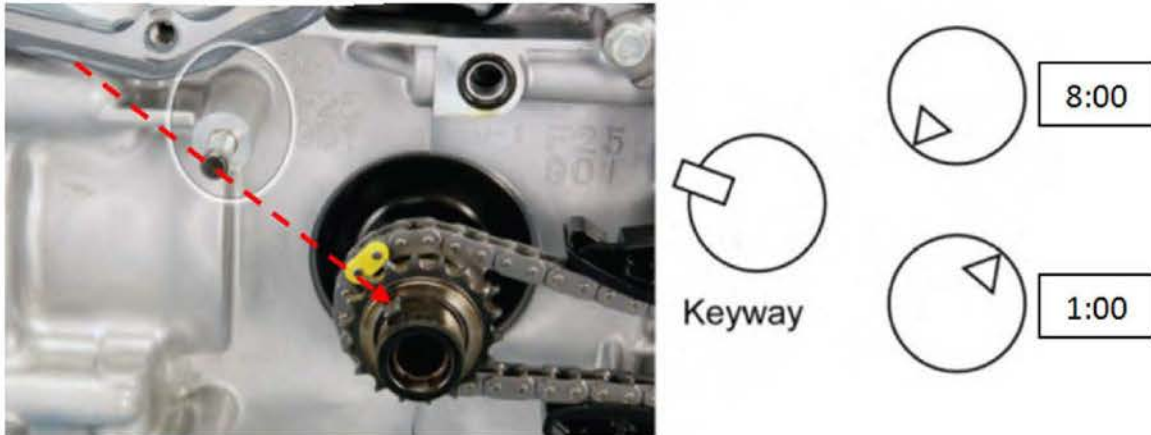
- Arrange the timing marks as shown below, turning the crankshaft **CLOCKWISE** into position. Align the indicator link with the timing mark on the crankshaft sprocket, keyway with the dowel pin.

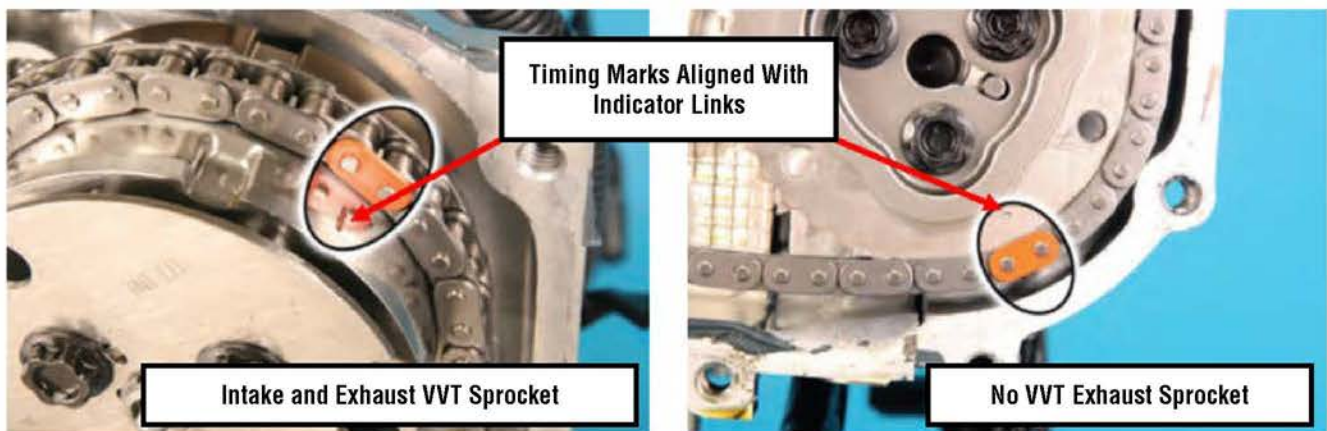
- Align the indicator links to the timing marks found on the outside of the sprocket assemblies as shown in the photos below (Exhaust sprocket face images vary with / without exhaust VVT).

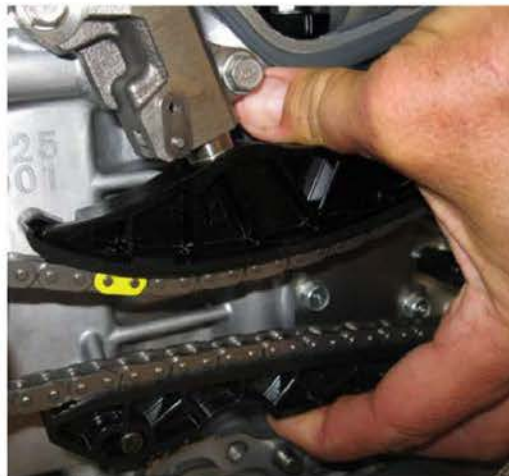
- Install the chain guides and tensioner. Once proper positioning has been confirmed, pull the pin to release the tensioner. With your hand, grab and squeeze the upper and lower chain / guides together as shown in the reference photo below to allow the plunger in the tensioner to fully extend and click into its furthest notch.

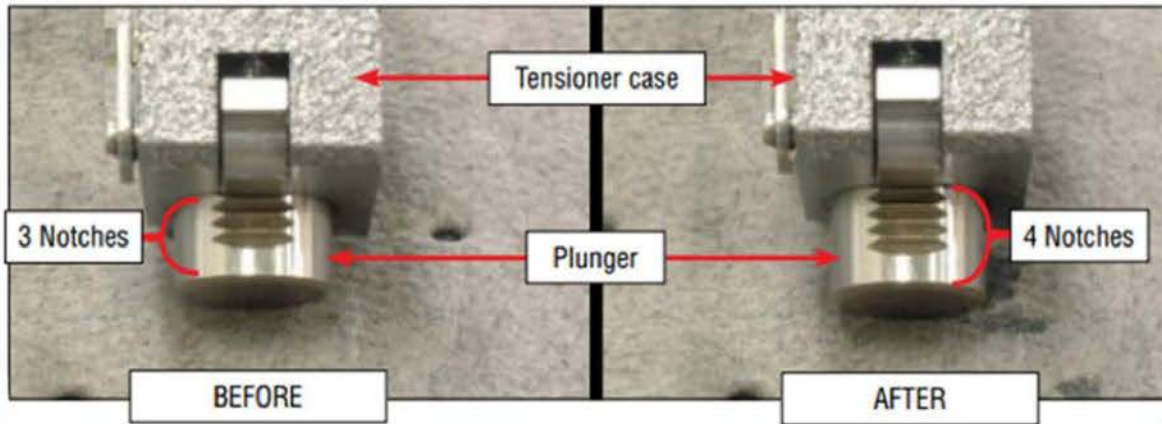
- If you have 3 notches showing, you want to get one more “click” so that 4 notches are visible as shown in the photos below. If you have 4 showing, you want to end up with 5. Whether you start with 3 or 4 will depend on the amount of wear present on the chains and guides. The number of clicks listed here is simply a guide. The point is to ensure proper initial chain tension is applied to avoid creating a brief rattle sound at engine start.

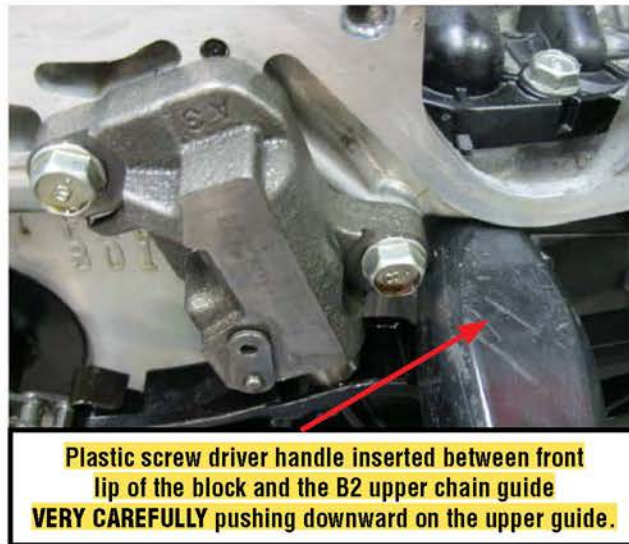
- If necessary, insert a plastic screwdriver handle between the lip of the block and the left side (B2) guide. Then, **VERY CAREFULLY** push down on the guide just enough to get the extra tensioner notch / “click”. When using this method, always make sure you are using plastic on plastic and NOT metal on plastic to avoid damaging the chain guides.

Plastic screw driver handle inserted between front lip of the block and the B2 upper chain guide **VERY CAREFULLY** pushing downward on the upper guide.

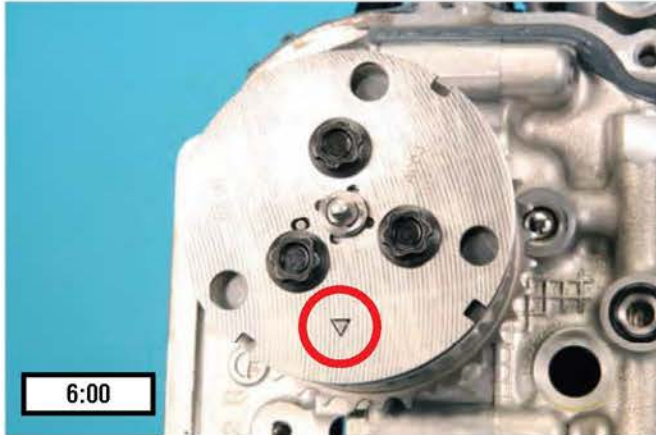
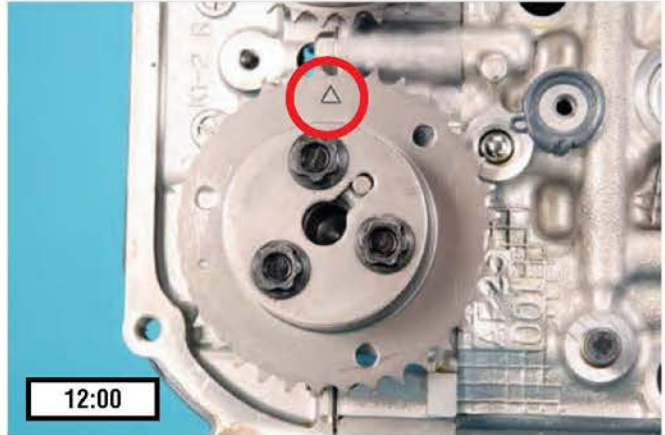
- Rotate the crankshaft **COUNTER-CLOCKWISE** until the crankshaft sprocket timing mark is at the 6:00 position. Position the cam sprocket timing marks as shown below; intake 6:00, exhaust 12:00.

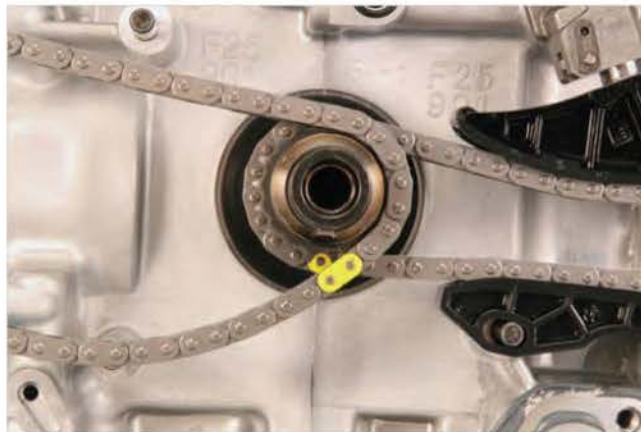
- Align the indicator link with the timing mark on the crankshaft sprocket as shown below.

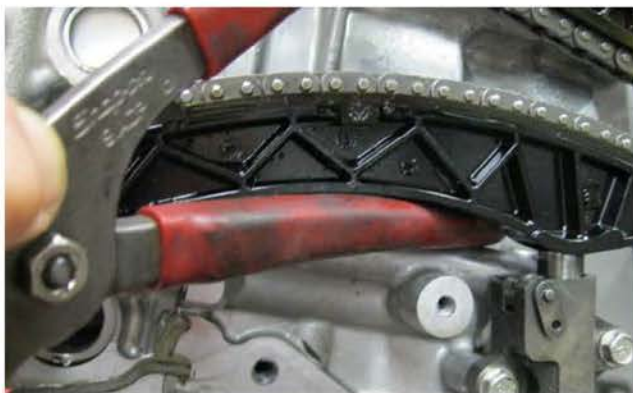
- Same as the left side, align the indicator links to the timing marks found on the cam sprocket assemblies. Install the chain guides and tensioner. Once proper positioning has been confirmed, pull the pin to release the tensioner. With your hand, grab and squeeze the upper and lower left side chain / guides together to allow the plunger in the tensioner to extend fully and click into its furthest notch as shown in the previous (right side) photo. **If necessary, insert a rubber-coated plier handle between the ledge area on the front of the block and the right side (B1) lower chain guide. Then, VERY CAREFULLY lift up on the guide just enough to get the extra “click” on the tensioner as shown in the photo below.**

Rubber-coated plier handle inserted between a ledge area on the front of the block and the B1 lower chain guide VERY CAREFULLY lifting upward on the lower guide.

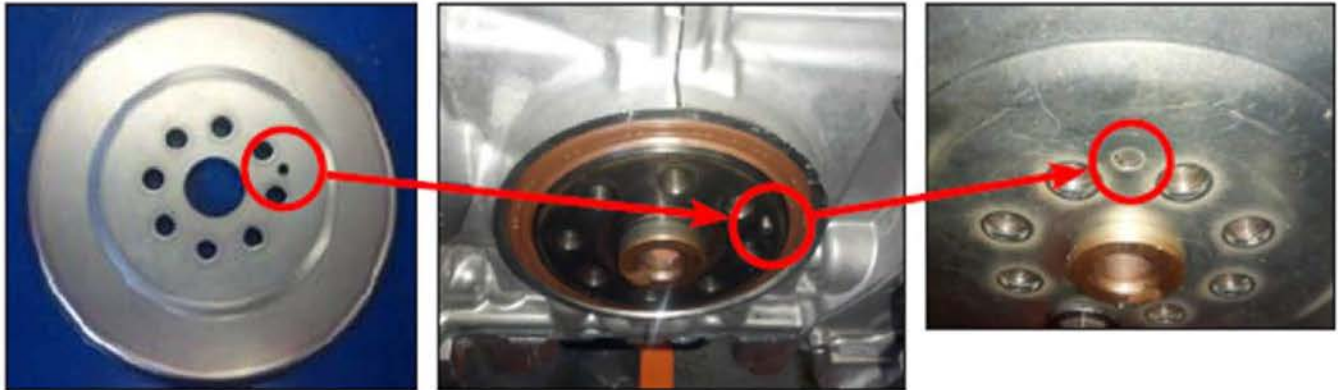
- **REMINDER:** When replacing the short block, in addition to transferring the crankshaft position sensor, be sure to index the reluctor properly onto the crankshaft as shown in the photos below. The reluctor is indexed by a dowel pin in the rear crankshaft flange which aligns with a corresponding hole in the reluctor. It is possible to install the reluctor without indexing it correctly. Failure to index the reluctor correctly will result in a no-start condition due to an out of time crank position signal to the ECM.
