Program Bulletin

CUSTOMER SATISFACTION PROGRAM

SUBJECT: HVAC Drain Tube Misalignment

MODELS: 2014 Chevrolet SS
2014 Chevrolet PPV

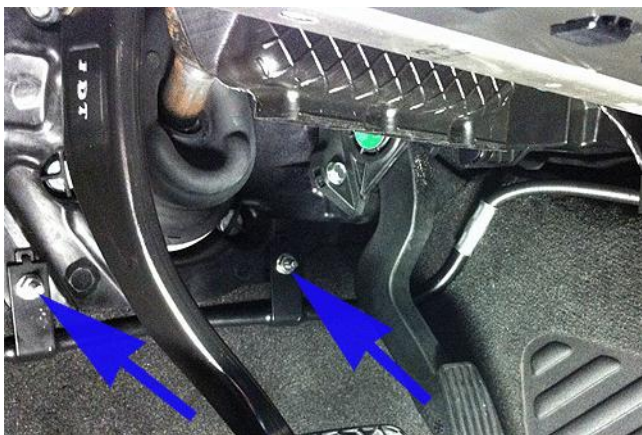
3924637

1. For vehicles with a dash mounted shifter, remove the nuts holding the foot operated park brake cable and reposition the cable to allow clearance for the repair. This step is not required on floor shift models.
2. Remove the left console extension panel. Refer to Front Floor Console Extension Panel .

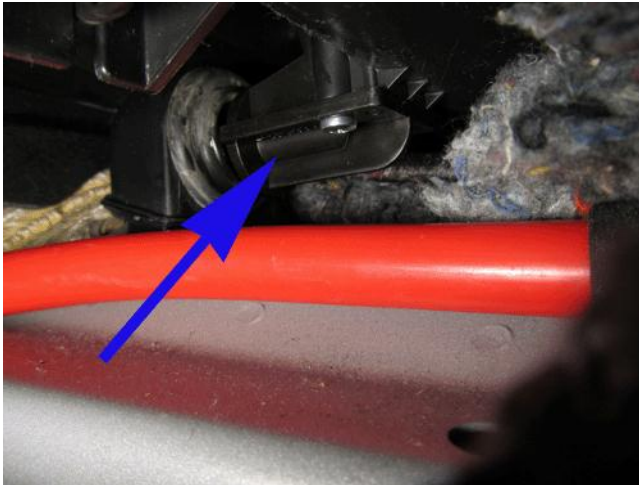
3924595

4. Locate the spigot (drain) at the bottom of the HVAC case.

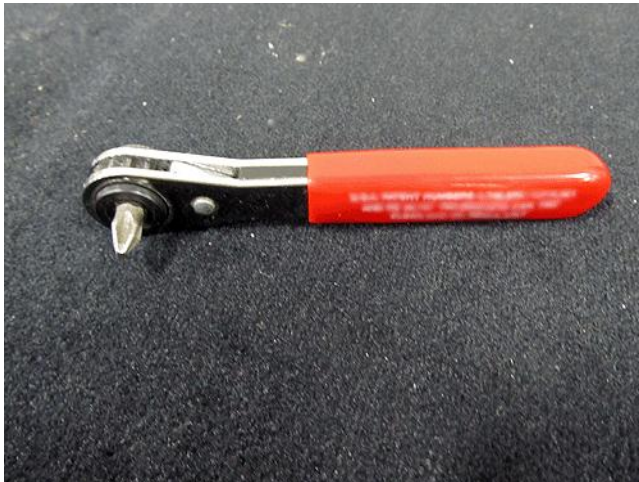
3924596

5. Using a mini ratchet handle and a (shortened) Phillip's head bit as shown, remove the two drain mounting screws. Use a telescoping magnet to capture the screws.

Tip: Screwdriver bits are not standardized for length. Clearance to access the drain mounted Phillips screws is limited. If required (using a grinder) remove some length from the screwdriver bit to gain necessary clearance.

6. Remove the spigot.

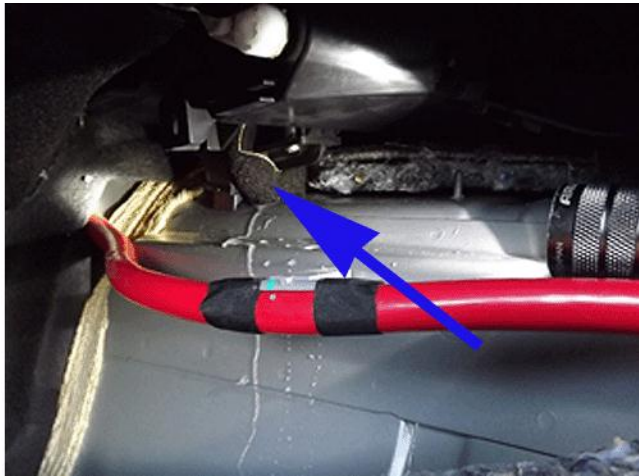
3924597

7. Remove and discard the foam seal between the spigot and the lower drain housing.

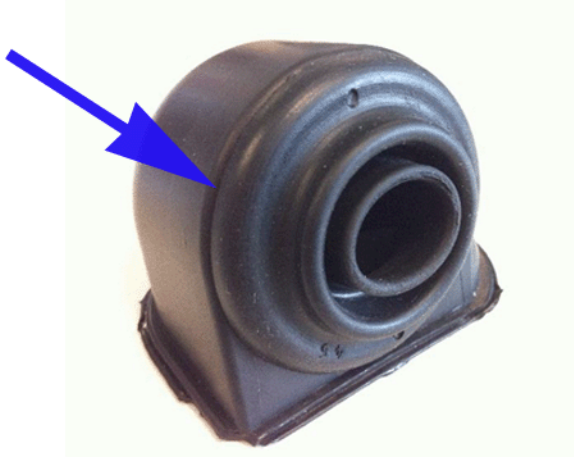
3924600

8. Lubricate the new service grommet with silicone spray and install the grommet into the lower drain housing. Ensure the lip on the grommet is fully seated on the drain housing (the drain housing is shown out of the vehicle for photographic purposes only, do not remove the housing).
9. Reinstall the spigot, ensure the drain hose from the HVAC housing is securely attached to the spigot. Insert the spigot into the grommet.

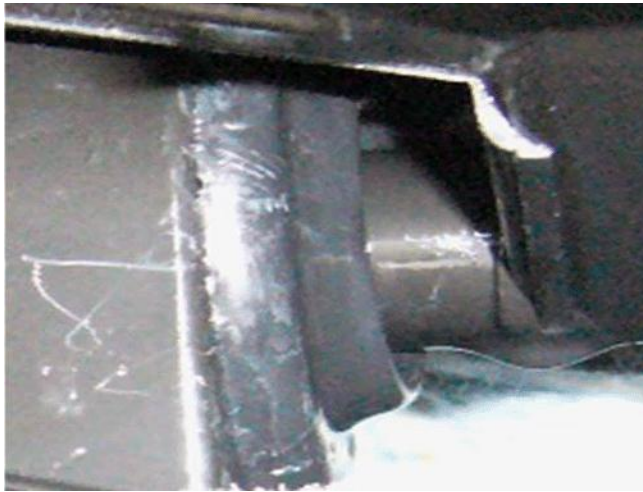
3924602

10. Push the spigot all of the way into the grommet and pull the spigot out until the grommet is positioned as shown in the photograph.

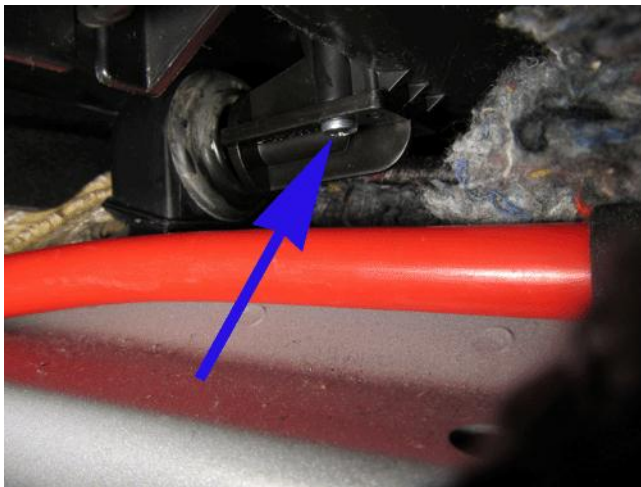
3924634

11. Install the outboard screw only, discard the inboard screw, it is not needed.
12. Position the carpet into the original position.
13. Reinstall the left console extension panel.
14. For vehicles with a dash mounted shifter, install the nuts holding the foot operated park brake cable and **Tighten** to 2.5 N.m (22 lb in). This step is not required on floor shift models.
