WMATA: Coolant Hose P-Clamp Addition

Property name and Top bus number: WMATA 325000, 325500

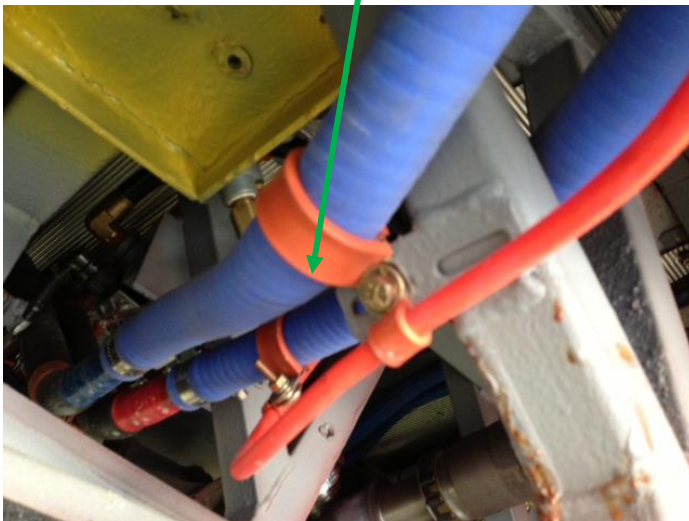
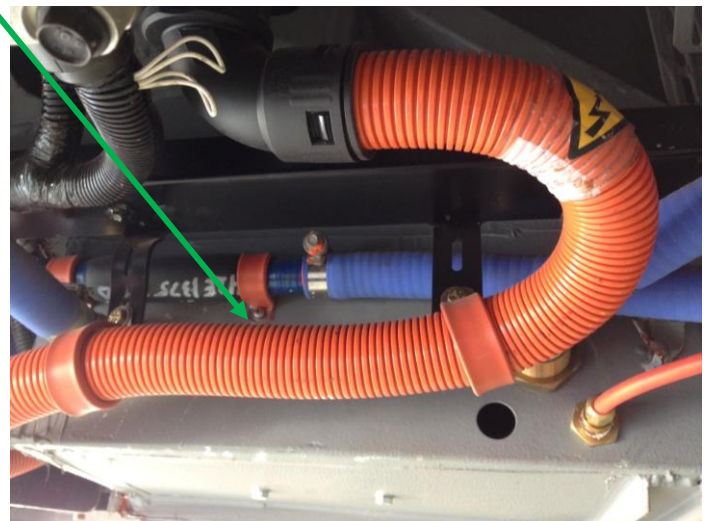
3. Replace 1-3/8 ID clamp at #3 location with new 1-1/4 ID clamp. Use original mounting hardware. Replace hardware if required.
4. Position hose assembly per the dimension noted on the drawing (3.5").
5. Place #1 and #2 1-1/4 size clamps beside the end of the hoses as photos show.
6. Install clamps with #10x3/4 self-drilling screws.
7. Check for completeness of work. Ensure that hose assembly is secured and not rubbing.
8. Remove all tools and unused parts from work area.
9. Record bus number, mileage, date of completion and the name of technician who completed the work.
