WMATA: Diesel Emission Fluid (DEF) Coolant Hose

Clamp Addition

Property name and Top bus number: WMATA 325000, 325500

Issue: Add clamp to DEF coolant hose

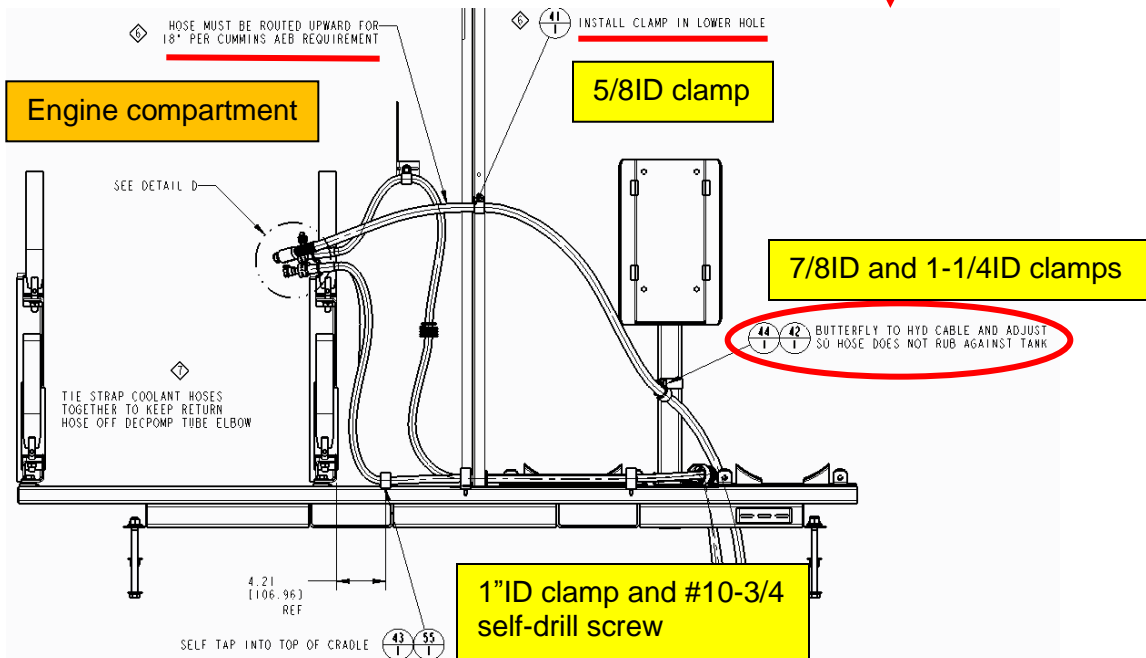
1. Park the bus and apply the parking brake.
2. Turn off main battery disconnect switch(es)
3. Open the rear attic compartment door and locate the coolant hoses of the DEF (see pictures below).
4. Install clamps per the engineering documentation (42H-1408-100) and photos below.
