TECHNICAL BULLETIN
JTBO0306NAS2
01 MAY 2014

Suspension 'Knock' / 'Creak' Noise From Rear of Vehicle

F-TYPE (X152)

Situation: A suspension 'knock' / 'creak' noise may be heard from the rear of the vehicle when going over bumps or when maneuvering at slow speeds.

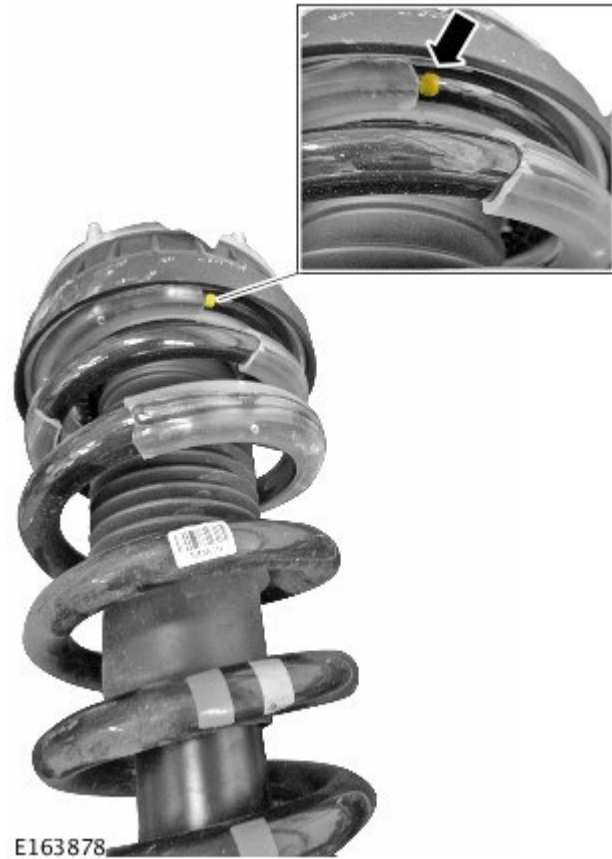
2. Make a note of the paint mark on the spring.

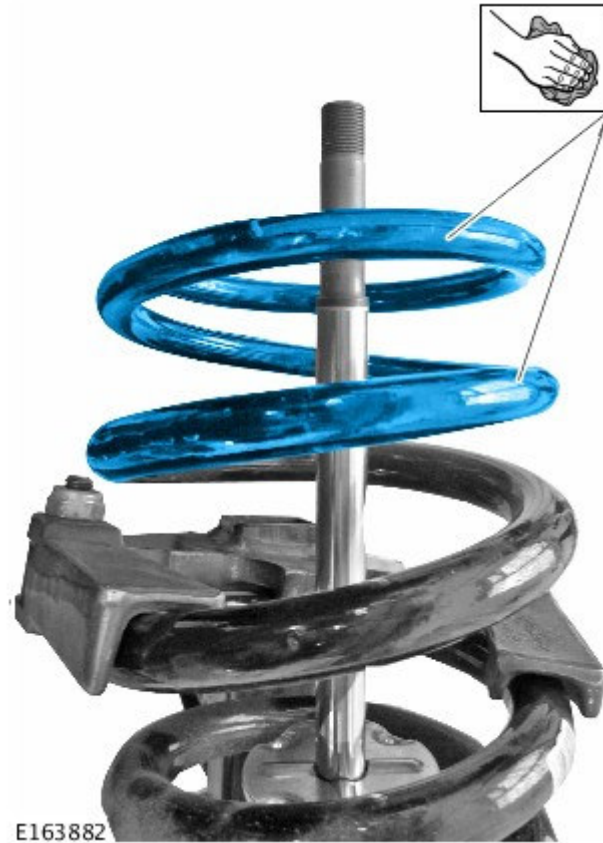
**NOTE: If previously fitted, remove all spring isolator sleeves.**

Using a suitable cloth, clean the spring in the section where the new sleeve is to be installed.

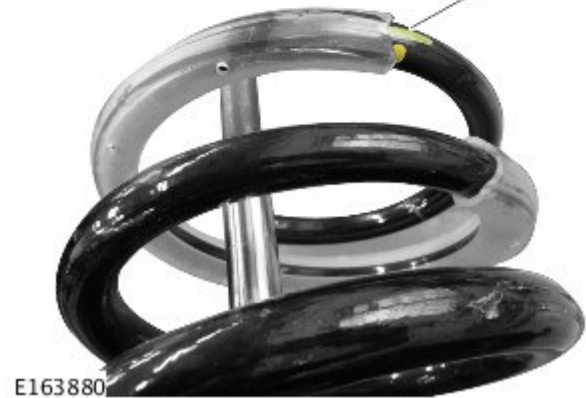
E163880

**NOTE: Note the paint mark.**

Install the new sleeve.
