Special Bulletin

SP14-84A

FRONT CENTRAL PILLAR REPLACEMENT B13R (9700 us/can)

Perform this bulletin on a "Fix As Fail" basis. On the vehicles affected by this bulletin, replace the front central windshield pillar for an improved version.

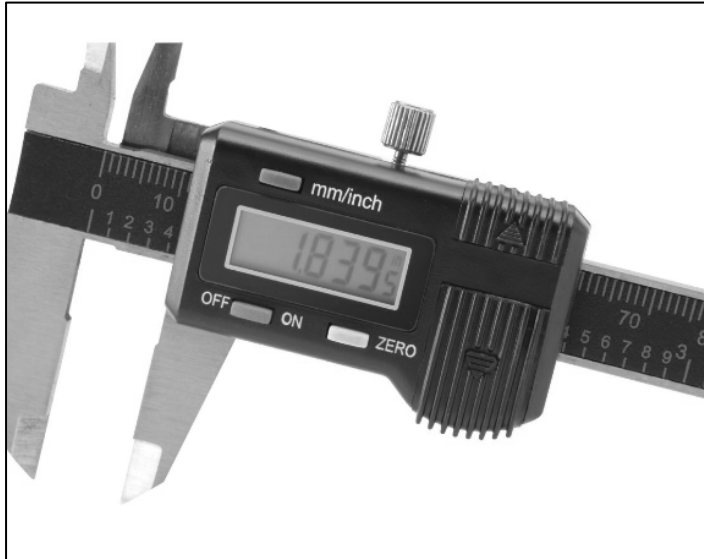
Digital caliper with "millimeters/inch"

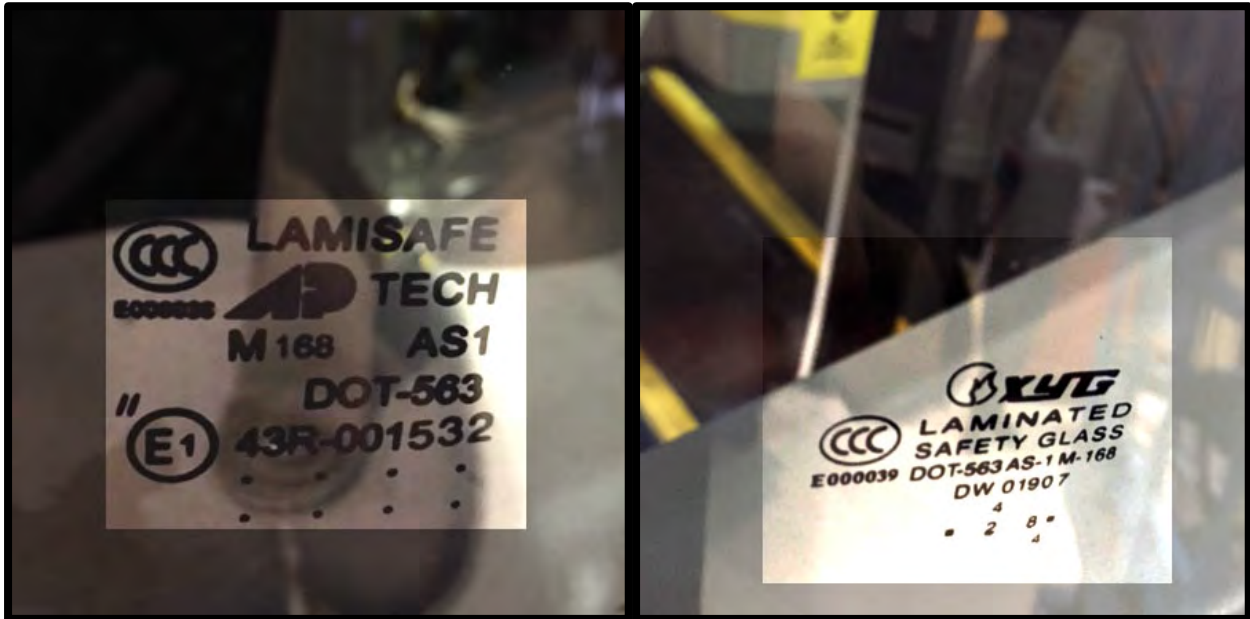
Possible windshield brands other than "Volvo"

If the brand is not Volvo brand contact your service representative.

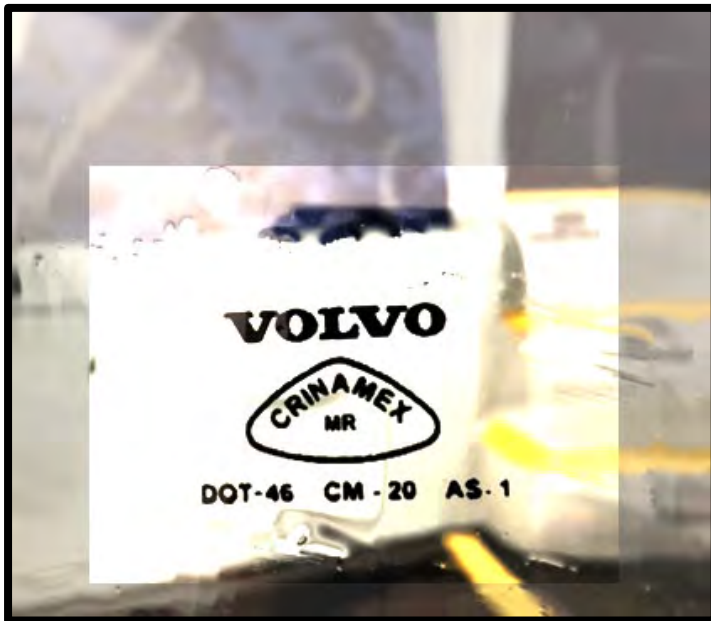
Volvo brand windshield:

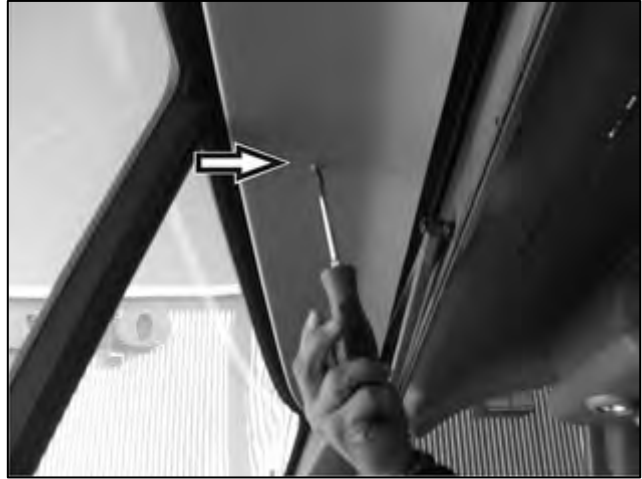
The new style pillar is stronger looking

1. Remove wipers
2. Move mirrors outwards.
3. Remove interior rear-view mirror
4. Loosen the upper roof cover.
5. Remove the existing windshields
6. Remove center the pillar. Discard the existing pillar if it is the OLD style. Keep if it is the NEW style pillar .

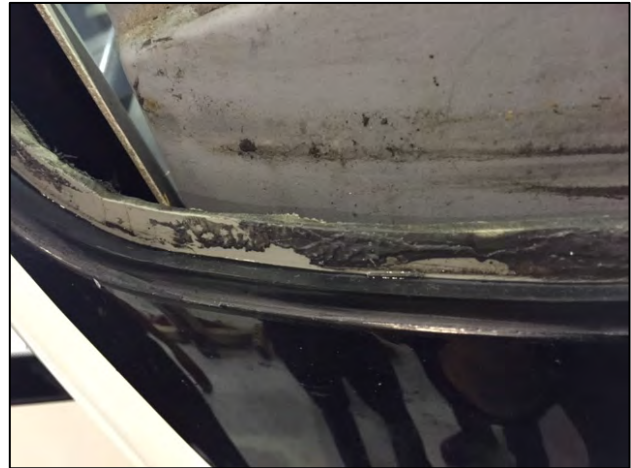
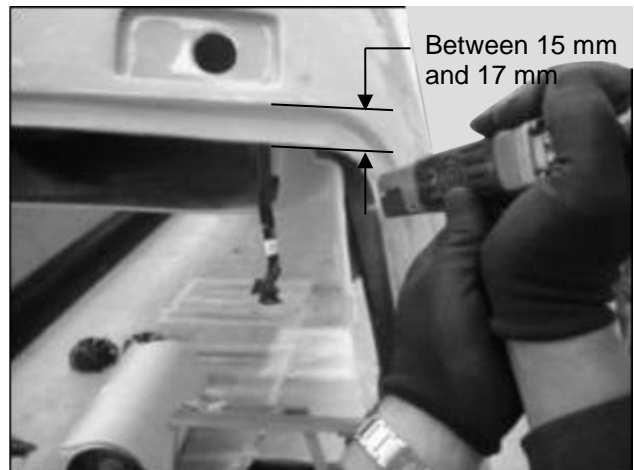
- Remove the seal.
- Manually scrape any SIKA residue from the fiber cap of the coach *before* using any removal products.
- Measure fiberglass lip with digital caliper to have between **15 and 17mm all around**

If required cut the fiberglass edge in order to achieve the fit.

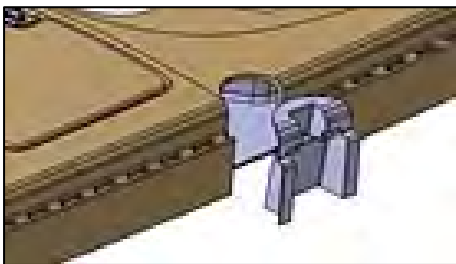
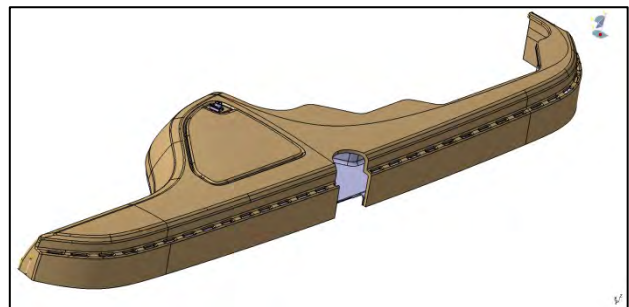
- Cut a portion of the dash board middle panel in order to house the Cover Dashboard PN: 22106050, according with the dimensions shown in Appendix at the end of this document.

Test and fit.

Only install at the end of the procedure

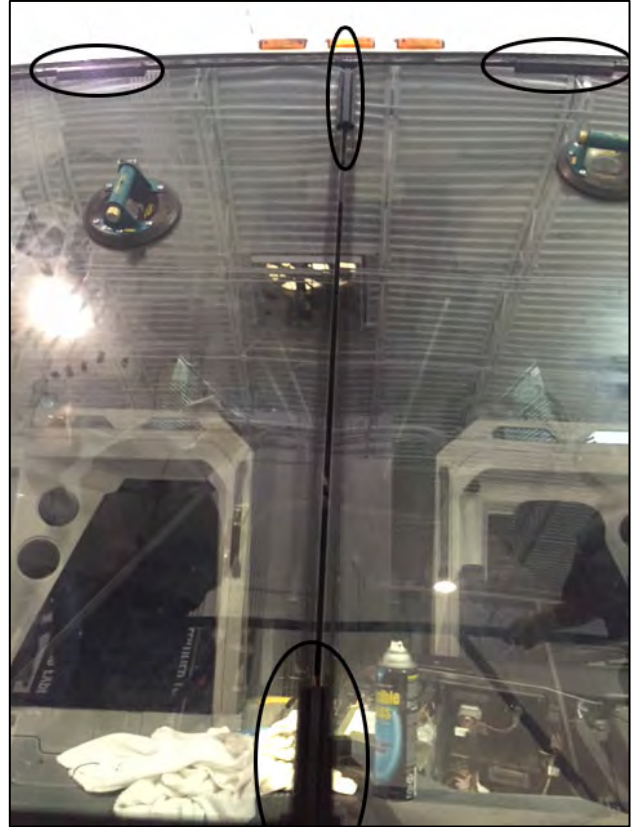
11. Cut 8" long sections of 21133962 sealing molding. To install temporarily the windshield.
12. Install at top and bottom of post.
13. Install a seal within 3" of each bottom corner.

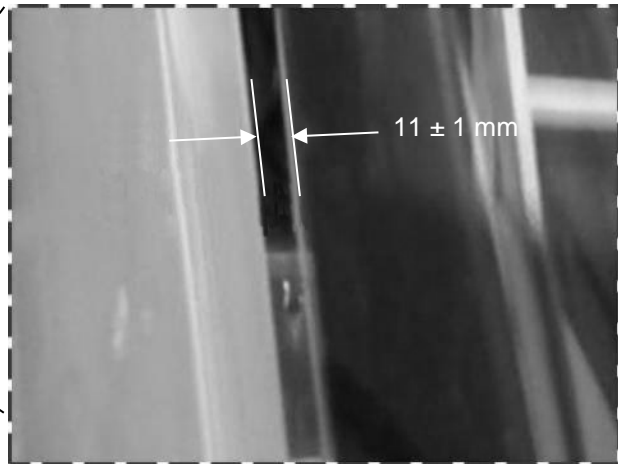
14. Fit the gap between windshield and fiberglass at 11 ± 1 mm.

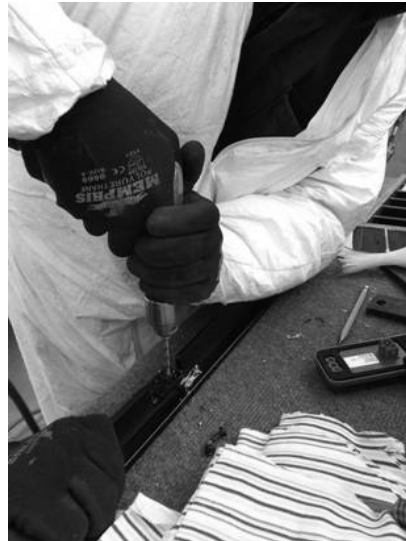
15. Install the mirror on the new Front Central Pillar PN: 22069304 make two holes (Drill: 5/32") in the plate for the mirror support screws, use the mirror support to locate the holes.

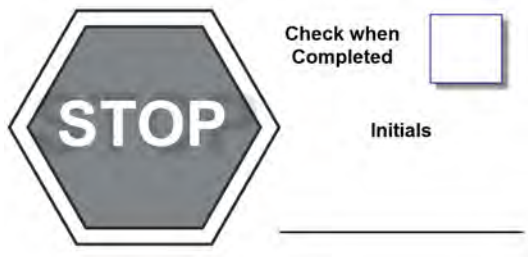
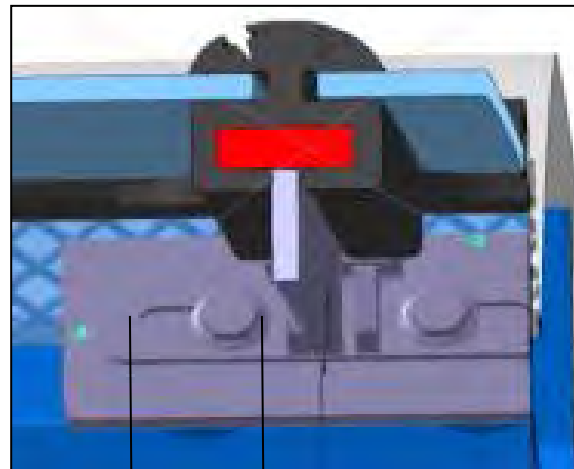
16. Check for positioning of slots in pillar bases with respect to the threaded holes.

If required, the new holes can be located along the slot in the pillar base.

17. If the slots and threaded holes don't match exactly, drill new holes. Drill along the slots to make new holes, see figure.

18. Drill a guide hole with a 13/64" drill, then drill 7 mm and finally tap M8*20

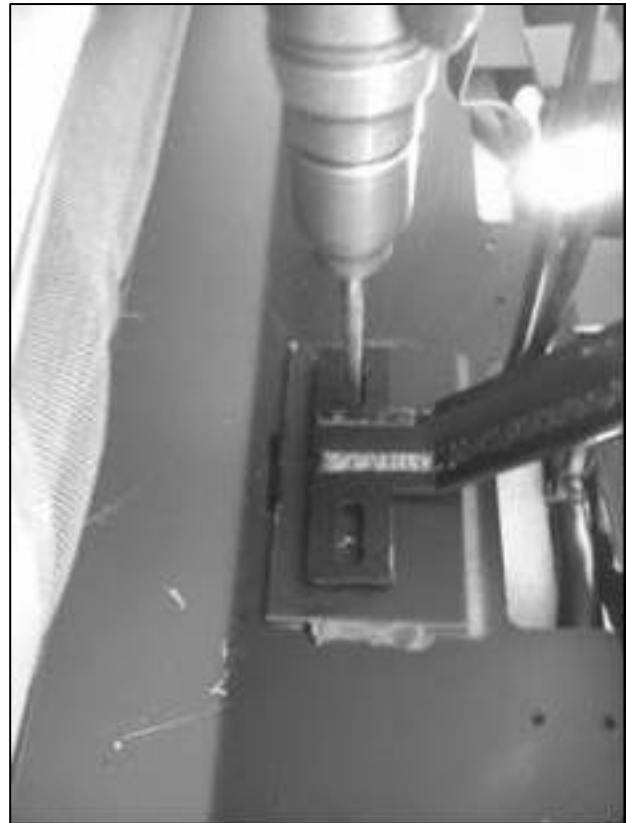
19. Install fasteners, tighten to: 24±4 Nm. (18lbf-ft)

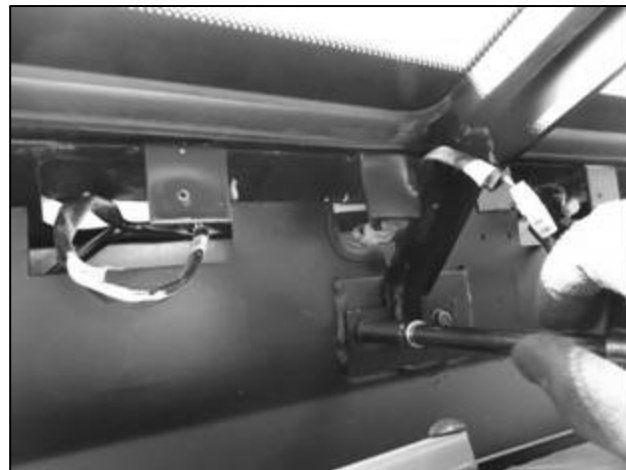
20. When the windshield gaps are all within the desired values, perform final assembly of the windshield according to local best practices.

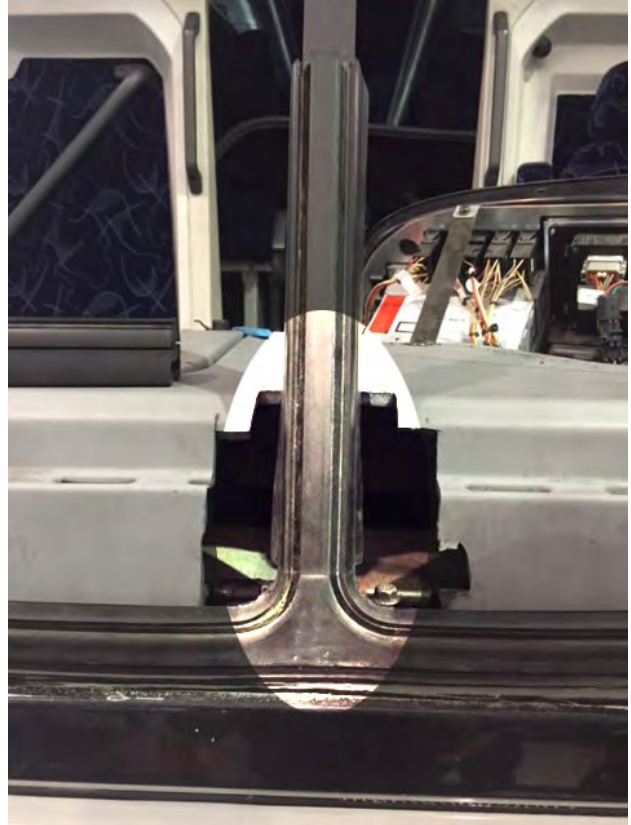
21. The lower part of the windshield seal should be cut to avoid warping in this area.

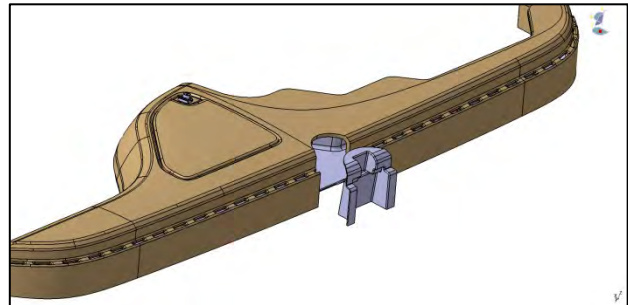
23. Assemble and seal the Cover Dashboard to the middle panel: remove any grease, oil or dust, promote sealing with Sika Aktivator and seal with Sikaflex-221, and fix with masking tape during curing time.

Note: Follow drying and curing time according to manufacturer instructions.

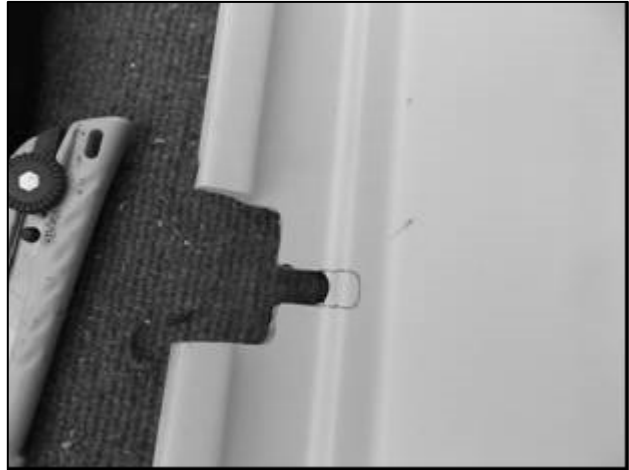
24. Mark and cut the upper plastic cover as required according with the position of new Central Front Pillar.

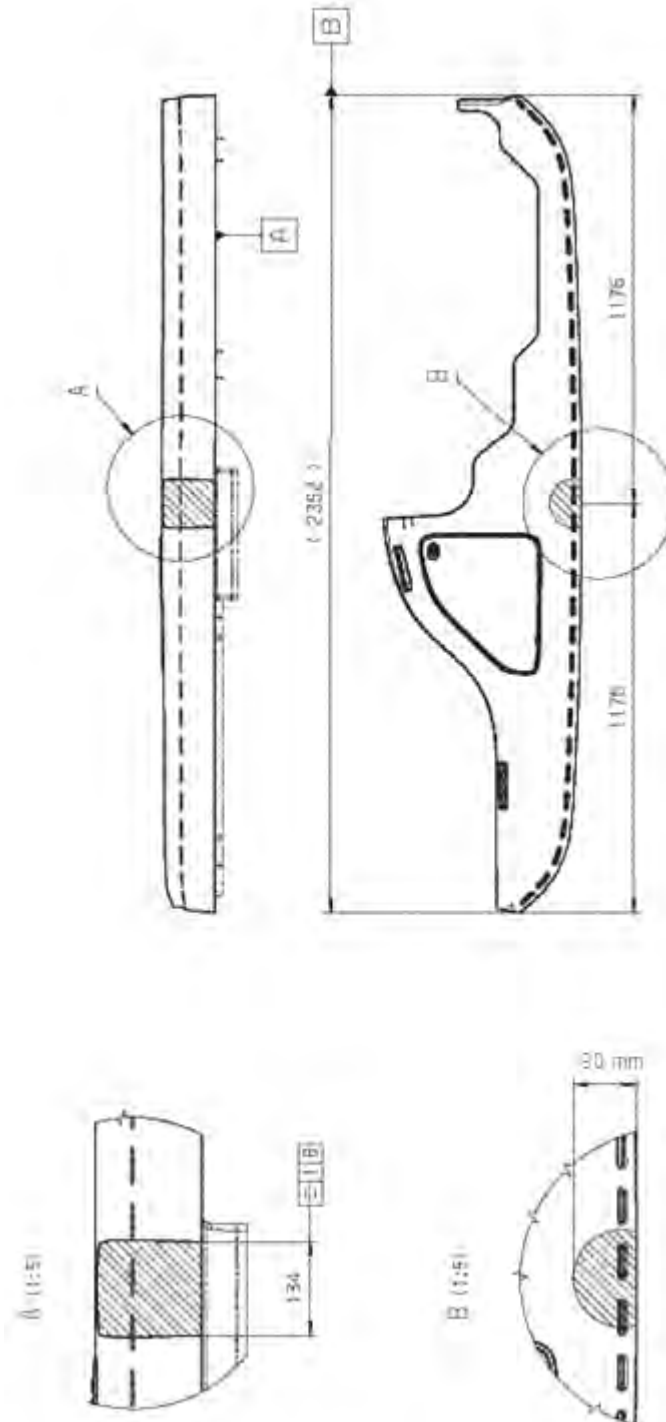
APPENDIX

Dimensions are in millimeters.
