**Countries:** CANADA, UNITED STATES **Document ID:** IK0600015  
**Availability:** ISIS, Bus ISIS, Fleet ISIS **Revision:** 0  
**Major System:** PROP SHAFTS **Created:** 11/10/2014  
**Current Language:** English **Last Modified:** 12/9/2014  
**Other Languages:** NONE **Author:** Matthew Boyer  
**Viewed:** 97

**Title:** Spicer® XC™ Center Bearing Installation

**Applies To:** Vehicles Built with Dana Heavy Duty Drive Shafts

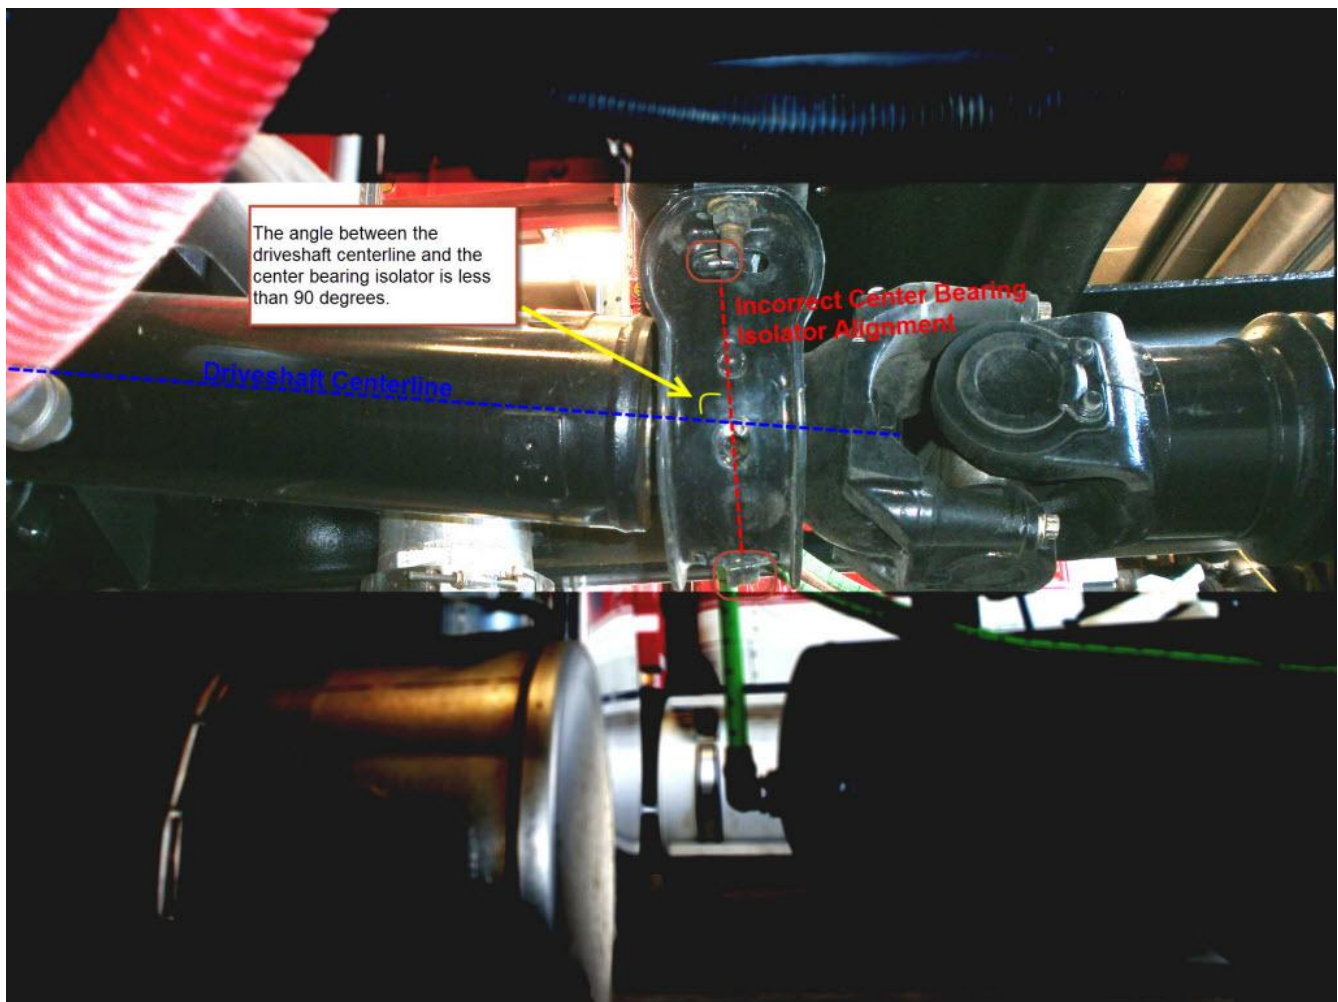
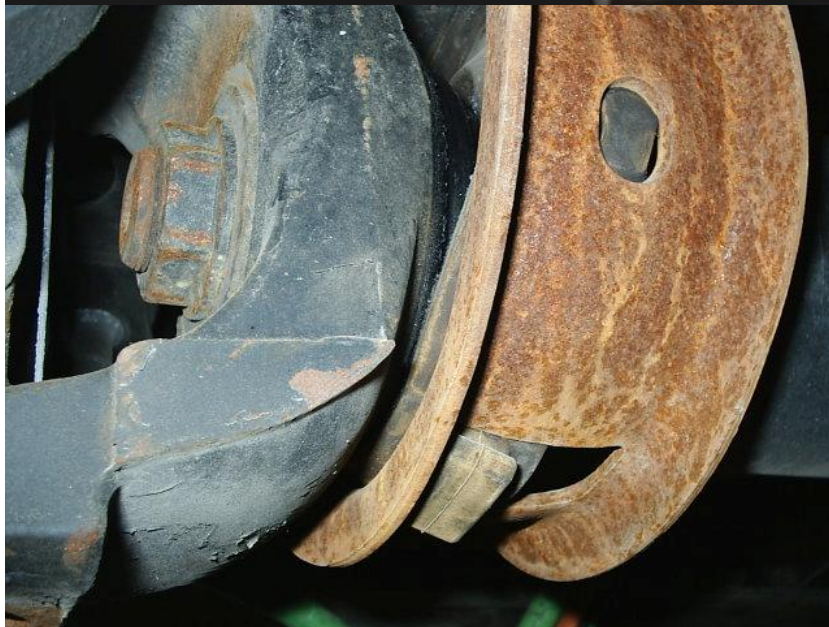
### Incorrect Installation

The Spicer® XC™ center bearing is an adjustable center bearing which can be adjusted to account for varying driveshaft or center bearing bracket angles. If these center bearings are not aligned properly, the isolator can become dislodged causing damage to the center bearing. This damage occurs because the driveshaft or the driveshaft yolk rubs on the isolator.

The proper alignment of the center bearing is when the isolator(rubber) of the center bearing isolator is perpendicular(at a right angle) to the driveshaft. The steel cage of the center bearing floats around the center bearing. The steel cage has slots in it so the isolator can be adjusted as much as 10 degrees in either direction.

1. Only install one driveshaft at a time
2. Attach the u-joint to the yolk at the end opposite of the center bearing
3. Using a driveshaft jack or suitable lifting device, lift the driveshaft until there is a slight gap from the center bearing to the center bearing bracket
4. Grab the edges of the center bearing cage and move it until the bolt holes on the center bearing are parallel with the center bearing bracket
5. Raise the jack or lifting device, install the center bearing mounting hardware and torque to specifications
6. Make sure the center bearing isolator is perpendicular to the driveshaft centerline
