Countries:	CANADA, TAIWAN, COLOMBIA, UNITED STATES, PUERTO RICO	Document ID:	IK1900172
Availability:	ISIS, FleetSIS, Body Builder	Revision:	16
Major System:	ACCESSORIES	Created:	11/4/2011
Current Language:	English	Last Modified:	11/7/2014
Other Languages:	NONE	Author:	Jon Pierce
Viewed:	11544

Title: Espar Heater Diagnostic Guide

Applies To: Airtronic D2 Heater, Hydronic D5 Heater, Feature code 16UZL, 16VTV

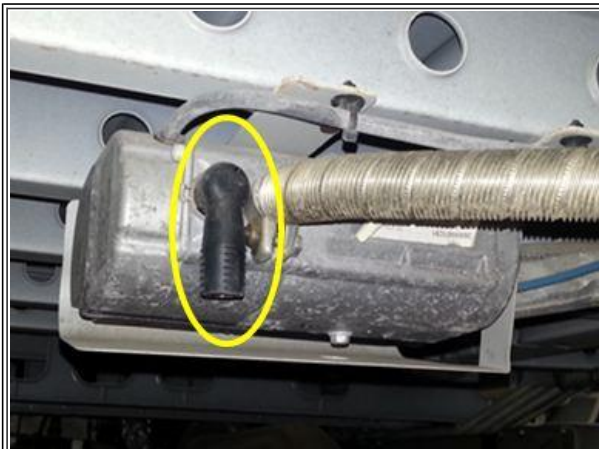
Figure 1: Hydronic Air Induction Pipe

1. Locate Air Induction Pipe (Figure 1)

The direction in which the hydronic heater air intake is pointed may accelerate wear on the hydronic combustion air blower. The entire Espar heater assembly **DOES NOT** need to be replaced if the combustion air blower is failed. When Espar hydronic system is serviced, refer to figures 1 & 2 below. If the air intake is already in the 45 degree position, the procedure does not need to be followed. If the air intake is not in the 45 degree position, follow the 2 step procedure as indicated below.

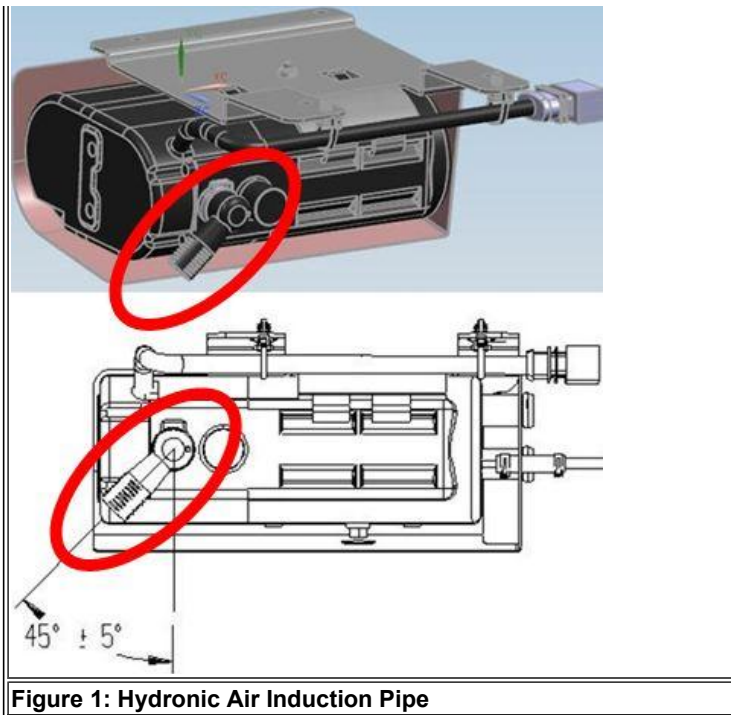
Figure 1: Hydronic Air Induction Pipe

2. Rotate Air Induction Pipe clockwise 45 degrees (Figure 2)
