Title: Prostars with Battery Discharge During Extended Storage

Applies To: Prostar equipped with feature 0008WEN

Vehicles equipped with feature 0008WEN can experience battery discharge during extended storage.

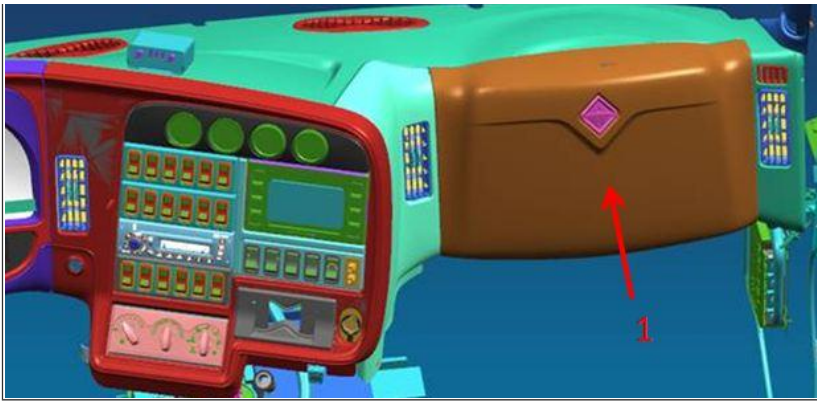
Figure 1: Fuse Cover

Item 1: Fuse Cover

1. Remove the fuse cover from the main power distribution center (Figure 1, item 1).

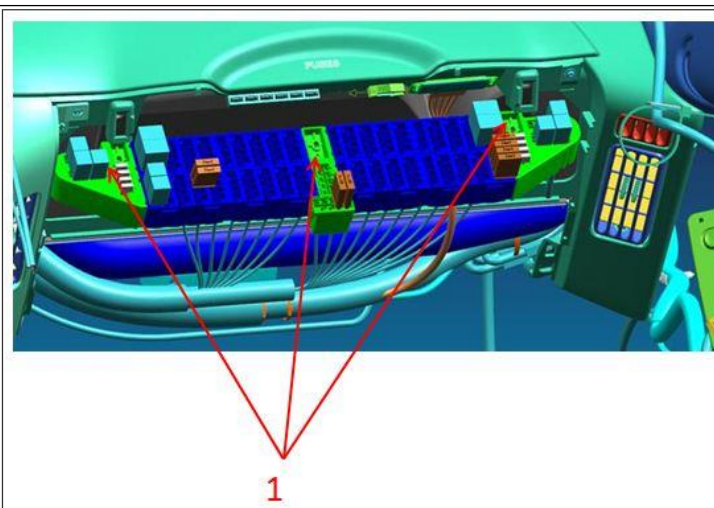
Figure 2: Power Distribution Center

Item 1: Power Distribution Center Mounting Screws

2. Remove the three mounting screws (figure 2, item 1) from the power distribution center, so that the backside of the power distribution center can be accessed.

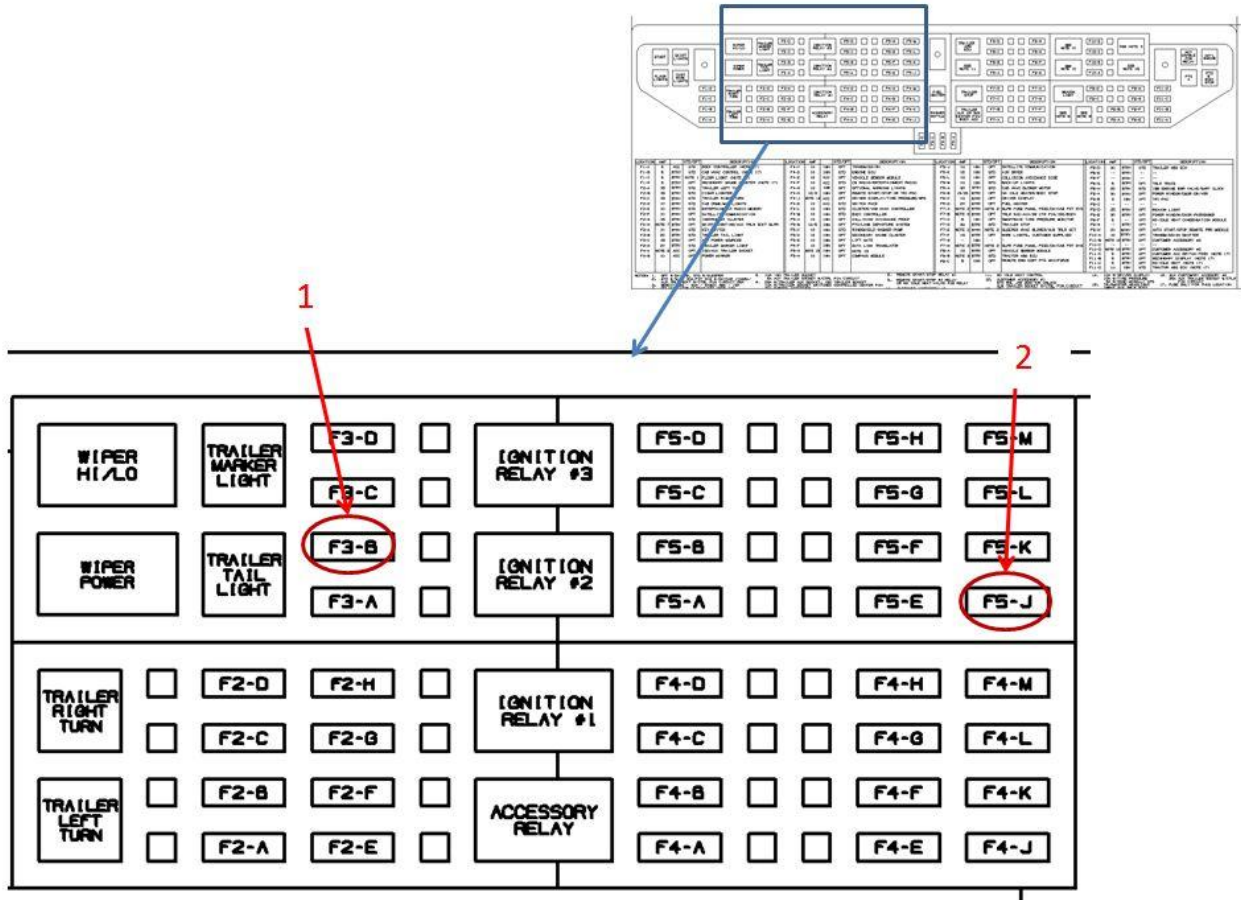
Figure 3: Power Distribution Center

- Item 1: Current Battery Feed Fuse
- Item 2: New Ignition Feed Fuse

3. Locate and cut the red wire labeled 14T, printed on the wire, which is under fuse F3-B (figure 3, item 1) at the power distribution center.

Note: Do not remove fuse F3-B because its still used by another circuit.

5. Crimp terminal (figure 4, item 1) to the jumper wire and insert the terminal into the empty cavity of fuse F5-J (figure 3, item 2).
6. Insert a 5 amp fuse at F5-J.

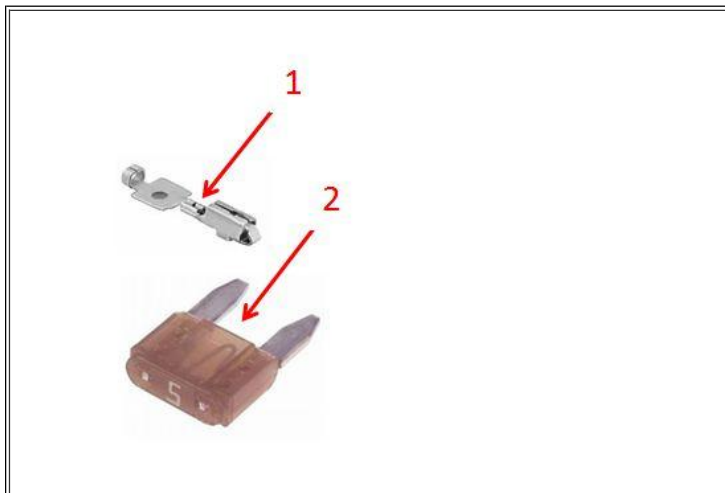
Figure 4: Parts

- Item 1: Terminal 3515517C1
- Item 2: 5 amp fuse

4. Splice a red 16AWG (1.29mm) 100mm long wire to circuit 14T (this is the wire that was cut in step 3).
