TECHNICAL BULLETIN JTB00307NAS2 04 FEB 2014

SECTION: 501-08

Front Door Finisher Contacts Rear Door Finisher

XF (X250)

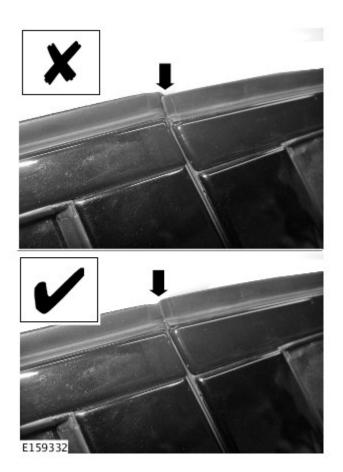
- Front / rear door foul condition (X) and correct condition (tick).
 - Check condition of both the left and the right doors.

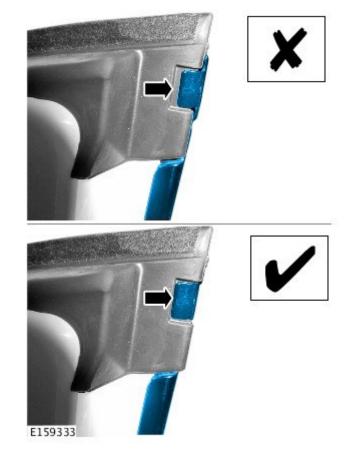
Poor trim overlap of finisher on front right door (X) and correct trim overlap (tick). • Check condition of both the left and the right doors.

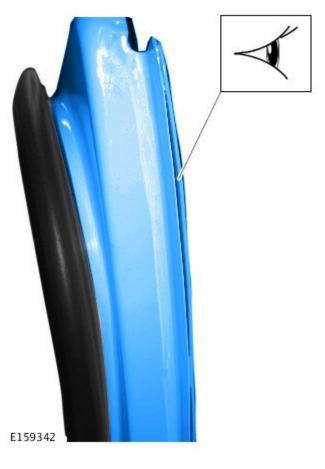
12. Check the door seam condition (incorrect (gap) seam shown).

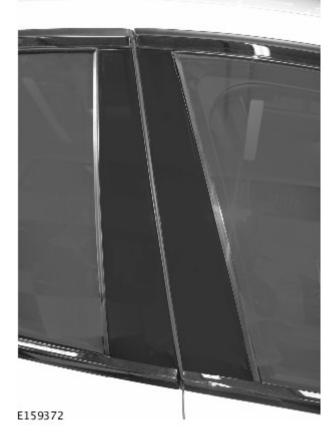
55. Check the profile of the front-to-rear doors. This should be 4mm +/- 1mm over the full length.
