| Reference | SSM71538 |
| Models | XK / X150<br>XJ / X351<br>XF / X250 |
| Title | Door Lock Cylinder Cover - Fitment at PDI / Replacement. |

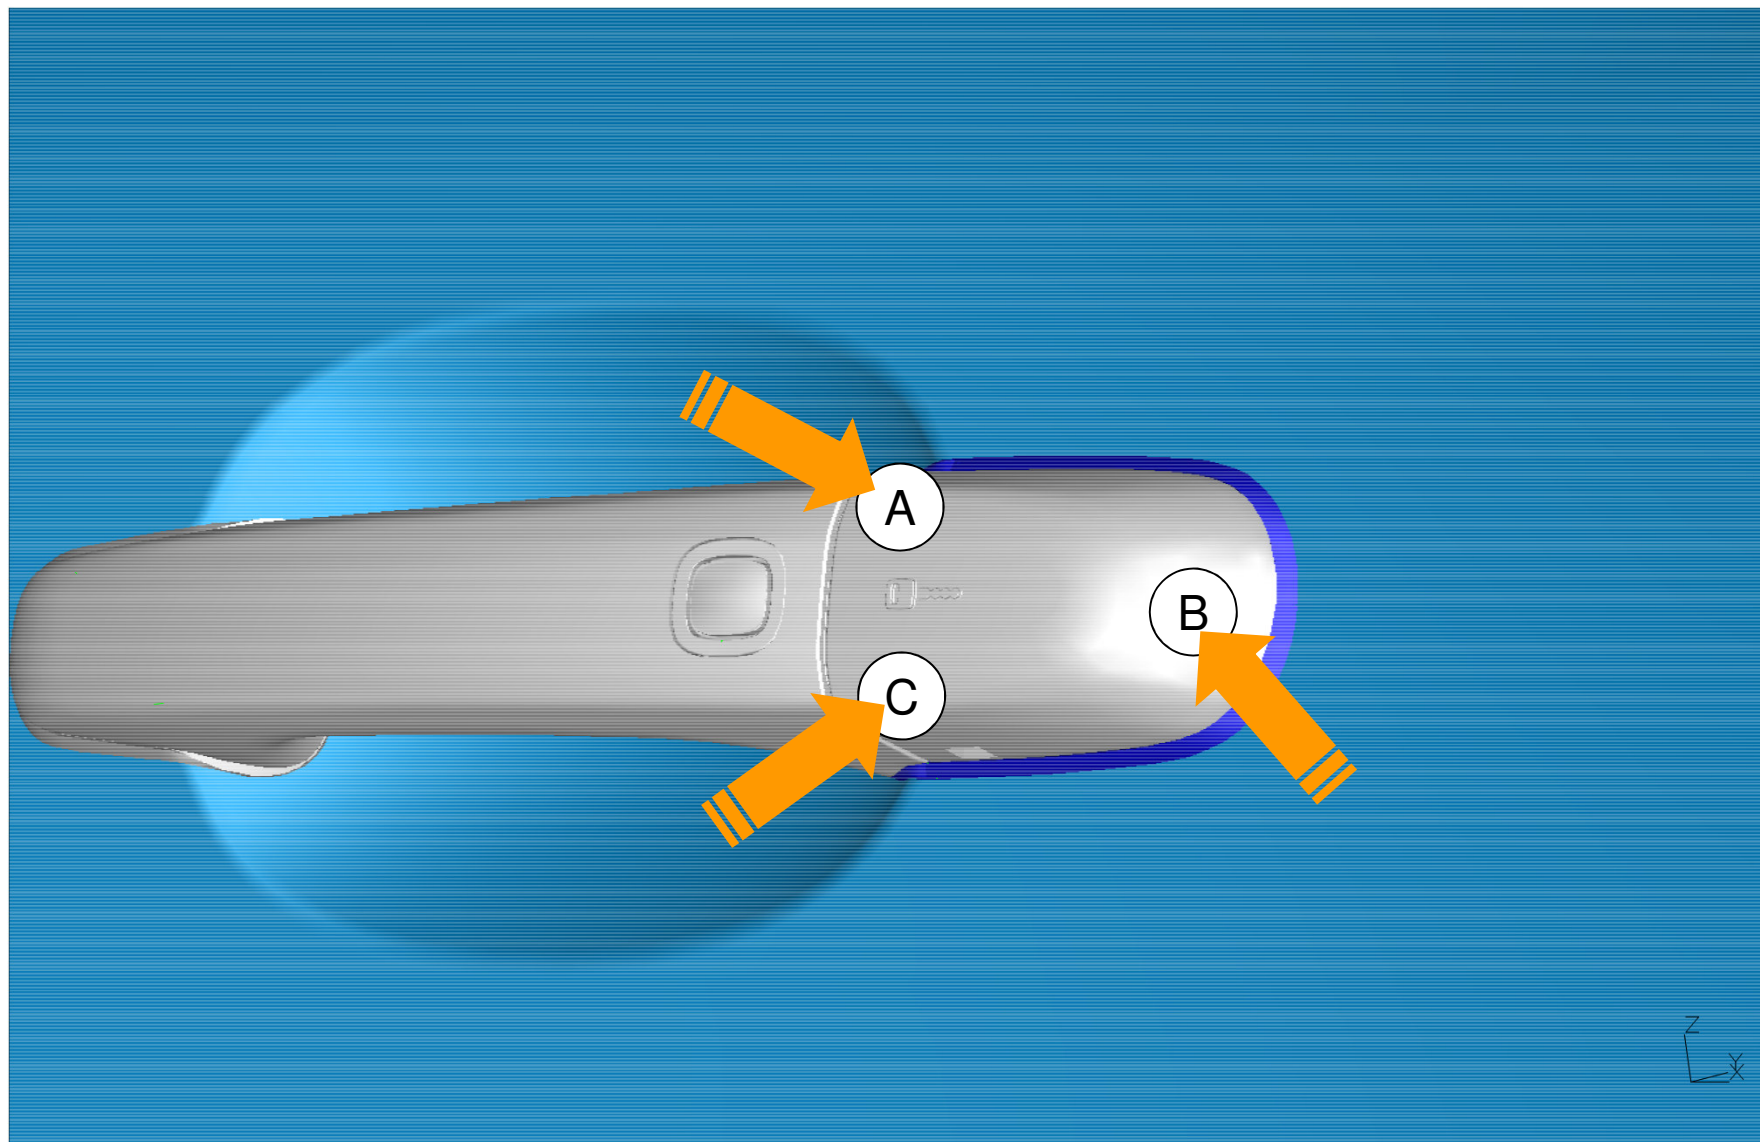
| Content | <p>Issue:<br/>Customer may report door lock cylinder cover missing.</p> <p>Cause:<br/>Cylinder cover may have been incorrectly fitted at PDI or after emergency vehicle entry.</p> <p>Action:<br/>The sequence of installing is shown on the attached doc. Please make sure that the door lock cylinder cover is pushed firmly in the sequence shown to install all 3 clips. The cover will now be securely attached to the vehicle.</p> <p><u>Ensure correct fitment by testing with a vigorous pull</u></p> |
