**SERVICE ADVISORY # 14-199**

Summerland 2600 Furnace Grill

**Models Included:** 2014 Summerland 2600TB Travel Trailer

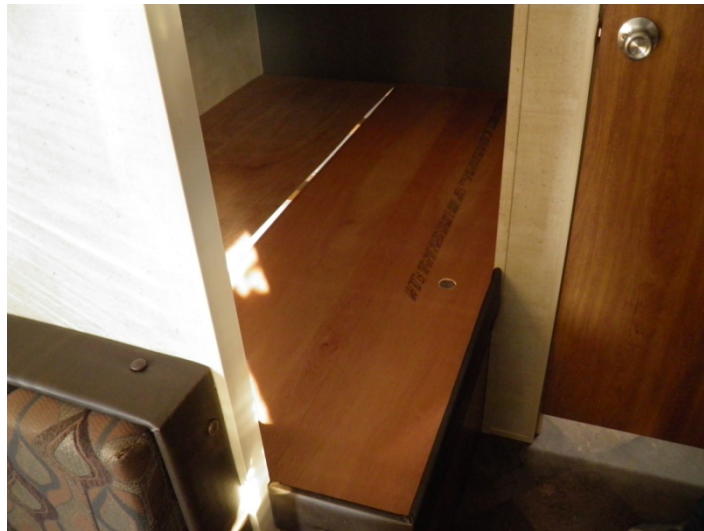
Fig. 1

**Step 1** Remove the mattress and bed platform covering from the rear bottom bunk bed. See figure 1.

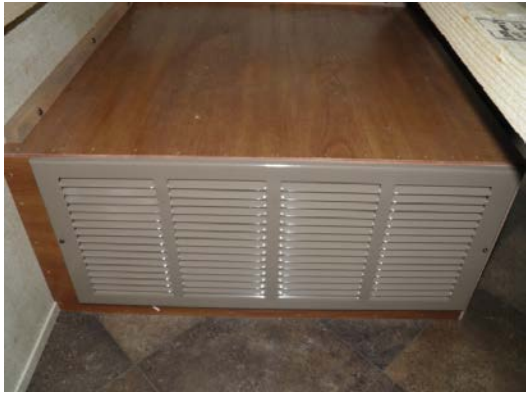
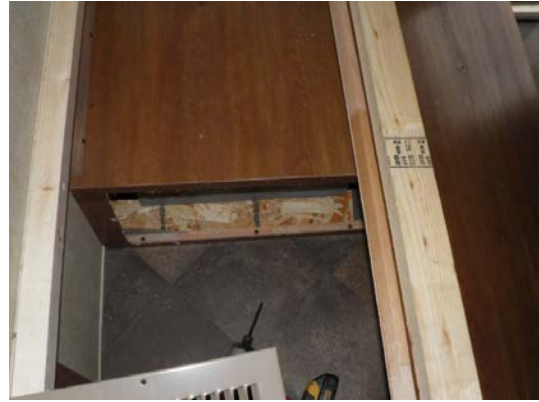
Fig. 2

**Step 2** Locate the furnace box. Remove the grill and set aside to reuse. See figure 2 & 3.

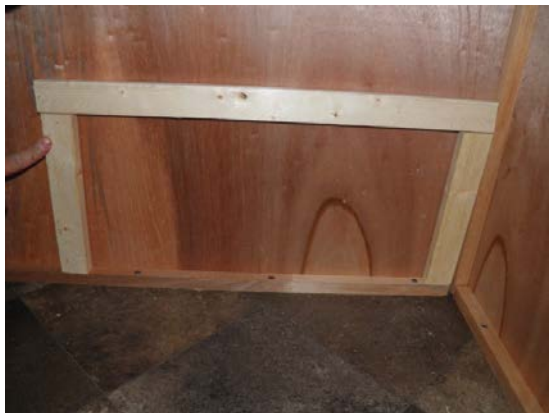
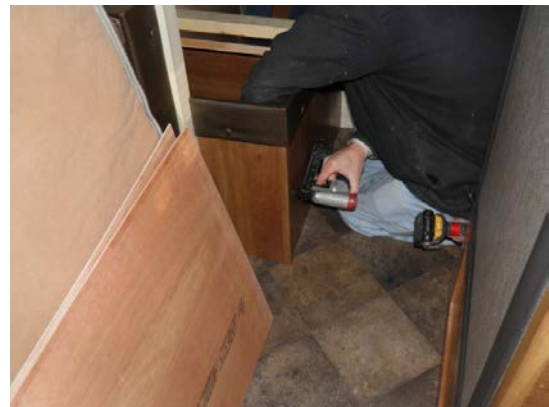
Fig. 4

**Step 1** Place the grill frame on the back side and against the bed base corner. Staple the frame in place through the panel. See figure 4 & 5.

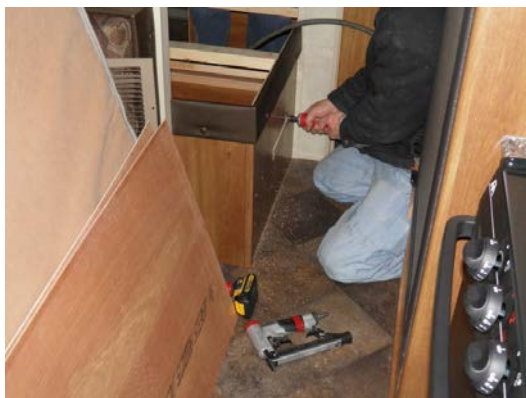
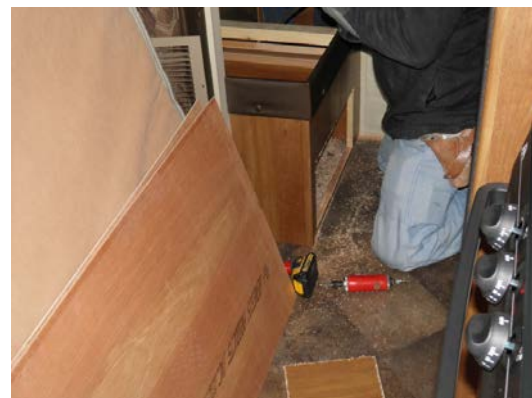
Fig. 6

**Step 2** Rout the opening of the bed base on the inside of the added frame. See figure 6 & 7. Vacuum the debris created from routing.

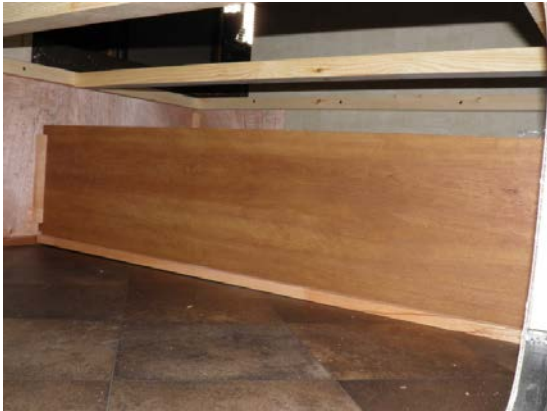
Fig. 8

Place the furnace cover in the bed compartment through the exterior baggage door. Place the furnace cover over the existing furnace box. Set the side panel upright. See figure 8. Place the top panel over the furnace box. Align the edges of the top and side then screw the cover together. See figure 9.

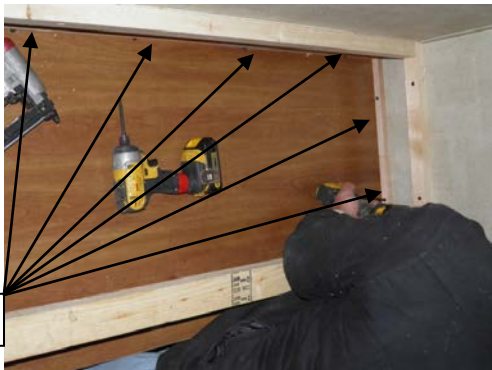
Fig. 10

Use 4 screws to secure the sides of the cover to the floor and wall. Use 2 screws to secure the ends to the sidewall and bed base. See figure 10.

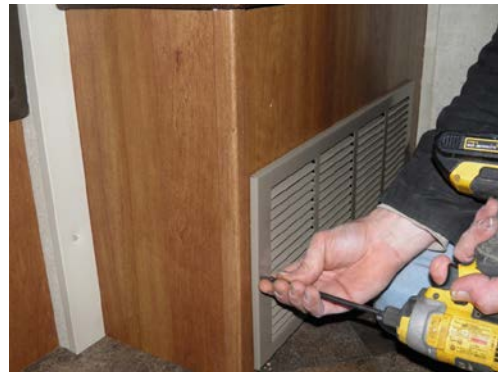
Fig. 11

Locate the furnace grill over the routed opening and secure to the bed base. See figure 11.
