## SERVICE ADVISORY # 14-201

### Kodiak Grill Bracket

Dutchmen Manufacturing, a division of Keystone RV Company, has determined that some Kodiak trailers have been manufactured with the wrong grill mounting bracket. This service advisory explains how to replace the mounting bracket.

**Models Included:** 2014 Dutchmen Kodiak Travel Trailers

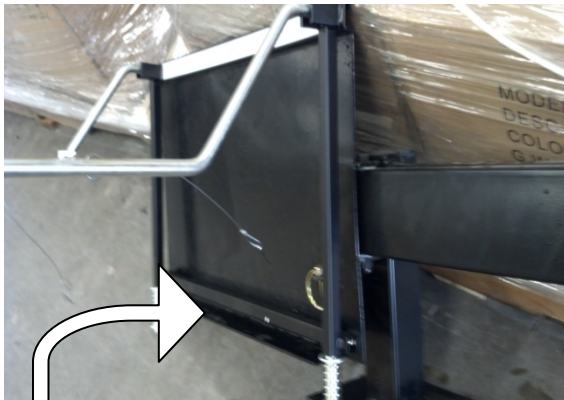
Fig. 1

Grill bracket rests against the bottom of the bumper mount bracket

CORRECT  
MONTING  
BRACKET

**Step 1** Flame King Grill Model # YSNHT-500 requires mounting bracket KRV# 324311. Remove the (2) U-bolts holding the bumper mount grill bracket to the bumper. Replace the bracket with KRV # 324311, secure with (2) U-bolts.

**Step 2** Verify the grill mounting bracket bottom cross bar will rest against the bottom of the bumper mounted bracket. See figure 1 & 2.

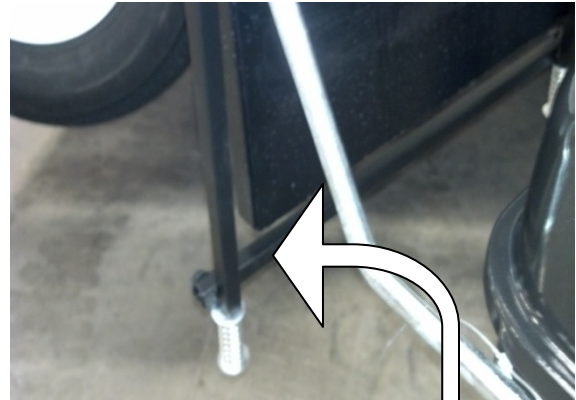
Fig. 2

INCORRECT  
MONTING  
BRACKET

Grill bracket does not rest against the bottom of the bumper mount
