**SERVICE ADVISORY # 14-211****Bullet 310BHS Exterior Shower**

**Models Included:** 2015 Bullet 310

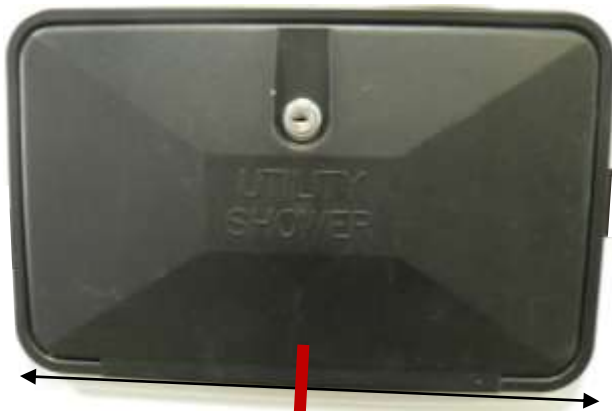
**Figure 1**

**ONE:** Locate bottom-center of exterior shower

**Step 1** Locate the center-bottom of the exterior shower. See Figure 1. Apply butyl to Bumper (KRV #318416) and install under bottom-center of exterior shower enclosure. See Figures 2, 3, & 4.

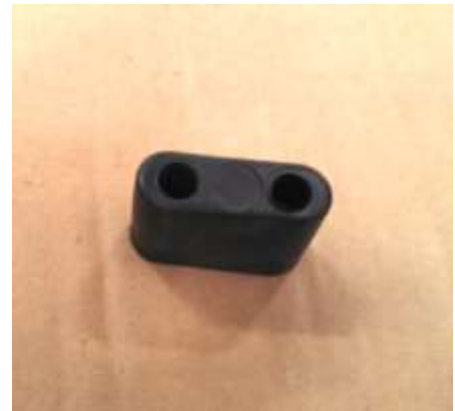
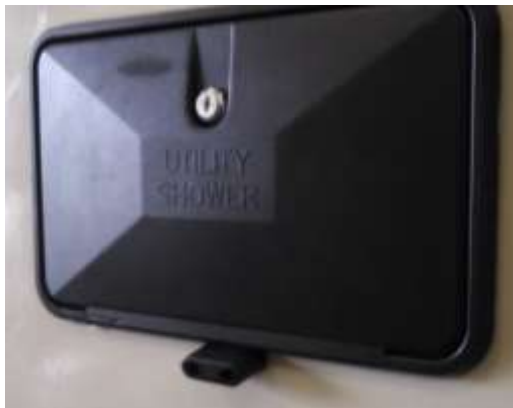
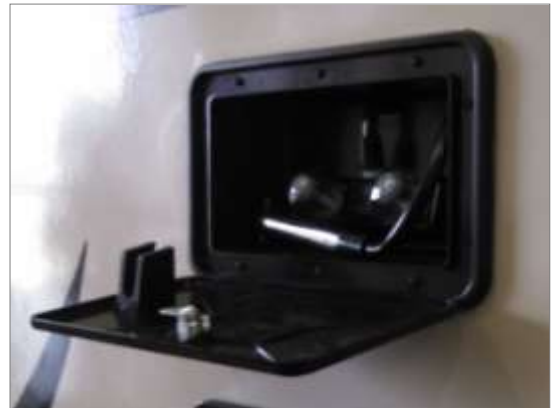
**Figure 2**

It has been determined that certain Bullet model 310BHS are missing a door stop on the exterior shower located above the water heater. The missing stop will allow the shower door, when in the open position, to contact the water heater exhaust grill leading to the potential for heat damage to the exterior shower door when the water heater is in operation. This service advisory explains how to correct the installation.
