TECHNICAL BULLETIN
LTB00592NAS3
06 FEB 2014

Front Brake 'Squeal' Noise

Range Rover Sport (LW)

Range Rover (LG)

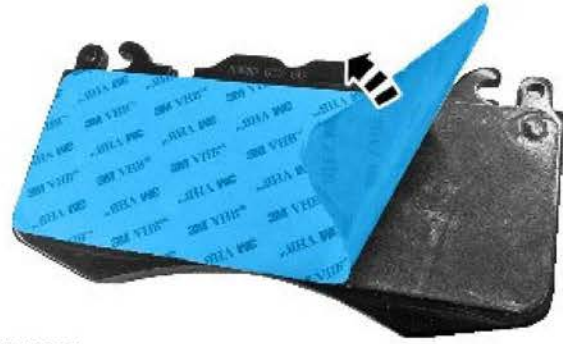
E160159

3. Gently remove the backing from the new brake pads.

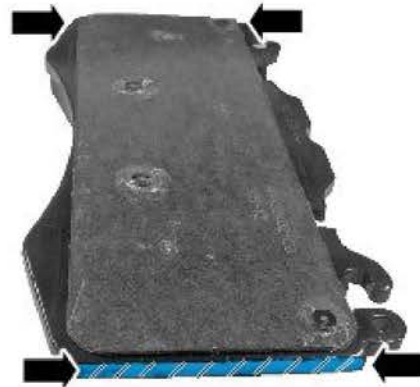
E160161

Grease pad abutments at both ends with Molykote® Cu-7439 PLUS.

**NOTE: Do not apply grease to the piston contact area.**
