# TECHNICAL BULLETIN

## LTB00631NAS2

### **SECTION: 501-14**

#### Compact Key Handset - Lower-Level Service Repair

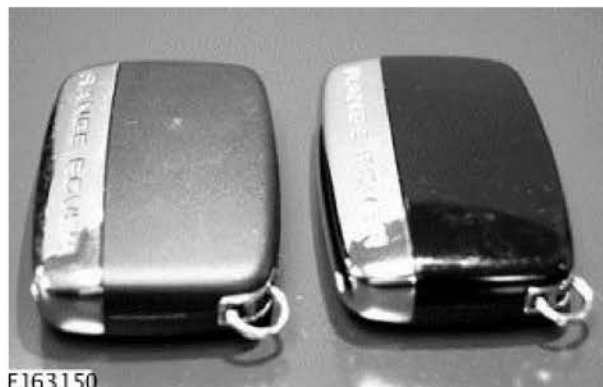
1. Identify the type of compact key handset currently fitted to the vehicle to ensure a like-for-like replacement handset is fitted:

- Left = matte finish.
- Right = gloss finish.

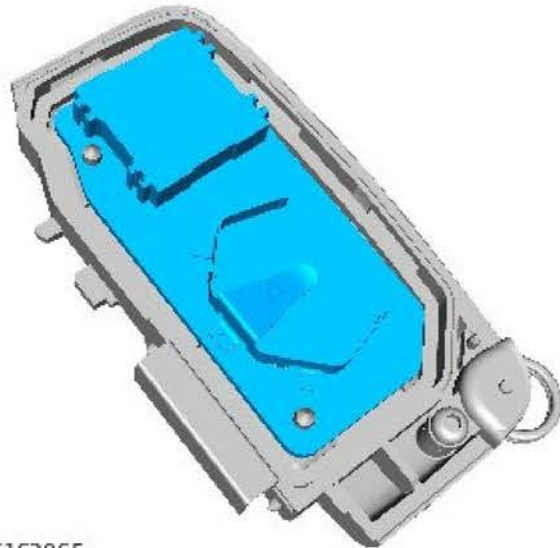
E162065

**CAUTION:** When removing the PCB, only handle the outer edges of the board.

Remove the PCB; place to one side.

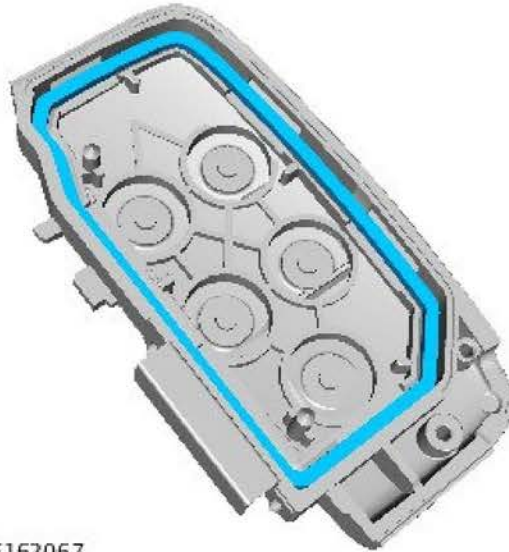
E162067

**9.** Remove the silicone seal from the lower case; place to one side.

- Discard the upper case.
-

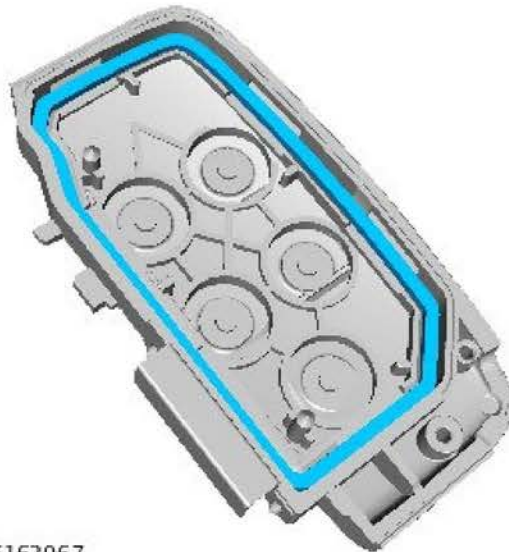
E162067

**11.** Install the silicone seal to the upper case.

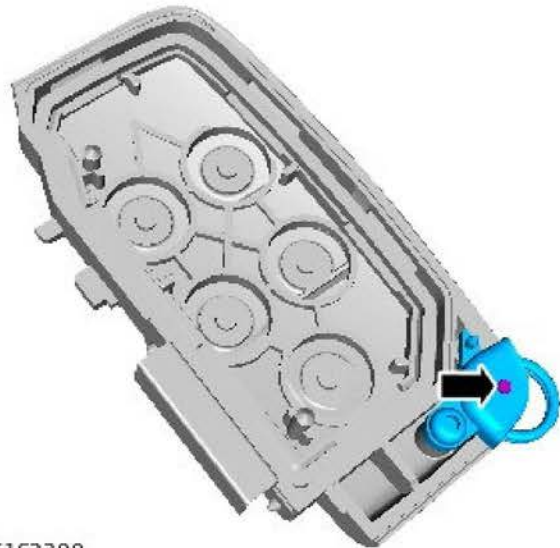
E162299

- 13.** Make sure the key ring retaining pin is present in the upper case.
