TECHNICAL BULLETIN

Q322NAS2

Service Action: Air Suspension Thermistor Wiring Short Circuit

Range Rover (LG)
Model Year: 2013
VIN: DA100000-DA107500

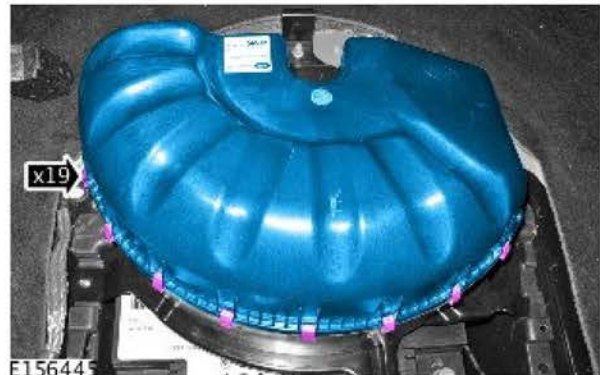
E156445

Gain access to the air supply housing (two parts [upper and lower] which surrounds the suspension air supply unit).

- Separate the upper and lower parts of the air supply housing and remove the upper part.

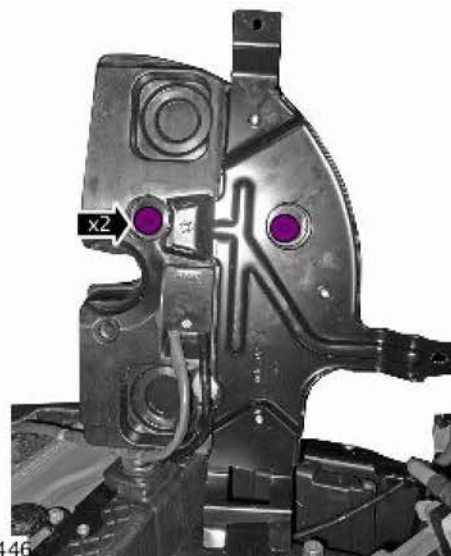
5.

**CAUTION: Pay attention to compressor mountings, washer, rubber cover, bolt, and spring.**

With the suspension air supply unit in the upright position, use a TX30 Torx tool to unscrew only two of the three suspension air supply unit fixing bolts.

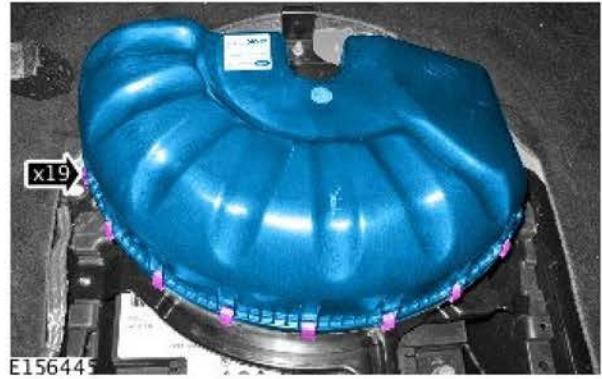
- 10.** Install the upper section of the air supply housing, making sure of the accuracy of the fit:
- Secure the two sections with the 19 metal clips.
