TECHNICAL BULLETIN  
LTB00566NAS4  
10 OCT 2014

**SECTION: 310-01**

**Fuel Gauge Operation Inaccurate**

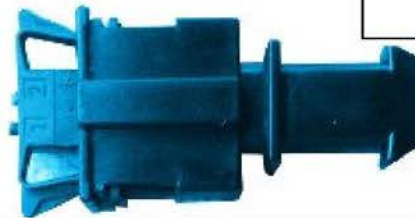
**7.** Repeat steps 5-6 to the other wire in the connector.

- Discard the connector.

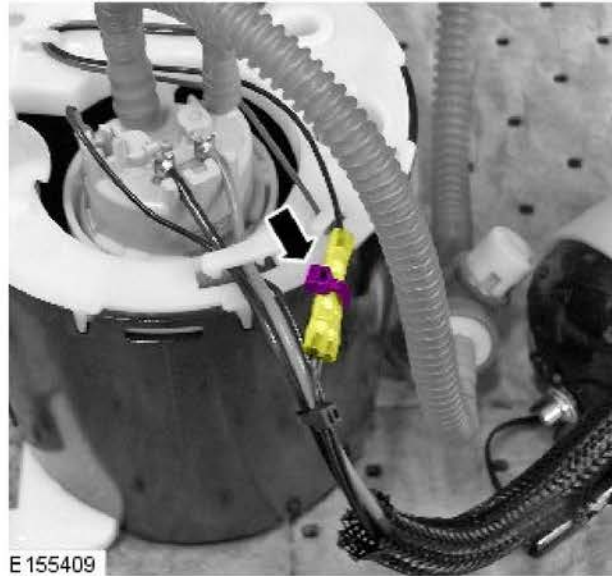
E 155409

**9.** Using a suitable tie strap, secure the two splices together.

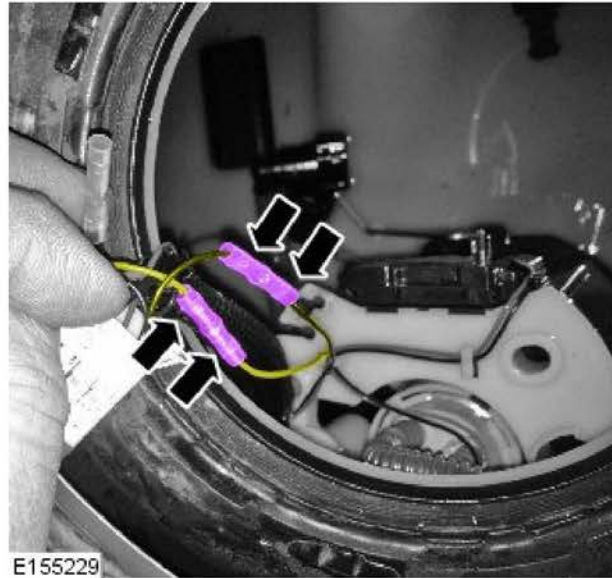
E155229

Using a suitable tool, remove 5mm of insulation from the end of each wire.

- Using Crimping Tool 418-116A / YRW500010, install and crimp a splice to the ends of each

- wire.
- Using a suitable tie strap, secure the two splices together.
