Service Bulletin

Issue Date: February 9, 2015

Subject: **Diesel Fuel Vent Hose**

Models Affected: Certain Collins Bus Diesel Models with Raised and Standard floors.

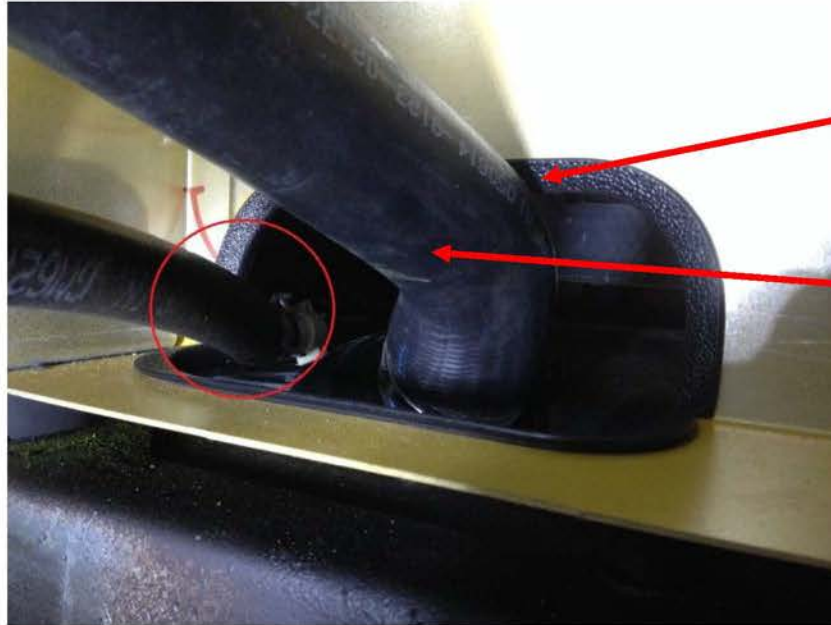
Figure 1-B

Fuel Vent Line Circled

Fuel Fill Hose

Make sure pinch weld covers all metal edges.

Note: Work can be done without dropping the fuel tank.

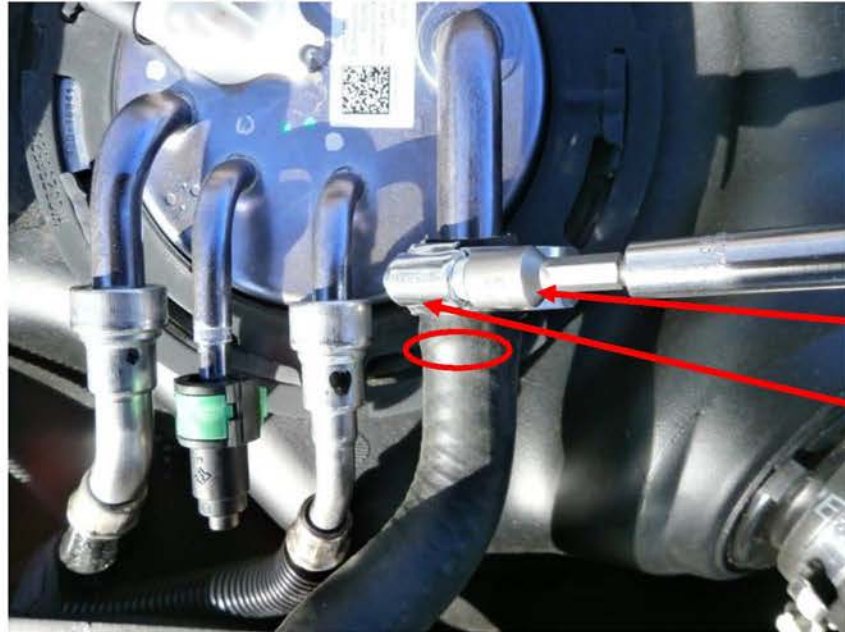
Figure 3-B

5/16" socket

Formed metal rib (circled).

4. Tighten the supplied worm gear clamp securing the formed vent hose to 25-38 in-lbs.
Location: Driver side attached to top of the fuel tank.

The clamp and hose needs to be 1" past the metal rib to ensure hose does not slip off.

Worm gear clamp
Tighten to 25-38 in-lbs.
