GROUP General	MODEL Multiple Models
	NUMBER PS382	DATE March 2015

SUBJECT: STOP LAMP SWITCH IDENTIFICATION MATRIX (SC098)

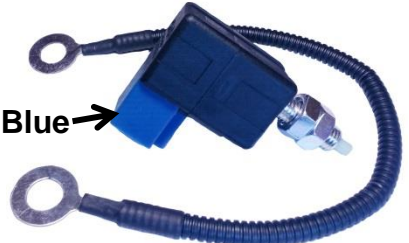
<p>Blue</p> <p>93810 4DRWBQQK 2007~2009MY Sedona (VQ) w/Adjustable Pedal (Includes ground wire)</p>

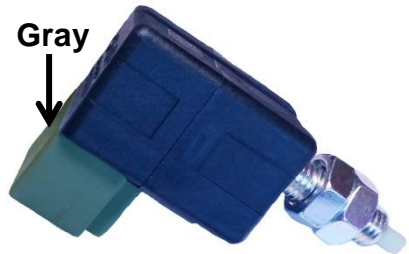
<p>Gray</p> <p>93810 3KRWAQQK 2009~2011MY Sedona (VQ) w/Non-Adjustable Pedal 2007~2010MY Rondo (UN) (Includes ground wire)</p>

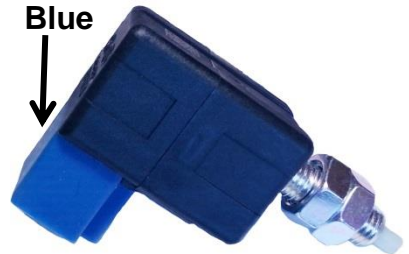
<p>Gray</p> <p>93810 3KR0AQQK 2010~2011MY Sportage (SL) 2011~2012MY Sorento (XMa) 2010MYForte (TD)</p>

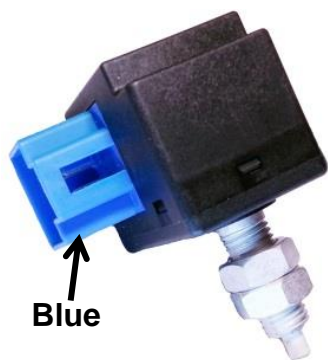
<p>Blue</p> <p>93810 3KR0BQQK 2007~2009MY Amanti (GH) 2007~2009MY Sorento (BL) 2009MY Borrego (HM) w/Adjustable Pedal</p>

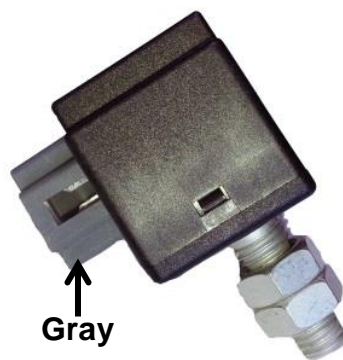
<p>Blue</p> <p>93810 4DR0BQQK 2010MY Soul (AM)</p>

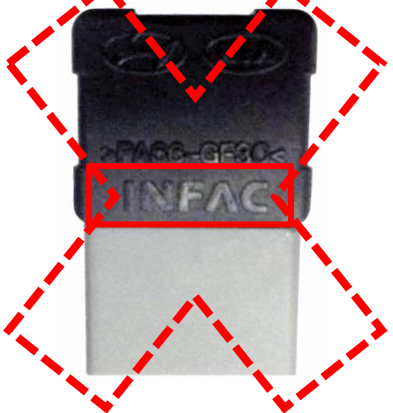
<p>Gray</p> <p>93810 4DR0AQQK 2007~2010MY Sportage (KM) 2007~2010MY Optima (MG) 2010~2011 Soul (AM) 2009~2011MY Sedona (VQ) w/Adjustable Pedal</p>
