**SERVICE ADVISORY # 15-229****Fuzion Ramp Step**

It has been decided the attaching bracket for the ramp door patio steps have been incorrectly located. The location of the brackets only allow the step to be assembled and pinned to one bracket of the ramp door and patio railing. This advisory explains how to correct the installation.

**Model and Serial Numbers Included:** 2015 Fuzion Chrome, 2015 Fuzion with Ramp Step Option

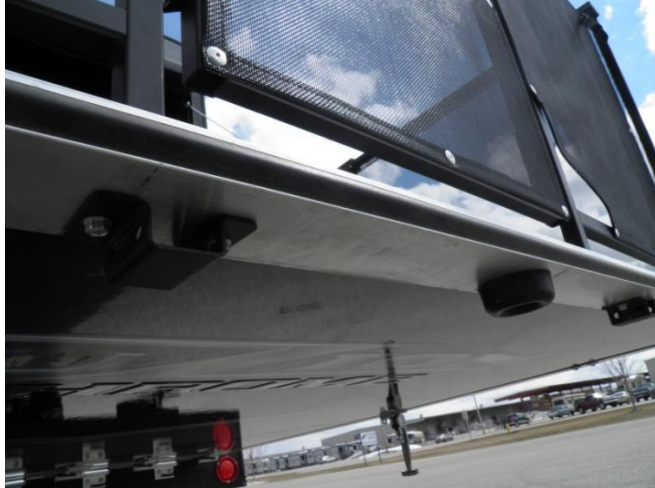
Fig. 1 Viewed from below with patio setup

**Step 3**                      Remove the step mounting brackets from the ramp door. See figure 1 & 2.

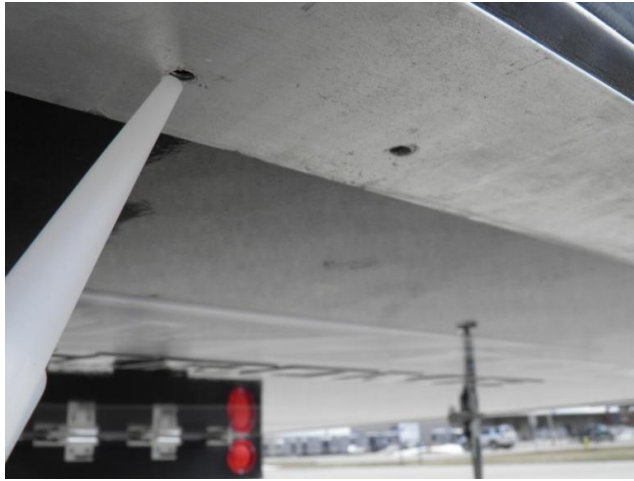
Fig. 3

**Step 4** Fill the screw holes with silicone. See figure 3.

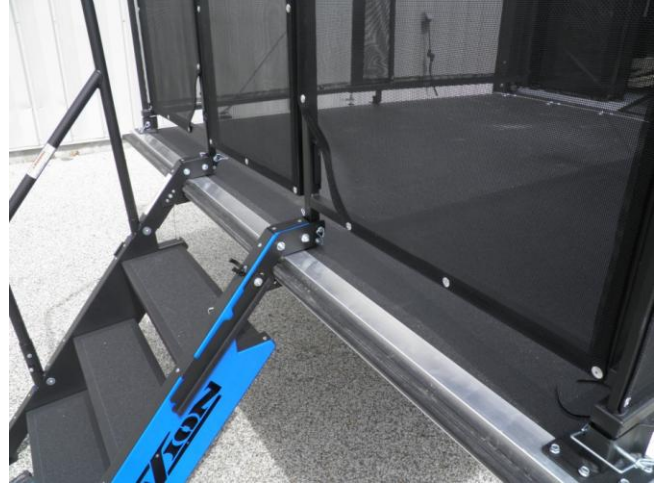
Fig. 4

**Step 5** Align the patio step with the patio railing and insert all associated pins. See figure 4.

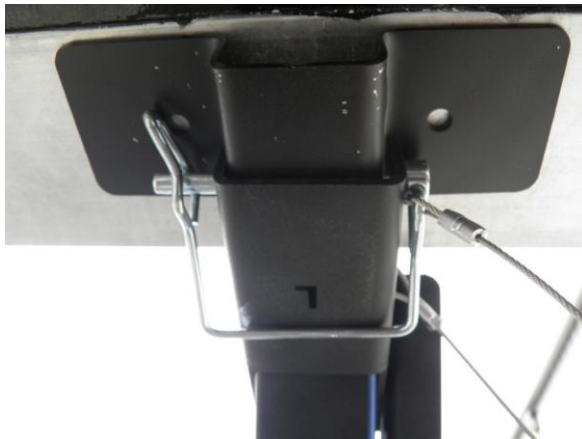
Fig. 5

**Step 6** Place the supplied step mounting bracket between the step and the top exterior of the ramp door and insert the pins through the bracket and step. See figure 5.

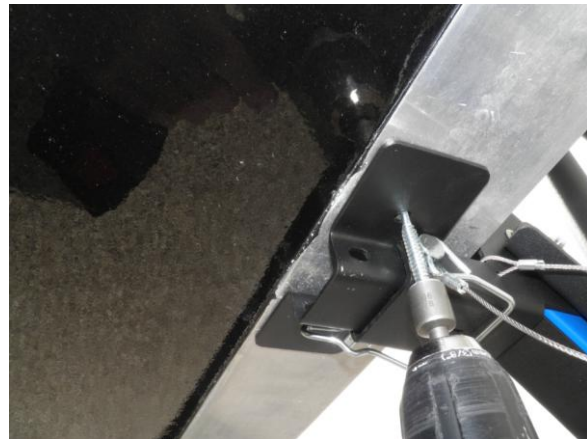
Fig. 6

**Step 7** Adjust the step assembly to seat fully onto the ramp door. Secure the ramp brackets to the ramp door using the screws from the original brackets. See figure 6.
