**SERVICE ADVISORY # 15-236**

Denali 280LBS Refrigerator Vent

It has been determined some 2016 Denali 280LBS models were built with improper refrigerator ventilation. A divider panel must be cut out to allow air flow through the refrigerator cabinet. This service advisory explains how to correct the ventilation.

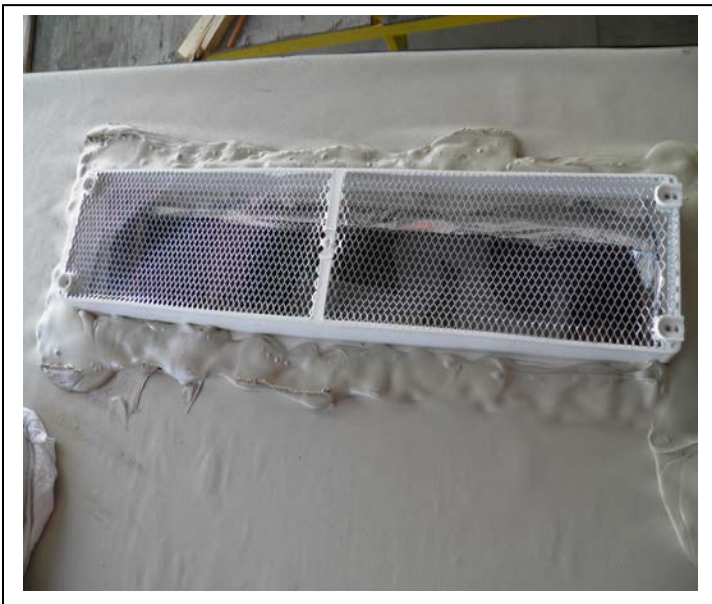
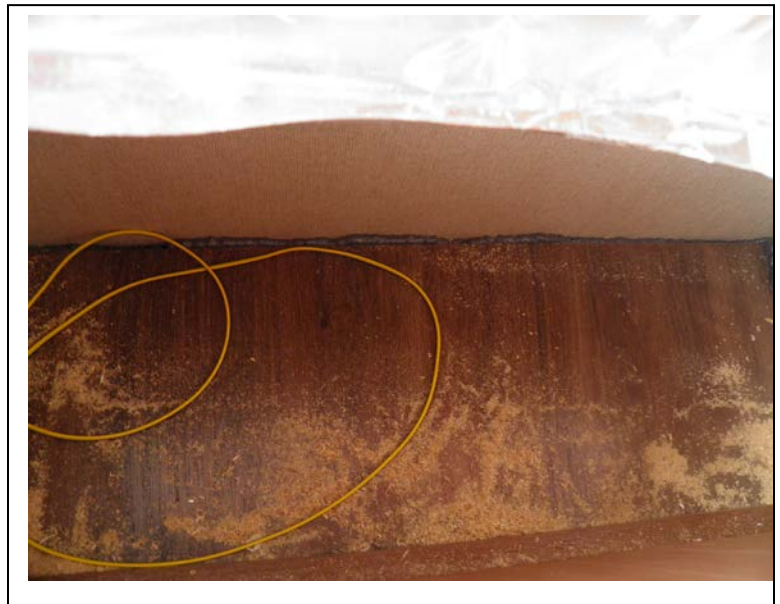
Fig. 1

**Step 1** Using industry practices remove the roof mounted refrigerator vent from the roof to gain access to the top of the refrigerator compartment. See figure 1 & 2.

**Step 1** Using industry practices reinstall and seal the refrigerator roof vent.

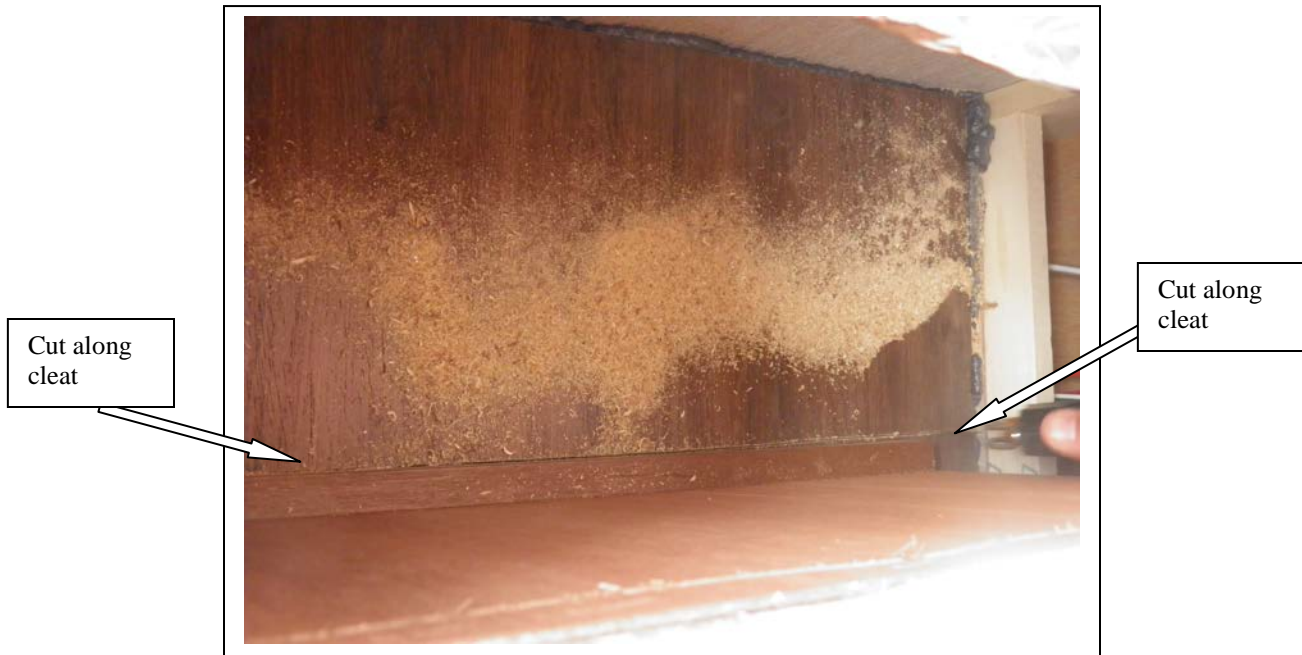
Fig. 3

The bottom panel of the top refrigerator storage compartment seals off the upper portion of the refrigerator compartment. This panel must be cut to allow air to flow through the back of the refrigerator compartment. Cut the panel against the back cleat of the storage compartment. See figure 3. Use care not to cut beyond the panel as the top of the refrigerator sets 1" below the panel. Vacuum the debris from the compartment. Remove the panel and foam seal from the compartment.
