Reference	SSM72259
Models	LR2 / L359
Title	Facia Air Vent Direction Control Lever
Category	Electrical
Last modified	27-Apr-2015 00:00:00
Symptom	208999 Other Climate Controls Concerns
Attachments	Broken vent.jpg

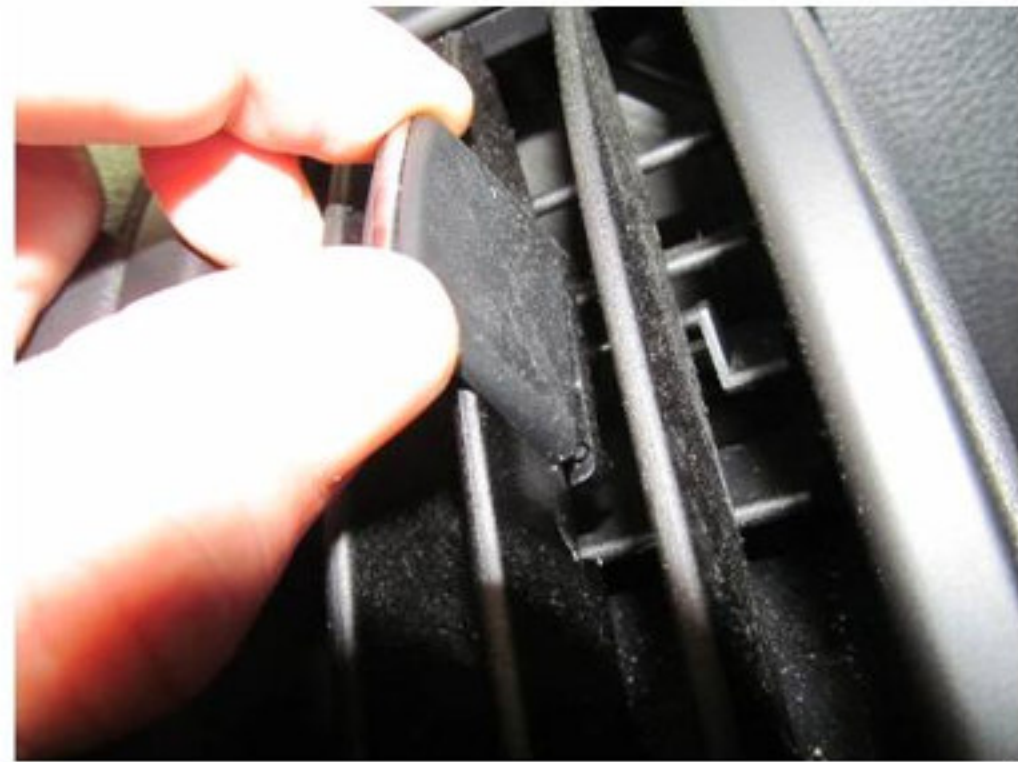
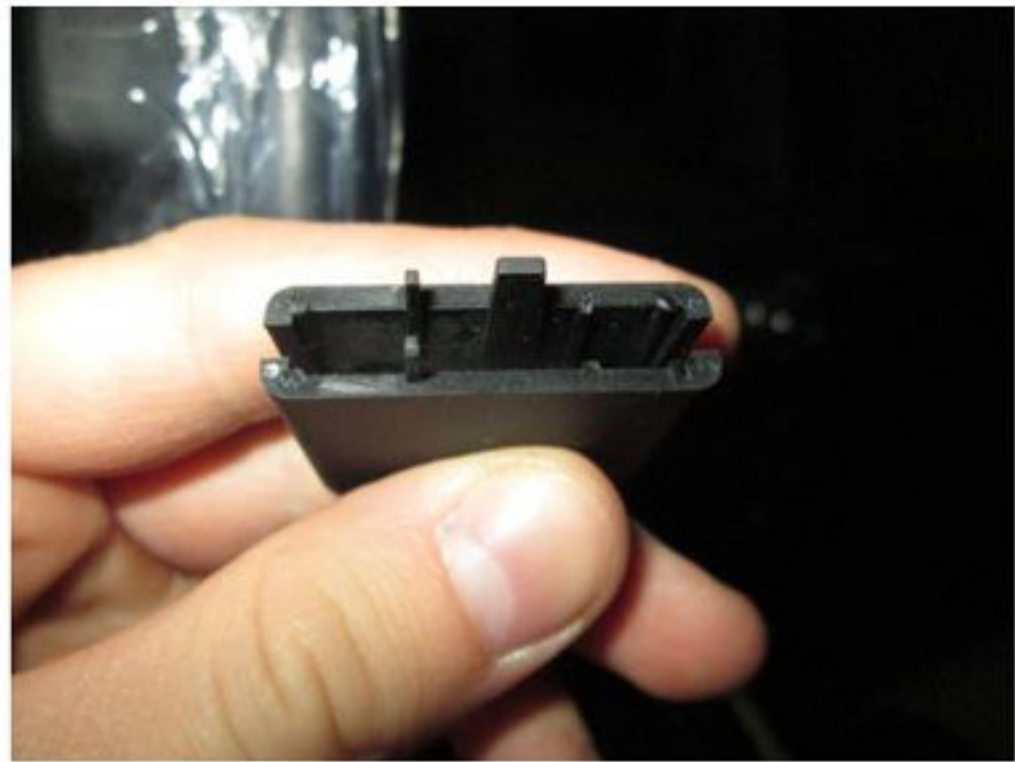
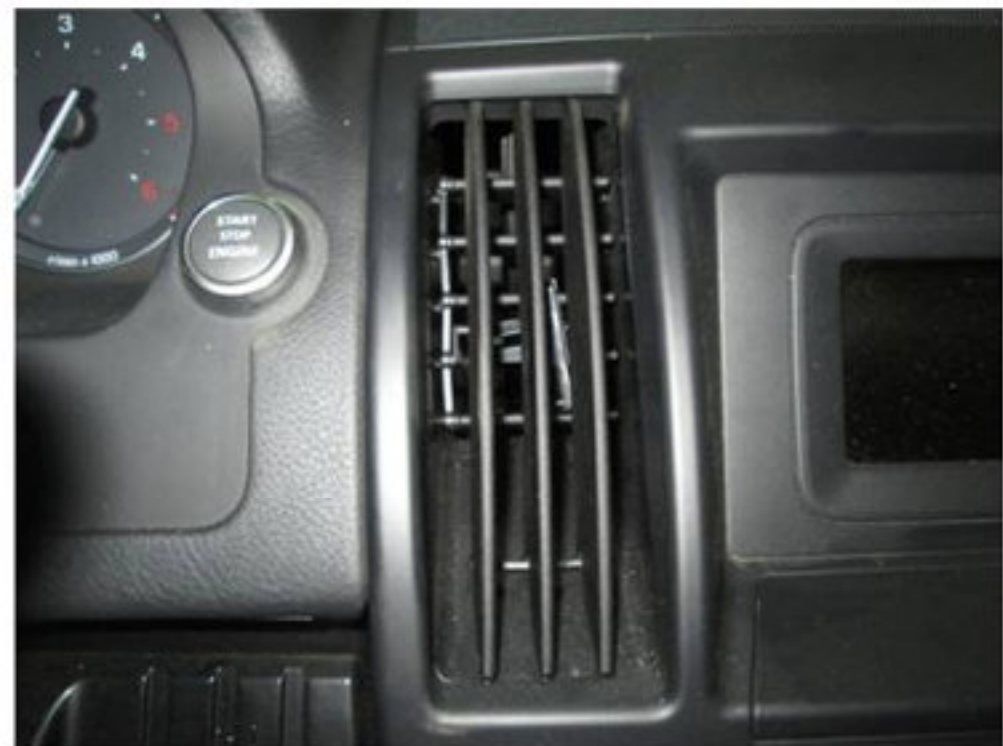
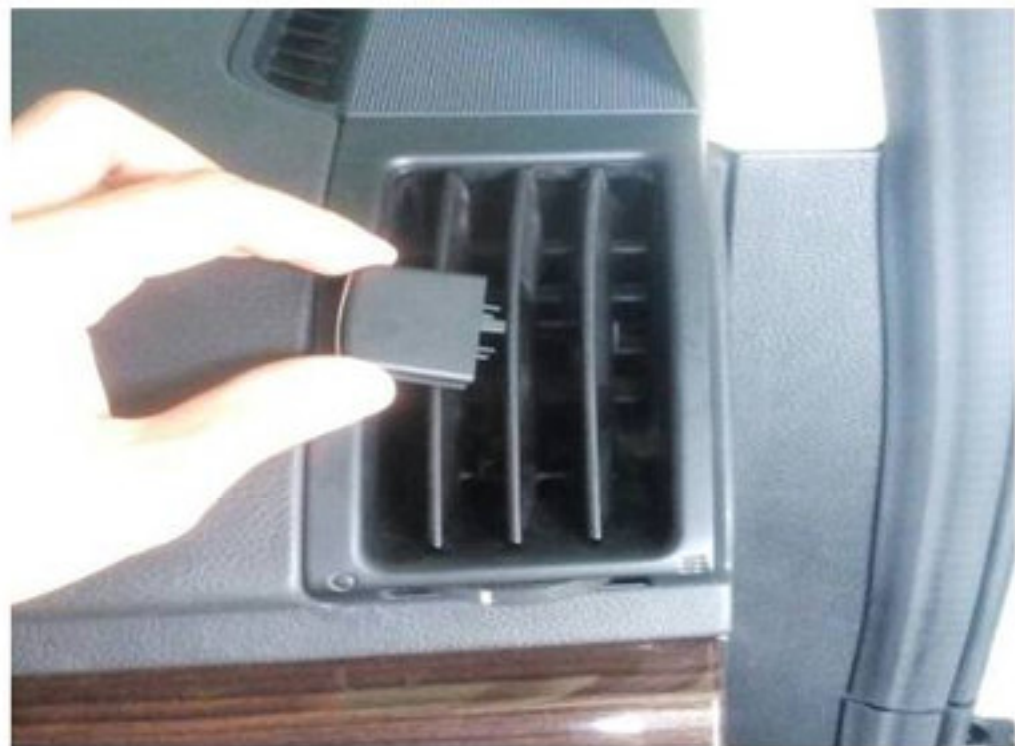
Detachment of the air direction control lever of facia air vents (please see attachment for examples of issue)

Poor retention of the retaining clips that attach the lever to the vent.

The material and design of the clips that hold the lever in place have been modified; all service parts are now to the new level.
 The new level parts were fitted in production from
 H419330 (14 MY) Halewood Production
 L911513 (14 MY) Pune Production
