Reference	SSM72428
Models	Range Rover Sport / L494
Title	Blue Road Wheel Display On Instrument Cluster Message Centre
Category	Electrical
Last modified	26-Oct-2015 00:00:00
Symptom	204000 Instrumentation
Attachments	11Blue wheel display in message centre.pdf (11Blue wheel display in message centre.pdf)

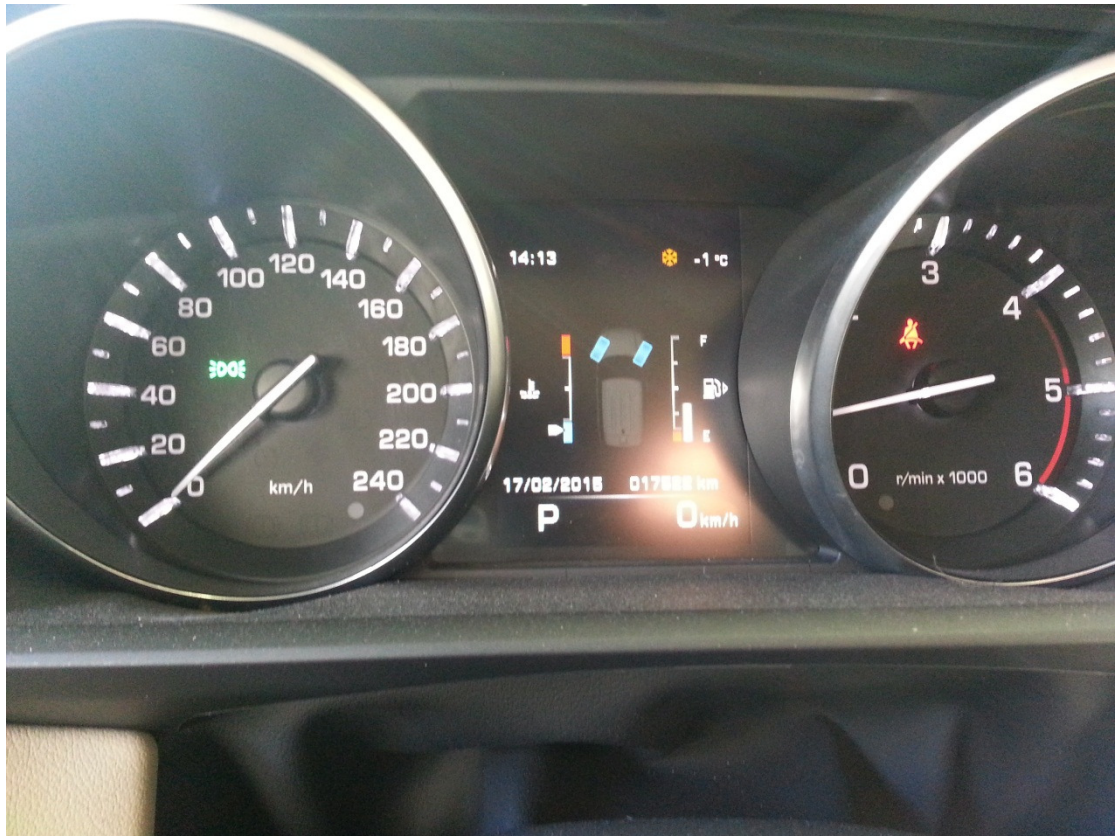
A customer may report that a set of blue road wheels appear in the message centre on the Instrument Cluster, when the Terrain Response Control is set to Auto mode. On occasions the wheel position shown in the message centre appears to remain in a constant position that does not match the road wheel position. The display will return to normal when the vehicle is stationary. Please view the attachment that shows the message centre display.

Software calculation. Low line Instrument Cluster affected only.

Land Rover are currently in the process of preparing a Technical Service Bulletin for release shortly to rectify the concern. In the meantime if you have a vehicle where the customer has reported the concern and requires a solution as quickly as possible, please raise a Technical Assistance case for further guidance.
