TT 96-16-01

2016 Tiguan – Vehicles equipped with Kessy, Entry Handle electronic indication does not work

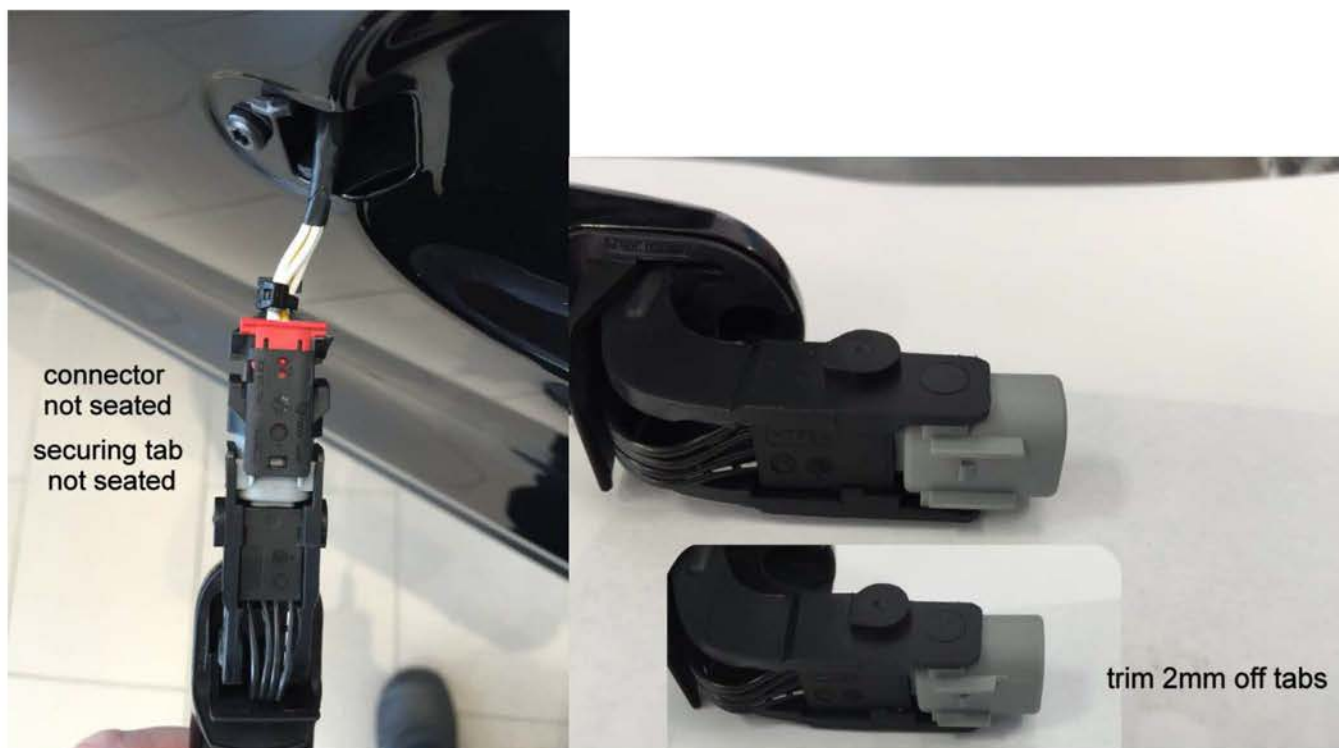
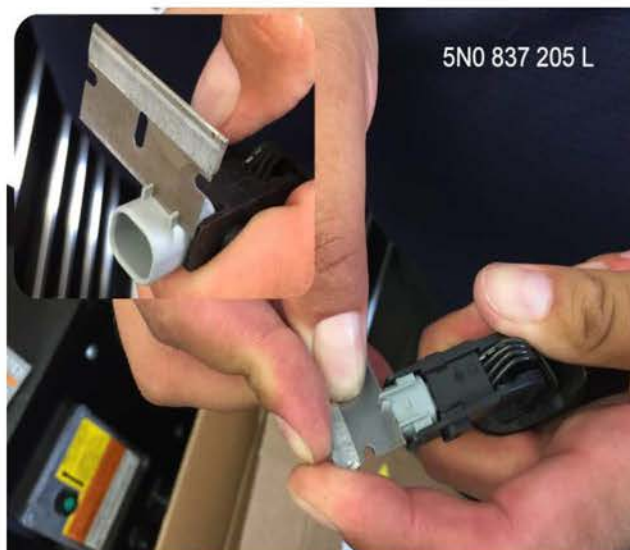
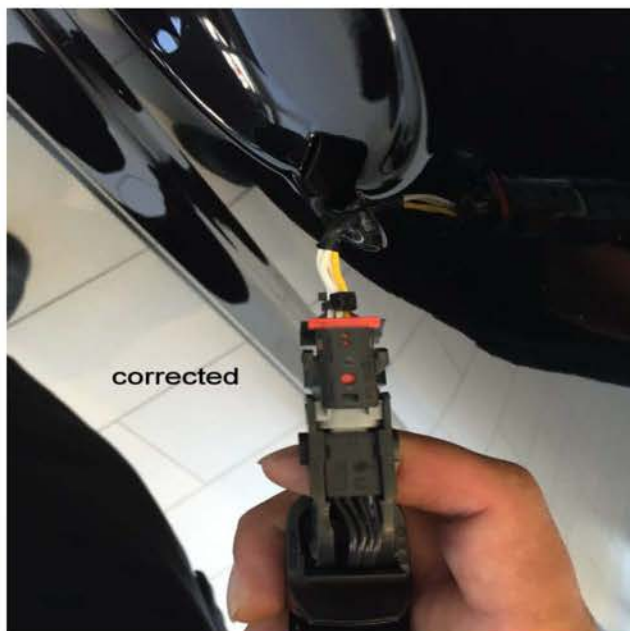
The door handle connector may not be fully seated, as a result of connector guide ribs being too long. Trimming the connector ribs will allow the connector to seat fully. See Photos.

**Be extremely cautious using the blade!**
