ATB 51811-01884 Version 8

## Safety Recall: Front Passenger's Airbag Inflator Can Be Over-Pressurized

Supersedes 14-040, dated April 17, 2015, to revise the information highlighted in **yellow**

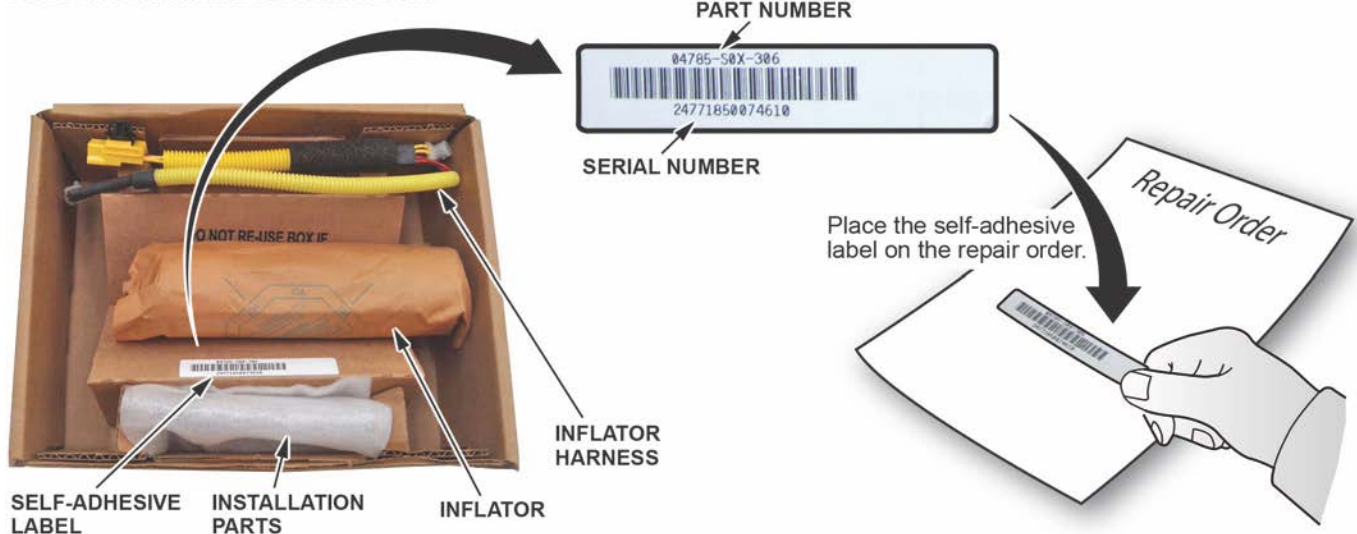
### PASSENGER INFLATOR PARTS BOX

- The replacement part number is printed on the top part of the label and the serial number is printed on the bottom. **Make sure you attach the label to the R.O. and give it to the warranty clerk.**
- There may also be a colored sticker located in the kit, ignore it because it is not used.
- Not all inflator kits have a label included. In those cases, write the serial number and part number from the side of the inflator box on the R.O. The part number always starts with 047.

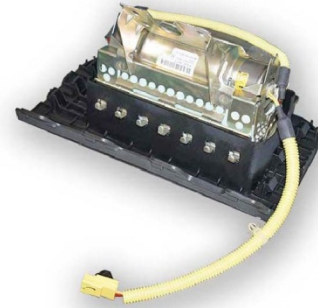
**PILOT**

3. Place the airbag face-down on a clean shop towel as shown.

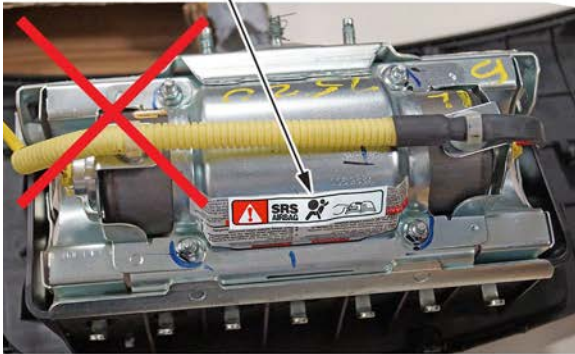
NON-STANDARD SAFETY LABEL

- If there is nothing unusual about the airbag or the inflator, go to step 5.
- If there are any unusual markings, like an incorrect label or a model year written in marker, the airbag and inflator may not be the correct airbag and/or inflator for the vehicle or it may be a counterfeit part. For more information about counterfeit airbags, you can refer to [safercar.gov](http://safercar.gov), enter keywords **MANAGING COUNTERFEIT**, and select **Recommended Dealer Guidance for Managing Counterfeit Air Bags** from the list. **If you suspect that the airbag or inflator is counterfeit, do not continue this procedure.** Contact your DPSM for assistance.

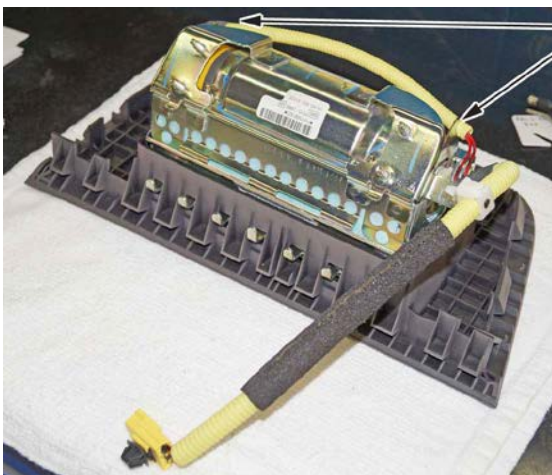
INFLATOR BRACKETS

5. Remove the harness from both ends of the inflator bracket.

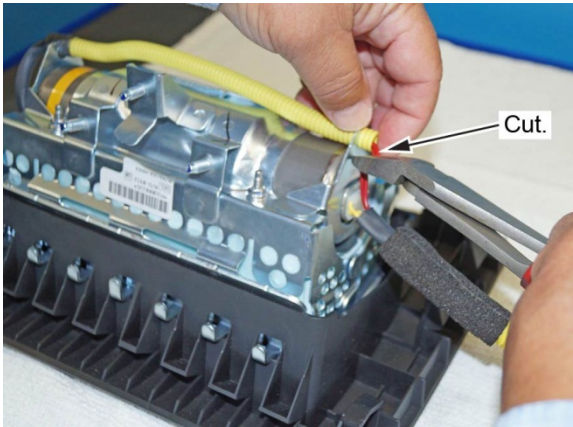
- Cut the red wires as shown.

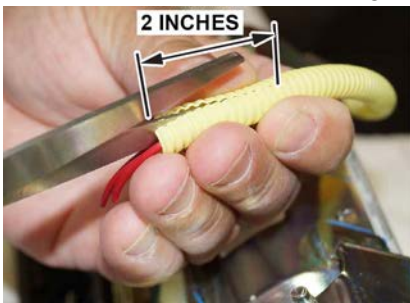
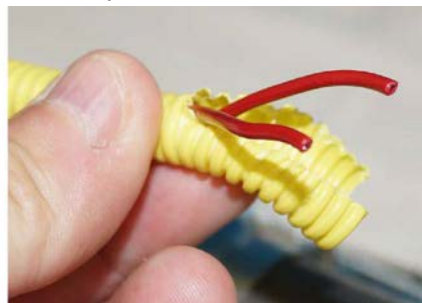
- Cut about 2 inches of the corrugated tube, then pull out the two red wires.

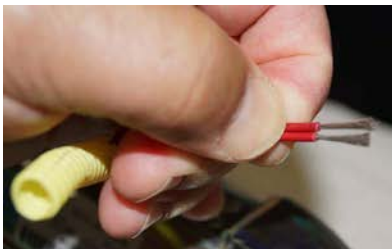
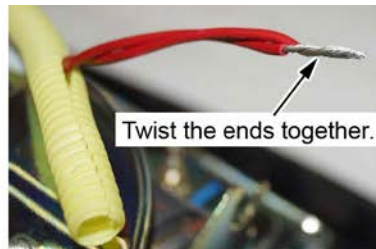
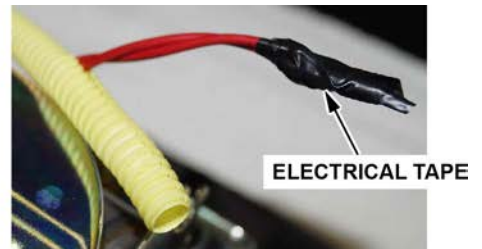
- Strip away about 1 inch of the wire insulation, then twist the wires together.

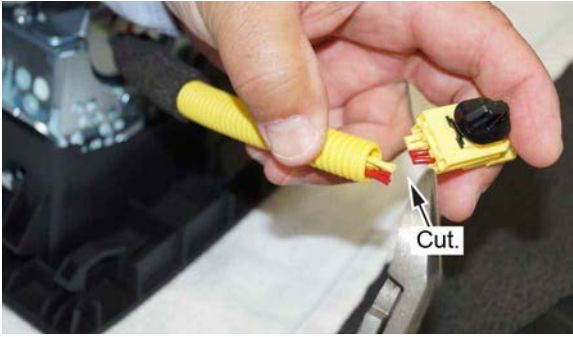
- Cut all four wires to remove the connector.

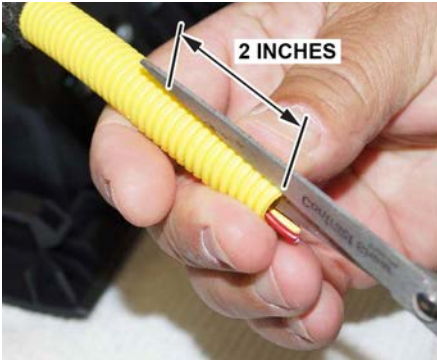
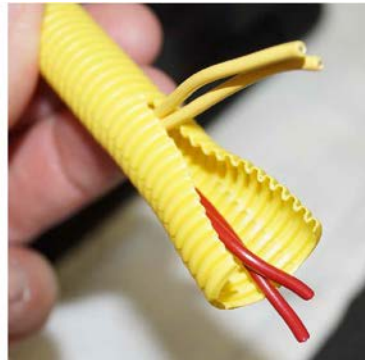
- Cut about 2 inches of the corrugated tube, then pull out the yellow wires.

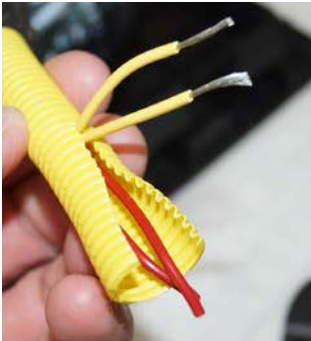
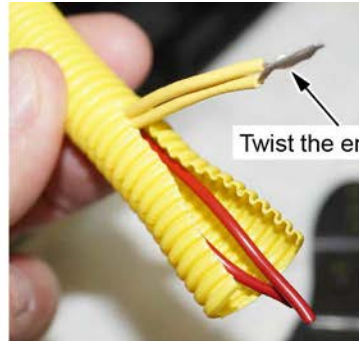
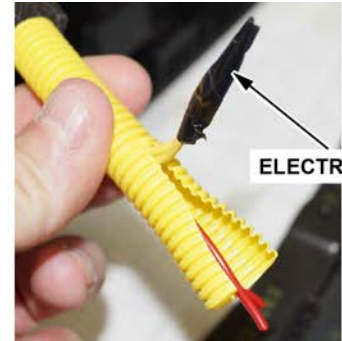
- Strip away about an inch of the wire insulation, then twist the wires together.

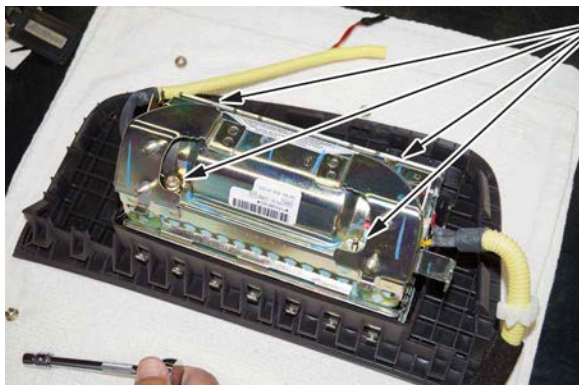
8. Remove the four inflator nuts.

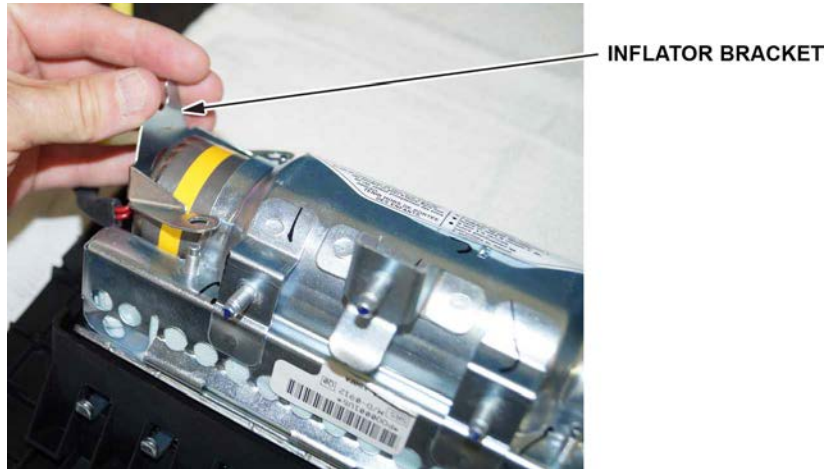
9. Remove the inflator bracket.

NOTE: You can only remove one of the brackets, as the other is welded to the airbag housing.

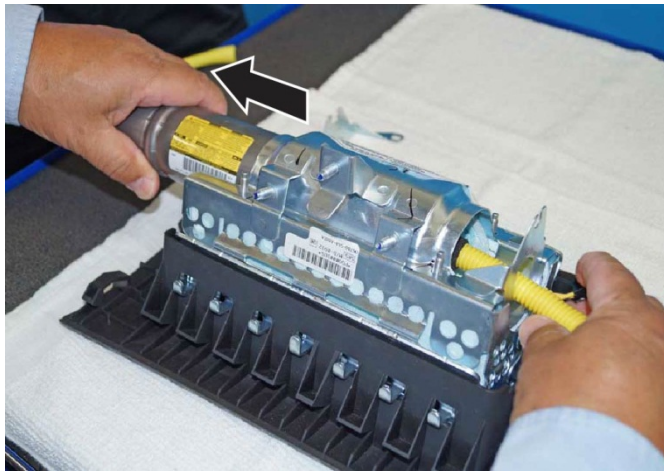
10. Remove the inflator by pushing it out.

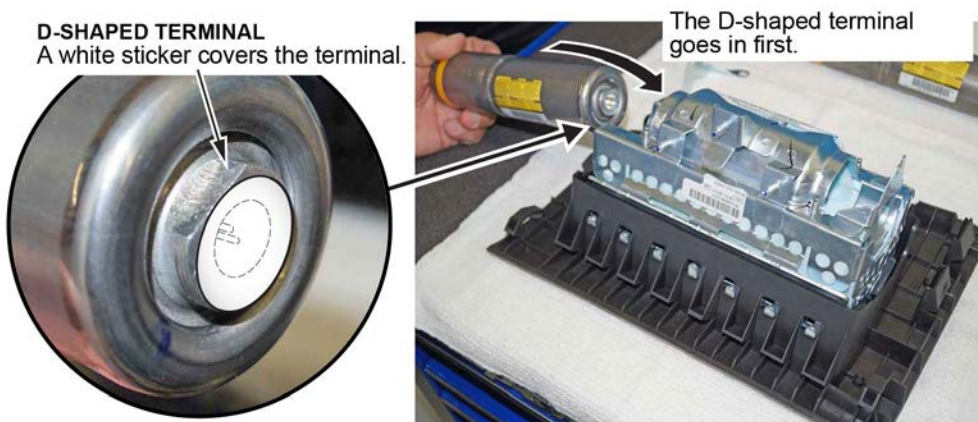
- One connector looks like a "D" whereas the other connector is a circle. Make sure you insert the "D" connector into the airbag first.

NOTE: There is a yellow band marking on the circle side.

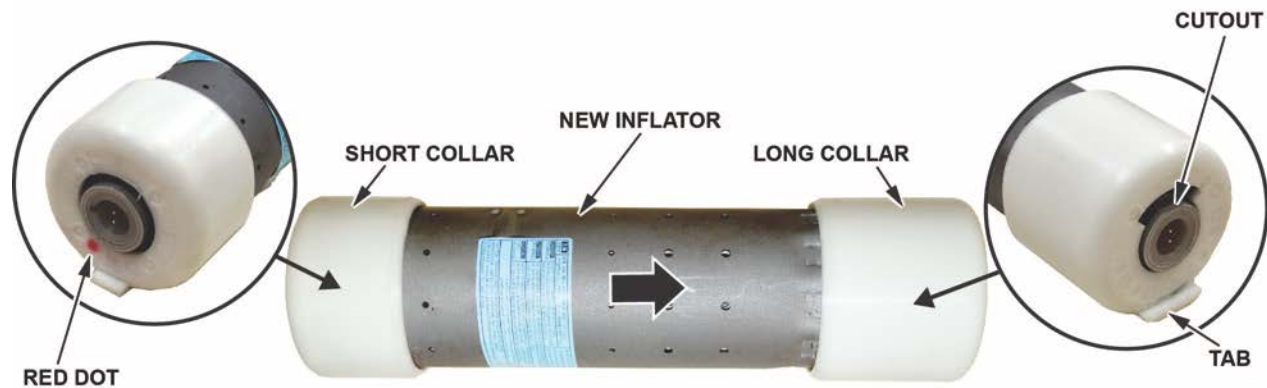
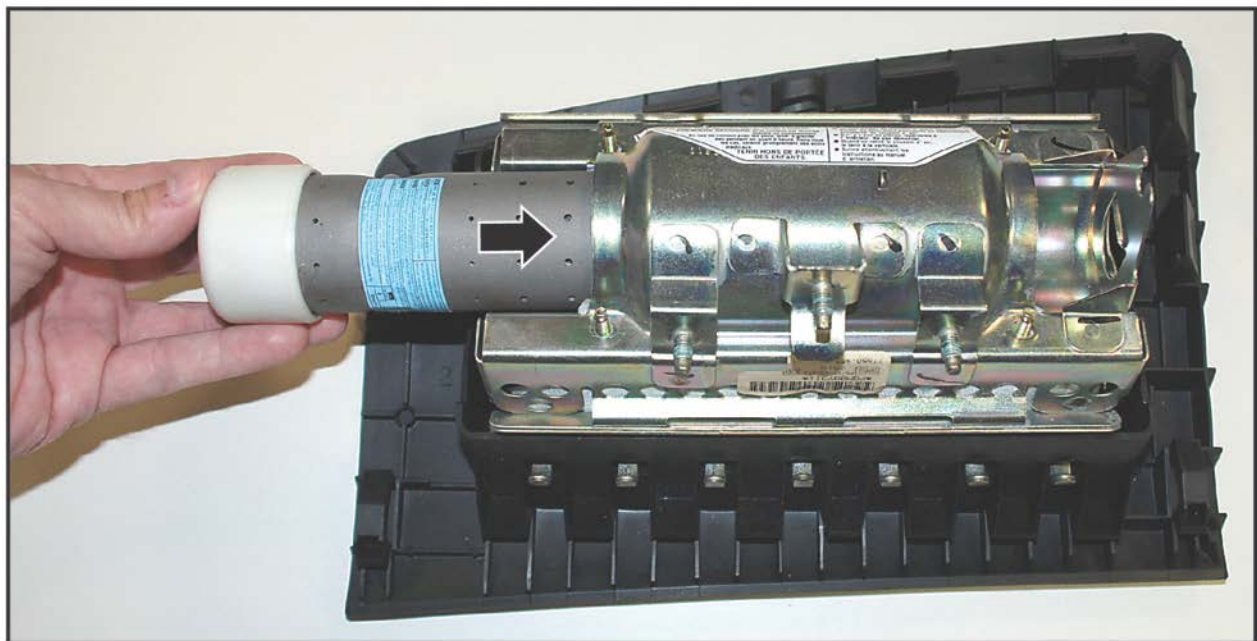
- One side of the inflator has a longer collar, a longer tab, a plastic cutout, and a small flat spot on the connector. The other side of the inflator has a shorter collar, a shorter tab, and a red dot. Make sure you insert the end with the longer collar into the airbag first.

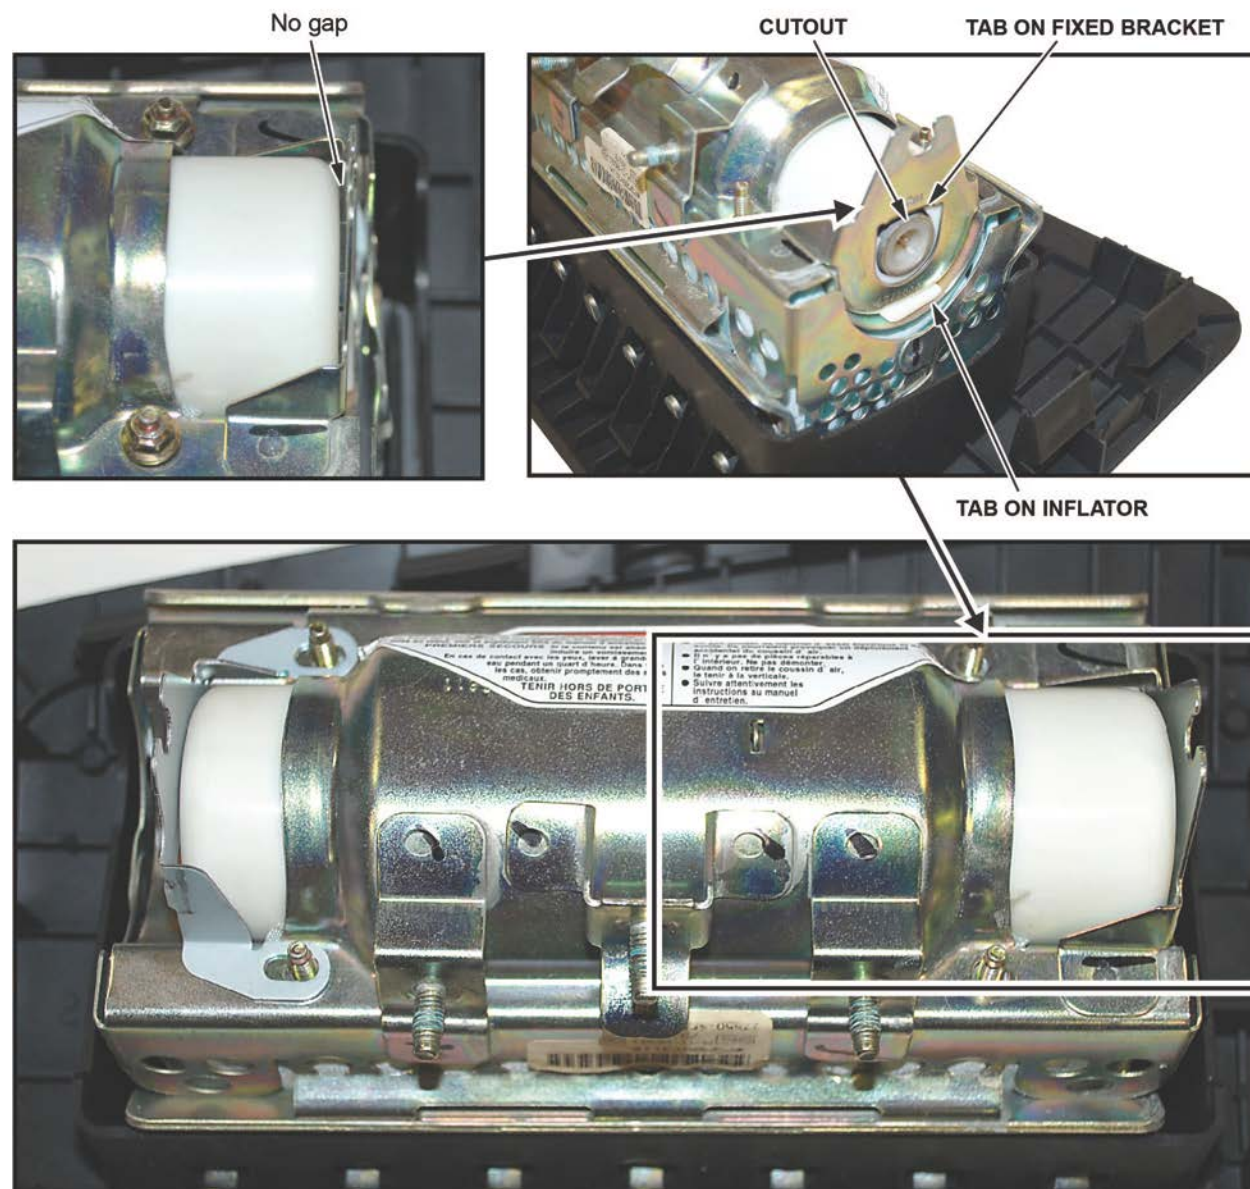
#### FIXED BRACKET END

- Slide the inflator in until the plastic cutout and the small flat spot align with the tab on the bracket. There should be no space or gap between the inflator and bracket.

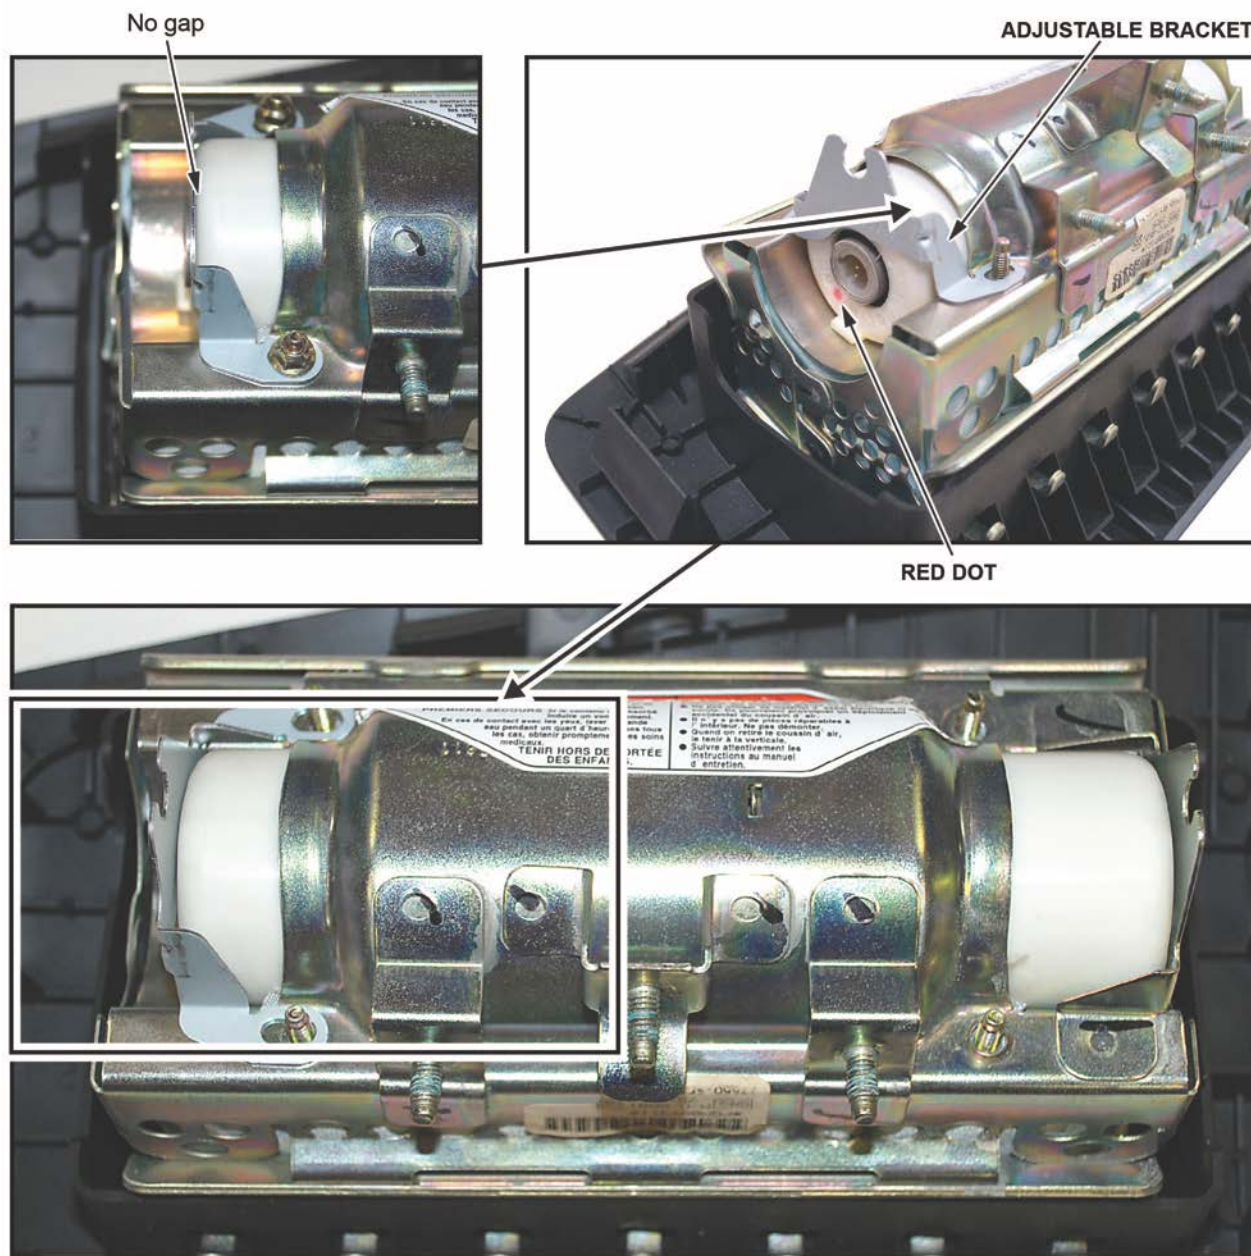
#### ADJUSTABLE BRACKET END

- Install the bracket included in the kit onto the airbag module. There should be a red dot visible on the end of the plastic connector. There should be no space or gap between the inflator and bracket.

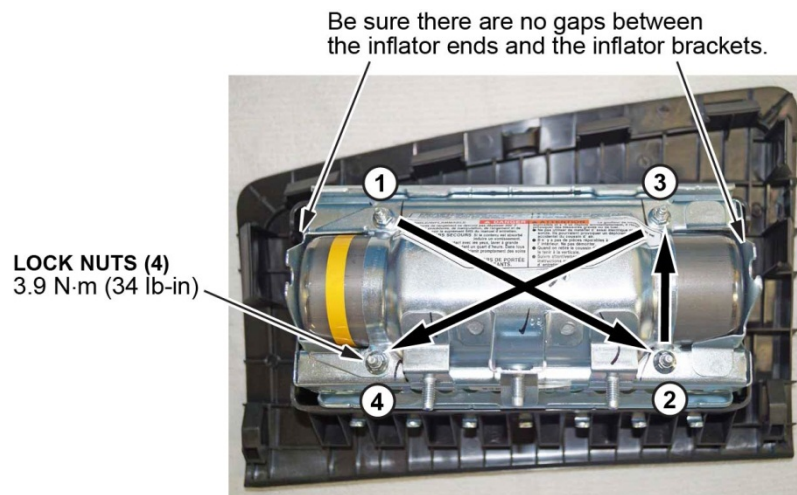
12. Install the new 5 mm locknuts and torque them in sequence to **3.9 N•m (34 lb-in)**.

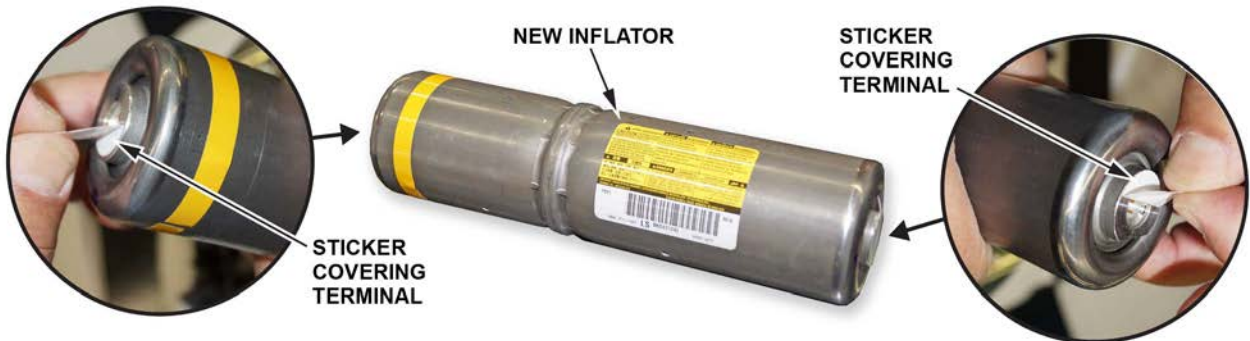
13. Remove the stickers covering the terminals on both sides of the new inflator.

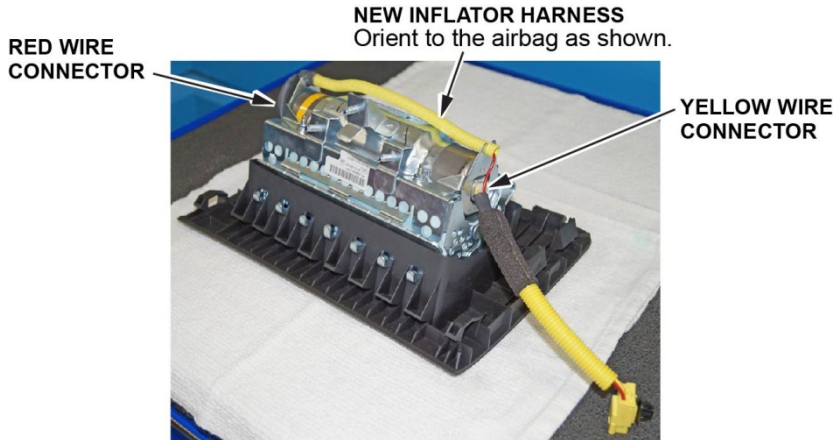
- Make sure the airbag and harness are aligned as shown.

- **Make sure you have the orientation correct as shown below.** If you connect the harness incorrectly, the harness cannot be removed, and you will not be able to reinstall the airbag because the harness will be too short.
- On the replacement inflators with plastic collars, connect the red wire connector to the connector with the red dot.
- On the replacement inflators without plastic collars, connect the red wire connector to the connector nearest the yellow band.

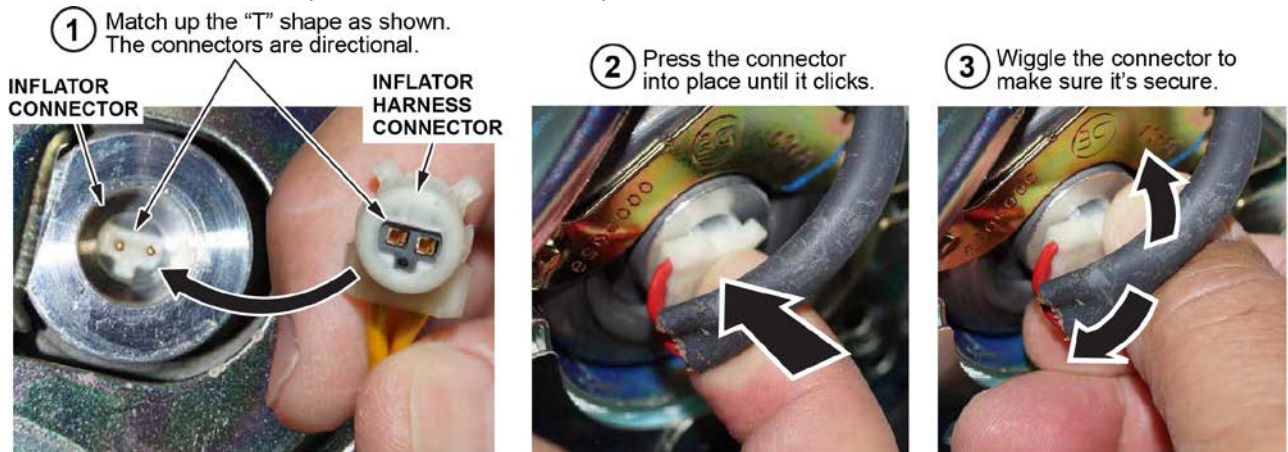
- Connect the two connectors. **Align the “T” shape in the inflator harness connector with the T-shaped inflator connector**, then press the connector into place.

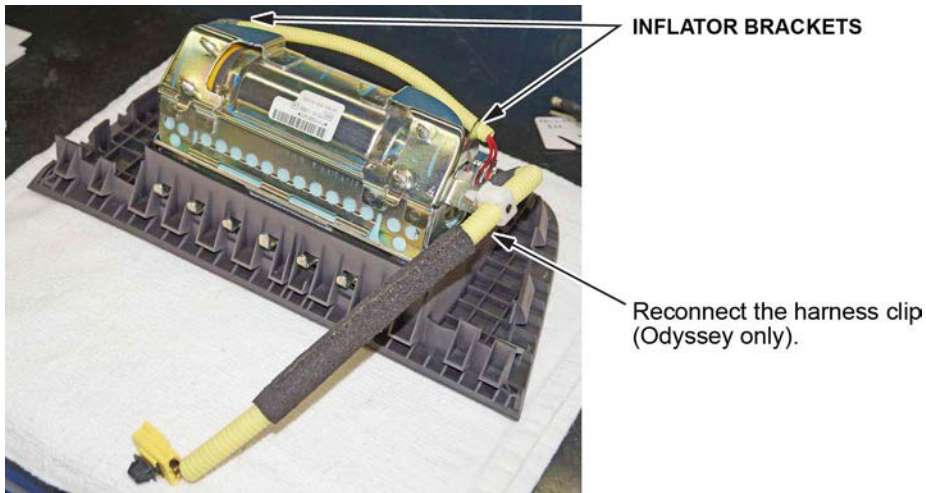
- Insert the side without the shrink-wrap tubing first. Insert the harness at the third “valley” in the corrugated tube.
- Insert the side of the harness with the shrink-wrap tubing into the inflator bracket. Make sure the harness is securely inserted and that it does not sag.
